English Brook Watershed Assessment

Warren County Soil and Water Conservation District

September 2008

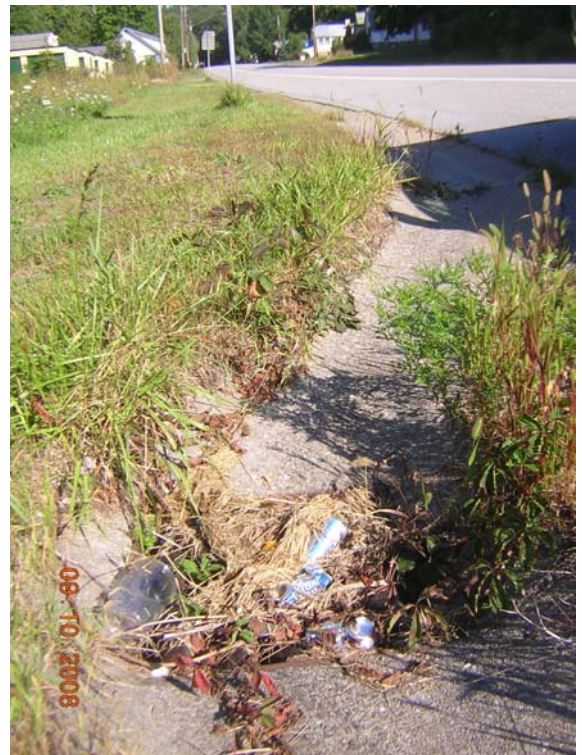
Drop inlet along NYS Route 9 which is plugged with garbage and debris. These locations are excellent candidates for stormwater retrofits

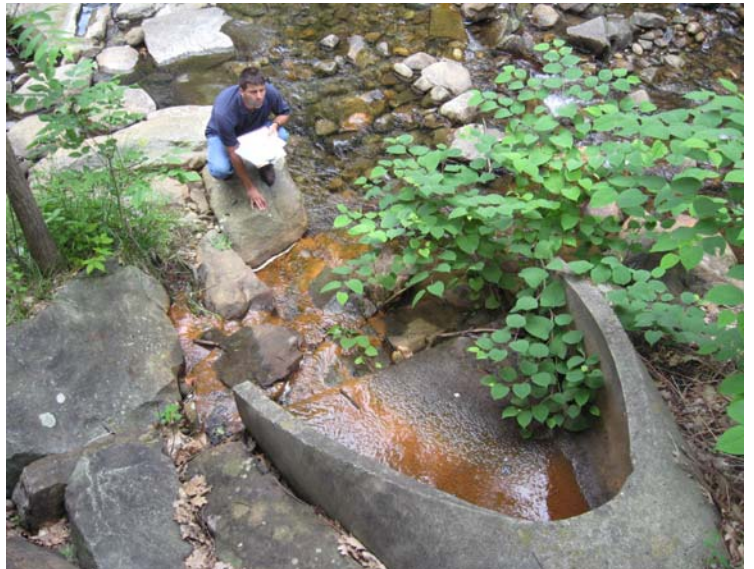
9. There is a 38" dia. concrete outfall just down stream of the exit 22 ramp off Interstate 87. This outfall has the capacity to pass significant volumes of water. Its drainage area includes two drop inlets on the south side of the exit ramp which are connected to the north side of the ramp by a culvert. This culvert accepts runoff through an asphalt swale that extends to the west side of I87 and encompasses a drainage area of approximately 60 acres. The concrete swale that runs the length of the onramp to I87 northbound should be reverted to a cobble/grass swale with earthen checkdams to allow water to infiltrate. The cobble swale would also reduce the velocity of the water and decrease its erosive force downstream. The drainage which ultimately comes to this point is complex and merits further study, as it is significant and has the capacity to discharge a large amount of stormwater into the brook. Estimated Cost: To Be Determined

Large stormwater outfall from Exit 22

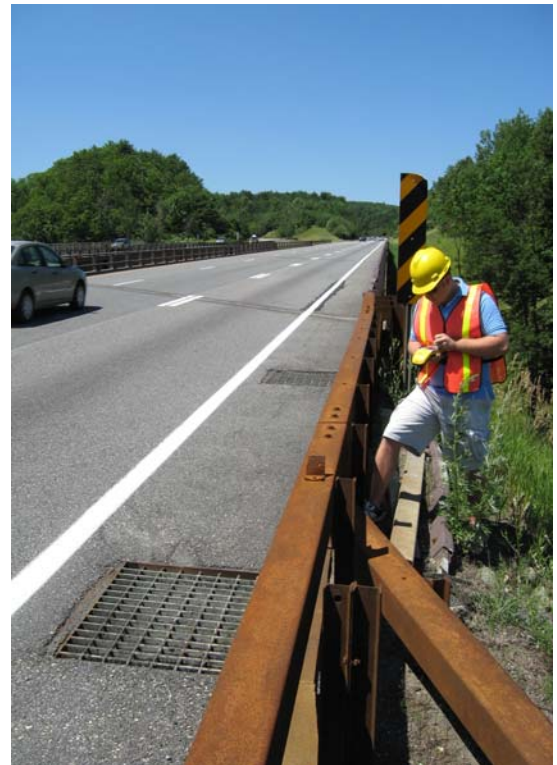
Drop inlets on I87 which drain directly down to NYS Route 9 and then into English Brook

3. Meet with NYS DOT to determine if the direct discharges from the I87/Route 9 overpass could be handled within the I87 corridor instead of being a discharge down to Route 9.

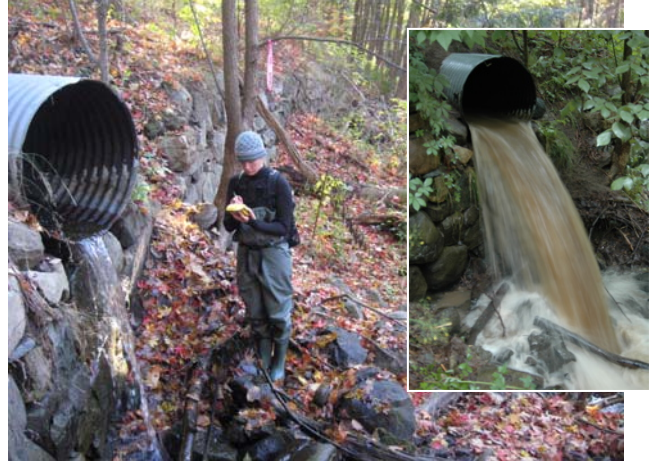
One of the largest stormwater culverts in the watershed can be found along Rt. 9N in Lake George on the north side of English Brook. This culvert is 36" in diameter. Stormwater from exit 22 and lower Hubble Lane enters two drop inlets at the base of Lower Hubble Lane. From there it is channeled under the road and picks up one more drop inlet before going to its outlet on the edge of the brook. Route 9N collects stormwater from all of Lower Hubble Lane and a large portion of the Exit 22 offramp as well. Hubble Lane stormwater is addressed separately in the "Town Roads" section.

Outfall at the Lochlea Estate from Route 9N

To improve the stormwater coming from this area, an open area adjacent to the current culvert outlet on the bank has been identified as a possible treatment area. The installation of a large (probably offline) hydrodynamic separator and associated infiltration chambers or similar could be placed in this location. It appears there would be minimal to no UFPO impact as overhead utilities are run on the other side of the road. This project would likely involve working on private property from the Lochlea Estate, which would need to be determined prior to any official movement on this solution. Also, this pipe shows evidence of flowing during non-storm events, suggesting inflow issues. If this is the case, this would need to be addressed prior to any infiltration component was added.

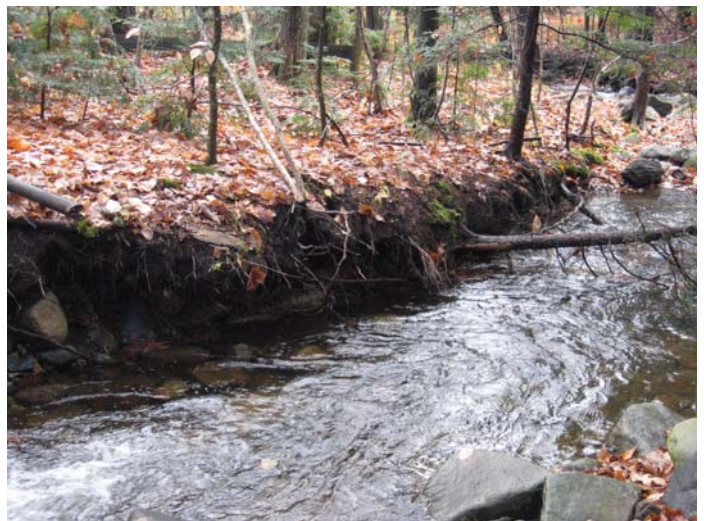
Undercut banks along English Brook are numerous and provide a fairly significant volume of sediment to the brook and Lake George

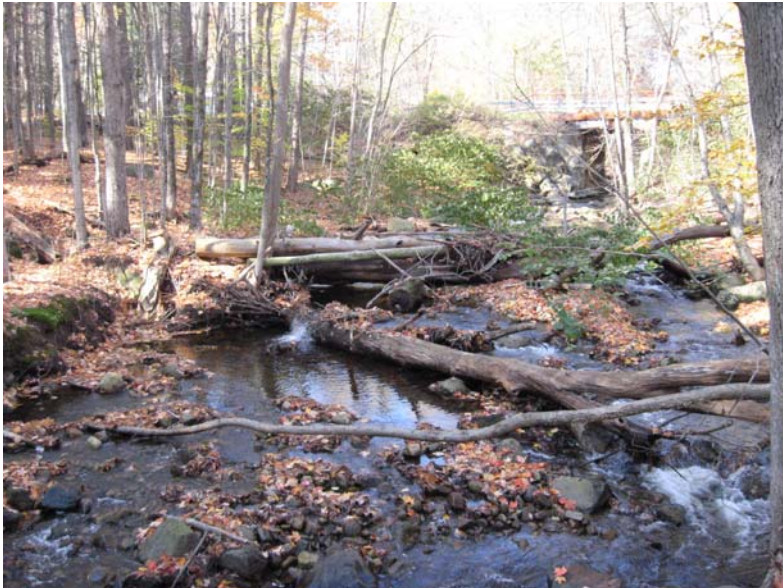
"Blowdown" of trees in English Brook is a common sight and a natural occurrence. However, situations like this can cause streams to erode their banks and overwiden, causing problems in the channel.

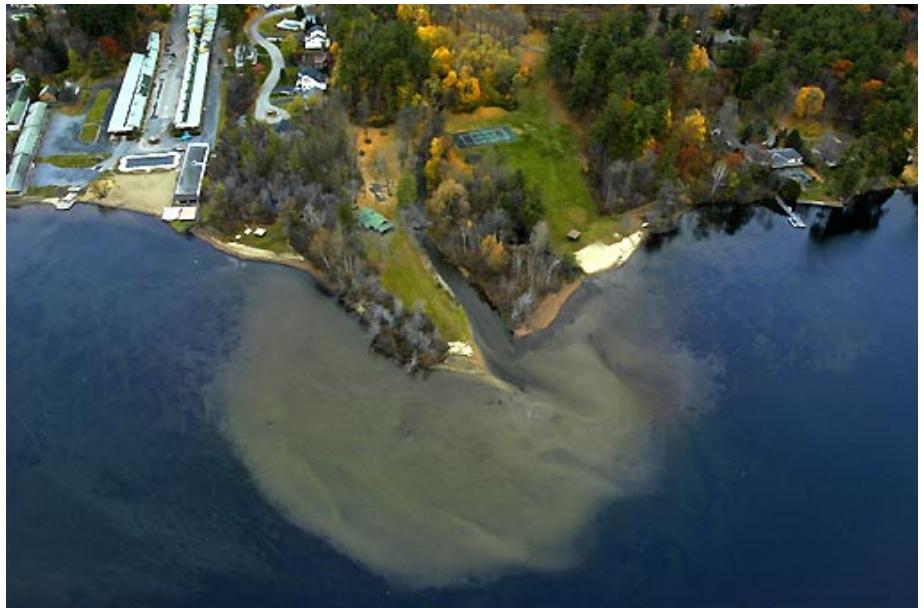
*English Brook Delta in Lake George – 2007
Photo: Post Star Newspaper*

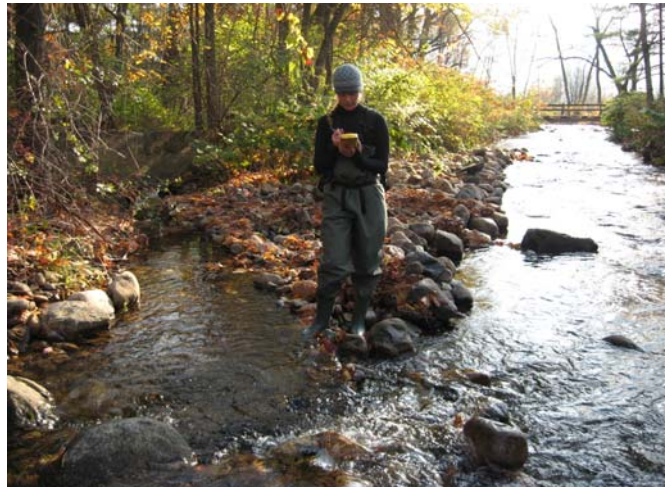
Channel aggradation on the Lochlea Estate property. The channel elevation has been increasing as over time, leading to localized flooding issues

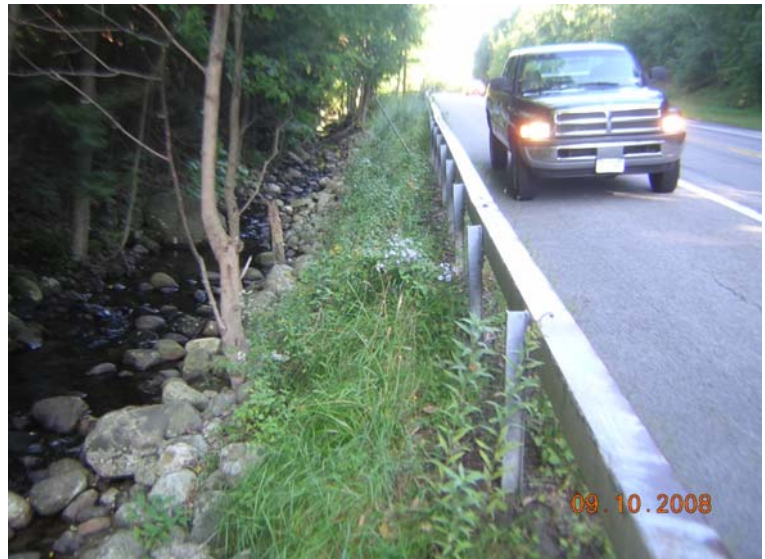
Vegetated buffer between NYS Route 9 and English Brook. Buffers average approximately 15 feet wide in this highway corridor
