Stewart Brook / Dula Pond Watershed Assessment

Prepared For the Town of Bolton

by the Warren County Soil and Water Conservation District

February 2012

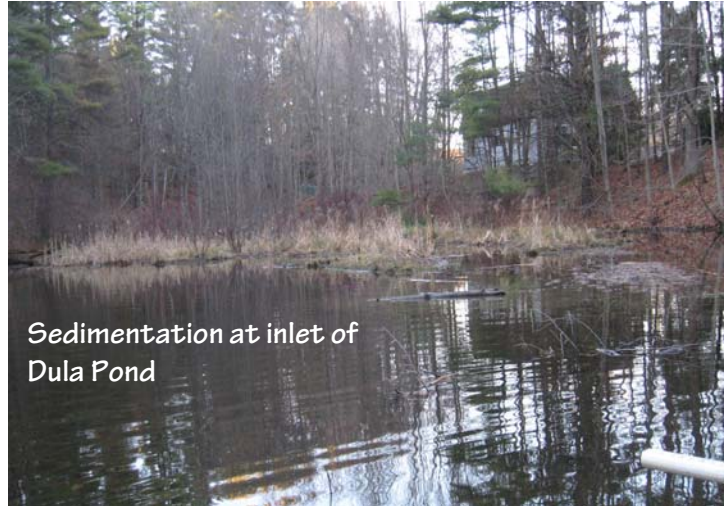
Visual inspections confirm that there is a fairly sizeable sediment delta at the inlet of Stewart Brook into Dula Pond. Based on the volume of sediment and the relatively rapid growth of this delta as reported by local landowners, it is fair to say that this delta results from upland erosion and stormwater runoff issues, exceeding what would be expected from natural conditions. This assertion is confirmed by the evidence of erosion issues within the stream system and on some private properties within the watershed.

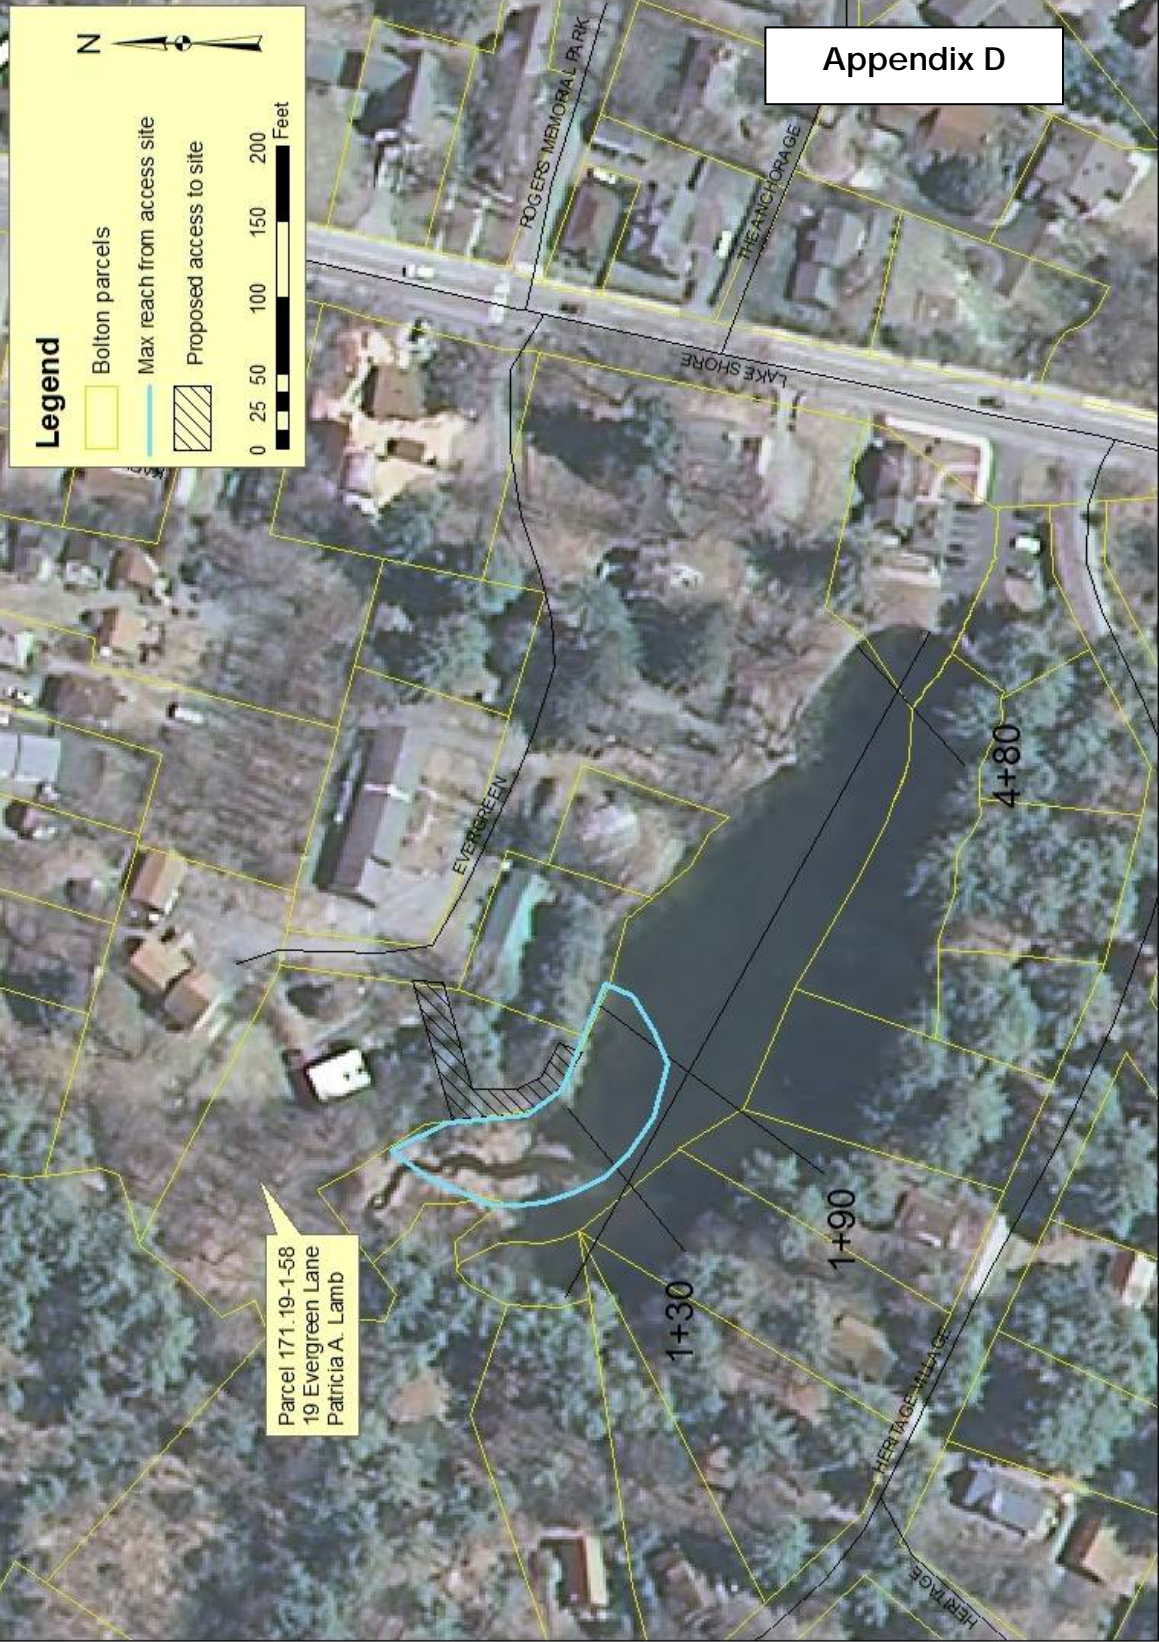
Dula Pond Access for Sediment Removal

From a logistical standpoint, the dredging of the inlet sediments would be feasible with traditional heavy equipment (excavators and trucks). Physical access to the site is possible from Evergreen Lane, between the houses at the northeastern tip of

the pond (tax parcel 171.19-1-58, property owned by Patricia Lamb according to tax records). A temporary access road of approximately 70 feet would need to be constructed across the property for trucks to enter and leave the pond dredging site. Temporary landowner access agreements and post-project site restoration would need to be worked out, but a project of this scale is not logistically difficult. As wetland vegetation has grown on the sediments over the years, it is highly likely that this area would be determined to be a regulated wetland by the Adirondack Park Agency. Their involvement and permit determination would be necessary before proceeding much further with logistics and project costing.

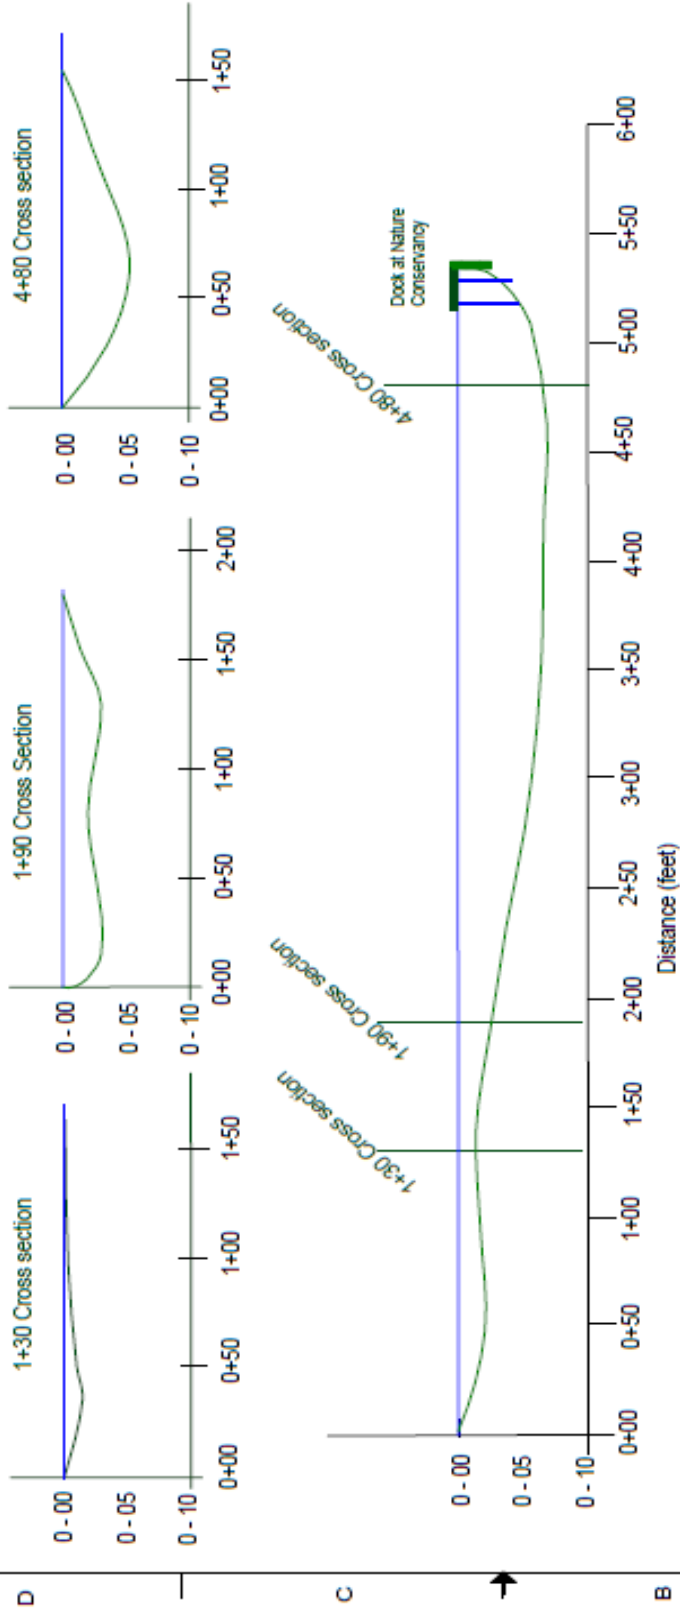
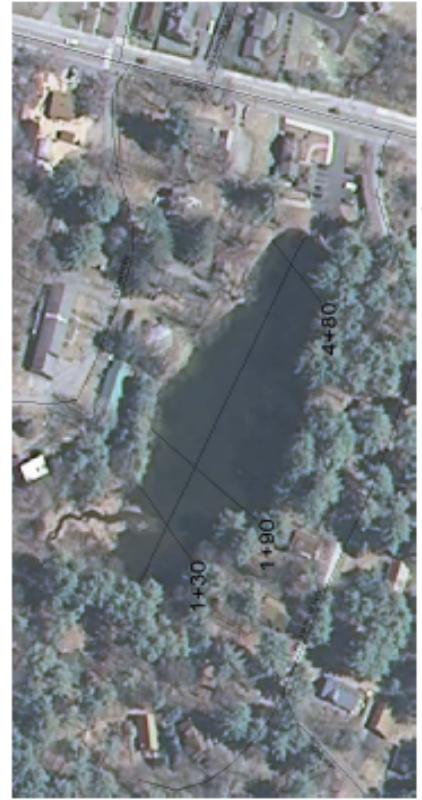
Dula Pond Bathymetry

SWCD staff took one longitudinal transect and three cross section transects of pond depths in Dula Pond to get an overall status of the general depths in the pond at various locations (Appendices D and E). The pond depth for the first 200 feet or so of the pond below the inlet ranges from zero to three feet, and then the depth slowly drops off to a maximum depth of six to seven feet towards the outlet. The SWCD does not have historical information on original pond depth or excavation, so comparisons to original condition are not reported herein.
