Town of Bolton Stormwater Retrofit Opportunities

Warren County Soil and Water
Conservation District

For the Town of Bolton under the Lake George Park
Commission Community Stormwater Grant Program

April 2013

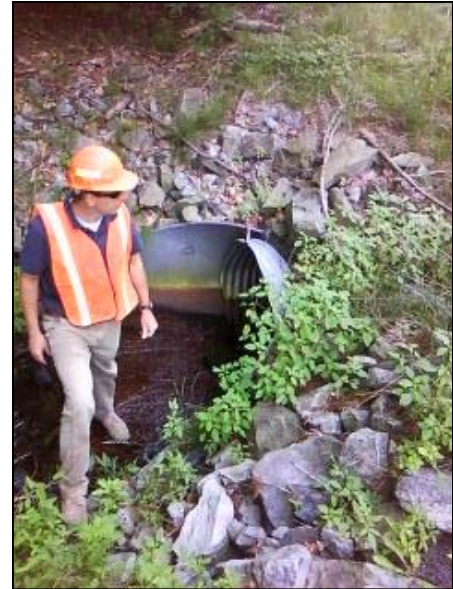
A paved ditch located 50 feet south of Heroes Loop on Valley Woods Road drains directly to Finkle Brook. The location where the paved ditch outlets to the brook is a low point in the topography resulting in a stormwater runoff collection point. Valley Woods Road is crowned in the center draining a road width of 10 feet and a road length of 1,500 feet. Roadside runoff is conveyed from both the north and the south with the majority of the stormwater draining from the north. During a one inch storm, this location receives approximately 9,350 gallons of stormwater runoff.

Paved Ditch to Finkle Brook
On Valley Woods Road

The recommended retrofit to slow velocity, capture and infiltrate stormwater runoff would consist of two parts. The initial work would be to replace the impervious paved swales with vegetation and check dams to slow stormwater velocity allowing for sediments to drop out, and by removing the impervious surface, stormwater will also be able to infiltrate, reducing runoff volume. The second part consists of two drywells that will capture and infiltrate stormwater preventing the first flush of stormwater which contains the highest amount of stormwater pollutants from entering Finkle Brook. Construction constraints, such as depth to bedrock and groundwater, will determine if this location is feasible for stormwater infiltration.

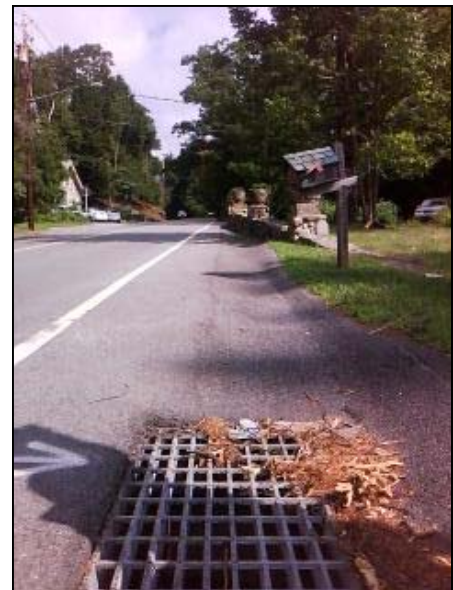
Three drop inlets located on Lake Shore Drive drain a significant amount of roadside stormwater runoff directly to Finkle Brook. The drop inlet located at the intersection of North Brook Drive and Lake Shore Drive captures 200 feet of roadside drainage in paved ditches and is connected to a drop inlet located west across the road from Darin Fresh Water Institute. This second drop inlet located on the west side of Lake Shore Drive across from Drain Fresh Water Institute outlets directly to Finkle Brook and captures an additional

Paved Ditch to Drop Inlet on
Lake Shore Drive

This 775 foot stretch of Lake Shore Drive is in a challenging location with multiple construction constraints due to Finkle Brook's proximity to the road and the steep slopes with very limited treatment space on the west side of the road. The heavily forested area, necessary road de-icing materials for safe travel, and paved driveways connecting to the road make it difficult to establish vegetated swales in this particular location. The housing and building development, steep slopes, and bedrock all reduce the ability for stormwater retrofit opportunities.

Due to all the site constraints, there are very limited possibilities for infiltration systems on this section of Lake Shore Drive. A system that works well in sites with multiple limitations is a hydrodynamic flow separator. The small footprint of this structure will make it ideal for the constrained location on Lake Shore Drive. In addition, the lightweight design makes for ease of install without the need for heavy lifting equipment. Hydrodynamic flow separators swirl stormwater allowing for the suspended solids (sediment) to be stored at the bottom, floatables such as plastic bottles and greases/oils to be at the top of the device until it is time for maintenance.

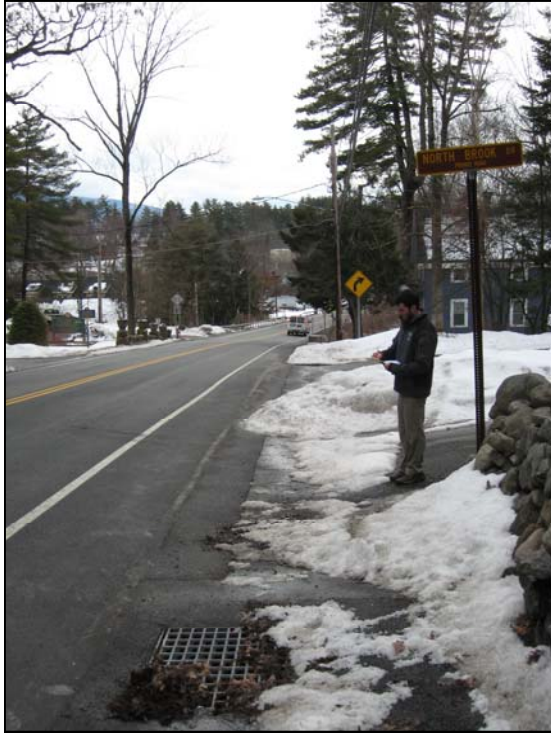
Intersection of Lake Shore Drive and North Brook Drive

250 feet of road in paved ditches adding to the 200 feet captured at the North Brook intersection. On the east side of Lake Shore Drive in front of the Darin Fresh Water Institute, another drop inlet captures 325 feet of drainage in paved ditches and connects to the drop inlet on the west side which outlets to Finkle Brook. Between the three drop inlets, the entire 775 feet of Lake Shore Drive stormwater runoff is capture and conveyed to Finkle Brook. During the summer months, stormwater heats up on the pavement causing superheated stormwater to runoff into the brook producing thermal pollution and disrupting the stream's ecology. Also, the paved ditches along both sides of Lake Shore Drive increase stormwater velocity allowing the runoff to pickup de-icing materials and other pollutants before draining into the brook. The two southern drop inlets across from Darin Fresh Water Institute are currently full of sediment, which is a good sign, because the drop inlets do allow for some sediment to drop out and collect before entering the brook. The

amount of sediment in the drop inlets is also a reminder of the maintenance that needs to be performed on stormwater conveyance systems and the need for additional storage capacity for sediment and other suspended solids before entering the brook.

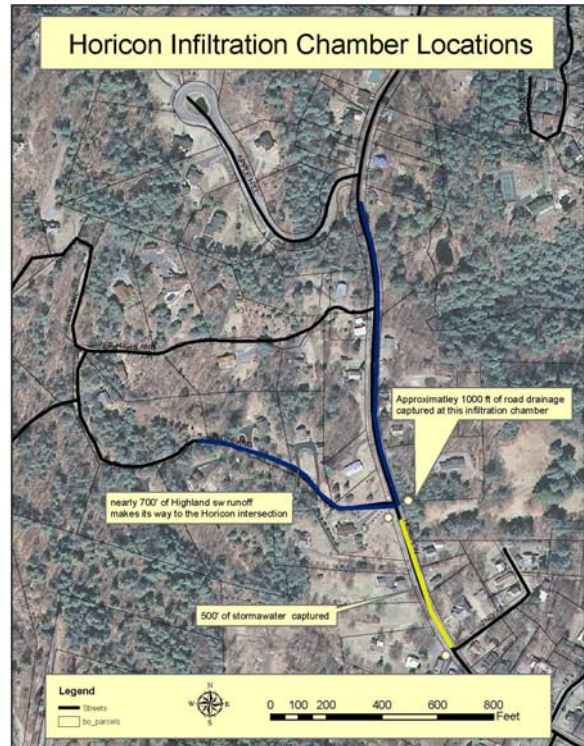
There is nearly a 2,000 foot stretch of Horicon Avenue starting just south of Apple Hill Road and continues to a bend just below Second Avenue. This portion of road includes upper and lower Highland Drive (which contributes another 1,000 feet) and continues down past the driveways across from Second Avenue that have been taking the majority of stormwater for some time. Residents have resorted to a speed bump deep lip in the swale at the end of their driveways to divert the stormwater further down the road. This section of Horicon Ave. has a nearly 20% slope. Much of this stretch of road drains towards Stewart Brook and carries the materials to Lake George. This stretch of road is neither ditched nor allows for the stormwater to splay to vegetated swales. Breaking up stormwater with retrofits above this location would go a long way to lessening the impact it currently has on residences, the road, and the stream below.

The recommended retrofit to slow velocity, capture, and infiltrate stormwater runoff would consist of three installations. The first of three would place a double stack infiltration chamber on the south side of Upper Highland Drive that would capture stormwater from the nearly 800' of that road as well as, 1,300' from Horicon Avenue itself through a turned out swale and catch basin on the north side of the road. A second installation would be placed on the east side of Horicon Avenue across from Highland Drive and would include a bowled out swale to a drop inlet on a single stack drywell. Lastly, a third infiltration chamber would be placed in the bend of Horicon Avenue above Second Avenue and would incorporate a rock lined swale to the drop inlet of the structure and a berm to divert excessive stormwater back to the ditch. These drywells will capture and infiltrate stormwater preventing the first flush of stormwater which contains the highest amount of stormwater pollutants from entering Stewart Brook. Construction constraints, such as depth to bedrock and utility locations will determine if this location is feasible for a stormwater infiltration system.

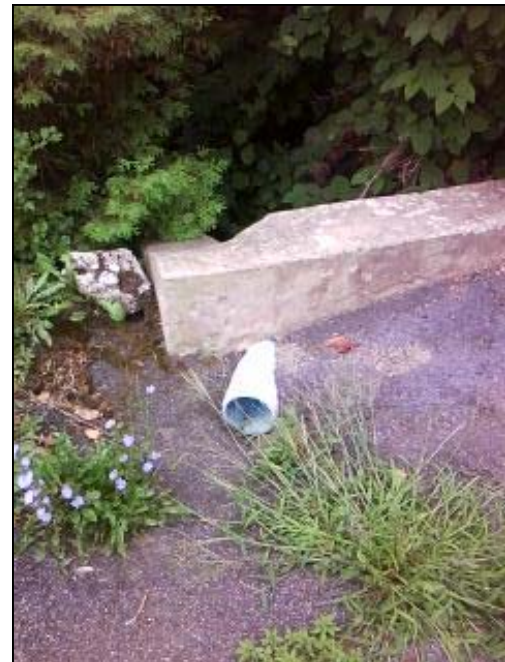
Goodman Avenue is a suggested site in the "Stewart Brook/Dula Pond Watershed Assessment" report, and while checking the feasibility of an infiltration system in this location, the District performed a secondary study. Stewart Brook flows south under Goodman Avenue where it receives roadside runoff at two location on the north and south side of the road. The north side of Goodman Avenue drains 150' of road while the south side drains 500' of road during a storm. At this location Stewart Brook receives 6,078 gallons of stormwater during a 1" storm event. The ditches are partially paved and partially vegetated with paved swales designed to catch stormwater around the outlets and convey it to Stewart Brook.

The North Side of Goodman Avenue Draining to Stewart Brook

Preventing direct stormwater discharge to Stewart Brook is a top priority in this location. The removal of the paved swales to the Brook and replacing them with vegetated swales at the north and south outlet to the brook. On steeper slopes it is recommended that the bottom or the entire ditch be stone lined to decrease stormwater velocities. To prevent any flooding during a large storm event, the swale would have an overflow outlet to the brook or forested area near the brook. This location would have to involve property owners. Also, connecting the roadside runoff and bio-retention basin with vegetated ditches. To aid with stormwater velocity in this particular location, the addition of check dams will slow the runoff and allow for additional infiltration and suspended solid removal.

The low point in the topography at the Stewart Brook culvert crossing indicates high groundwater. A test pit will need to be dug to determine if larger stormwater infrastructure will be feasible at the Goodman Avenue location or if the site constraints, such as depth to groundwater and bedrock, will prevent a shallow drywell from being installed. The installation of a drywell will capture additional stormwater runoff and infiltrate it while recharging the groundwater and capturing sediments and pollutants before entering the brook.

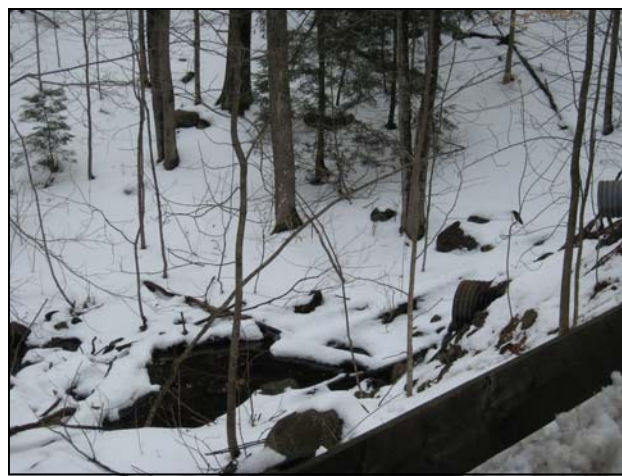
Three culverts located on Frank Cameron Road drain stormwater from the golf course to an unnamed tributary of Finkle Brook. Further research would need to be done on the inlets and drainage to these culverts. Stormwater draining from a golf course is just like draining from a lawn but on a larger scale. The stormwater draining from lawns, depending on how the lawns are maintained, may be conveying herbicides to the stream but on the plus side the stormwater runoff is flowing through vegetation before entering the culvert inlets. A more in-depth study of this outfalls and stormwater conveyance may want to be done at some point in the future.

Frank Cameron Road Culverts

Some overall recommendations for Frank Cameron Road would be talking to the golf course to see what kind and how much herbicide and nitrogen is applied to the grass. Once the information is gathered, further research (soil test) to see if any changes could be made to be more economical for golf course and outlet cleaner stormwater runoff.

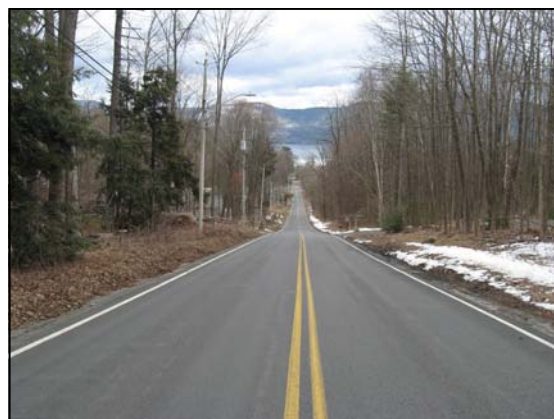
Mohican Road drains a significant amount of stormwater east towards Lake Shore Drive (Route 9N) and Lake George. Using infiltration systems to break up stormwater drainage throughout the Lake George watershed is the best way of dealing with runoff and preventing pollutants from entering the lake. Multiple infiltration site locations will prevent any one location from being overwhelmed with stormwater runoff and failing during the continuously more common large storm events the northeast has been experiencing. Breaking up and infiltrating

Mohican Road Drainage

stormwater also prevents large volumes from accumulating at high velocities on steep roads creating other stormwater issues such as roadside erosion. Mohican Road is a straight road with paved swales that allow stormwater velocity to build and increase which in turn increases distance of stormwater travel and decreases infiltration rates. The increased stormwater velocity also carries higher amounts of de-icing materials and other pollutants.

A Mohican Road stormwater infiltration system is already well into the planning stages and consists of three potential locations located a third of a mile west of the intersection of Lake Shore Drive. Each of the planned drywells installations are located above drainage outfalls which will divert the stormwater from the ditching to a drywell. Depending on site constraints, the plan is to install one or two drywells that would be in series at each identified location. A test pit will be dug this spring and the groundwater elevation will determine size and depth of drywells. The series of drywells will all be

located on the south side of Mohican Road due to utilities and other site constraints on the north side. The three drywell location will not be connected lessening the construction and disturbance footprint and allowing the ability to break up stormwater over a larger distance.

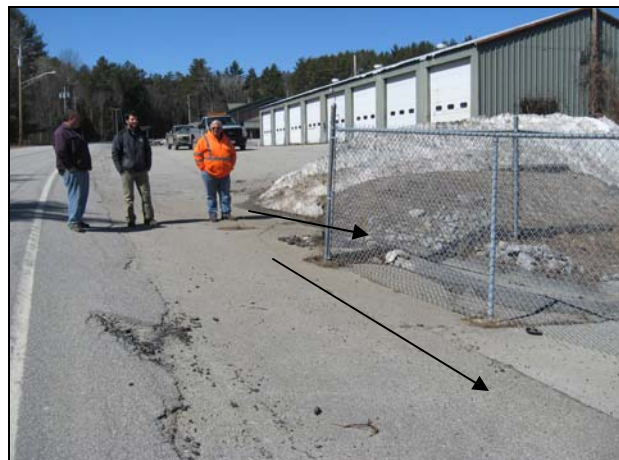
The other location on the highway garage property is located to the east of the old highway garage building. This section of the property receives stormwater flowing east from Finkle Road and turns north and flows through a ditch to the unnamed tributary of Finkle Brook. Each of these locations contribute stormwater drainage and de-icing material runoff to the stream. A single stack drywell retrofit or if feasible, a double stacked drywell will capture the majority of the runoff reducing stormwater impacts to the stream. This retrofit will

Stormwater Drainage from Lake Shore Drive to the Old Highway Garage

reduce the overall stormwater pollution Finkle Brook and eventually Lake George.

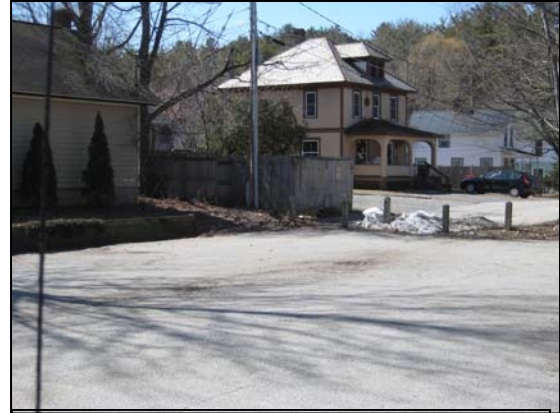
Town Municipal Parking Lot

The town municipal parking lot is located on the west side of Lake Shore Drive (9N) and has an issue with stormwater pooling on the lot. Approximately six feet in from Lake Shore Drive, the parking lot has a slight rise preventing the stormwater from draining to Lake Shore Drive. Not draining to Lake Shore Drive is actually good due to the multiple drop inlets on Lake Shore Drive that drain directly to Lake George but also requires a stormwater retrofit to prevent flooding in the lot. The lot is 13,125 square feet and in a half inch storm the lot collects

4,846 gallons of stormwater. Two 4'x8' drywells will have a storage volume of 3,007 gallons which does not include infiltration rates and the stone fill storage which will capture the majority of the stormwater prevent flooding on the lot.

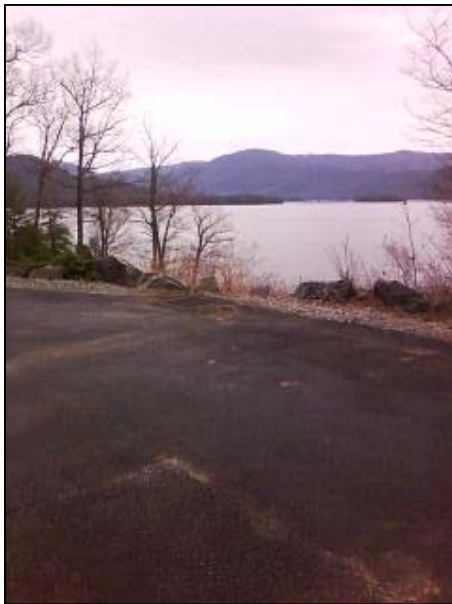
Juniper Hill Drop Inlet to Lake

The stormwater conveyance from the private roads is not significant and the majority of stormwater is properly taken care of with stabilized rock lined ditches and vegetated swales into forested areas. One area of concern is located on Juniper Hill and consisted of a maintained ditch that needs to be vegetated or rock lined, and a drop inlet at the end of the road draining to the lake. Other areas of concern were, two larger private driveways located off route 9N that drain directly to the lake with nothing to slow, divert, or infiltrate the stormwater runoff. Also, a drop inlet on The Anchorage Road drains a small area to the lake which is only a minor concern but may vary depending on de-icing materials used.
