# Halfway Brook Watershed Stormwater Assessment and Management Plan

Prepared by the Warren County Soil and Water Conservation District  
September 1999

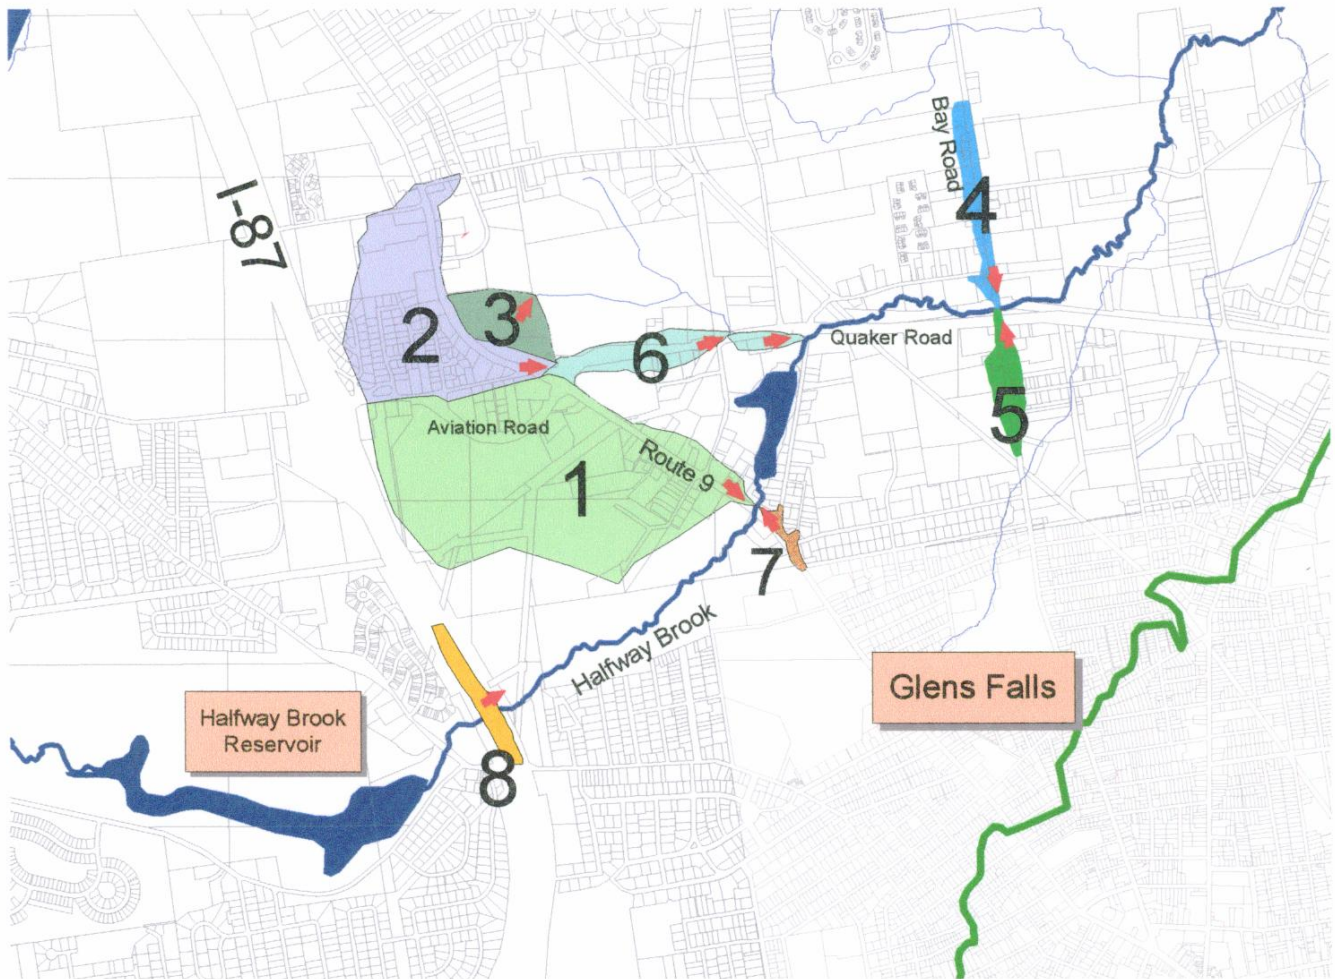
## Town of Queensbury - Areas of Stormwater Concern

3. Bay Road. Recent development by a large retail store has reduced stormwater runoff in the area. Bay Road itself is a well traveled road that has some residential development, a community college, a golf course, open space and commercial development. North of the Quaker Road intersection, a retail store was replaced by Lowe's Home Improvement center and their stormwater plan improved to lessen the effects of stormwater on the brook. A number of drop inlets are found which flow into the ACC tributary or Halfway Brook itself. South of the intersection of Quaker Road, residential and a concrete manufacturing plant is found. Stormwater from the area roads empties into the Crandall Park tributary, which flows into Halfway Brook by Cronin Road. (High Impact)

10. Glenwood Ave. Glenwood Ave. borders Halfway Brook along Hovey's Park Pond and the attached wetland to the south. (Low Impact)
11. Cronin Road. Cronin Road is a connector between Bay and Ridge Roads. Bay Meadows Golf Course is the major landowner at this location. Some development at the intersection of Bay and Cronin Roads can be found. A roadside ditch runs to the brook from the west and enters into a rock-lined section, before entering the brook. A few houses are found here as well. This area is heavily vegetated. (Low Impact)

**Recommendation - Aviation Road:** Stormwater flows down Aviation Road and outlets into the Route 9 drainage line at the intersection of Aviation and Route 9. To improve the water quality coming from this Aviation line, the undeveloped space between Burger King and Mobil Gas on the southern side of Aviation Road could be used as a treatment area. There is approximately 120 feet by 40 feet of grass area that is undeveloped, potentially available for the installation of one or more underground structures in series (i.e. Vortechincs or similar structure). This would capture approximately 80 % of the stormwater on Aviation Road and treat it. Although these type of underground stormwater improvement structures do little to remove dissolved pollutants, a large amount of road sand, trash, and debris will be removed from the stormwater.

**Recommendation - Lower Route 9 Corridor (Aviation Road down to Halfway Brook):** Field work and mapping have shown that there is very limited area to undertake stormwater improvements in this area due to the high level of development and high market value of the land. There are two options for stormwater improvement in this area.

**Recommendation - Option 1:** Using the grass covered state property located in front of Monroe Muffler, a series of underground structures may be installed to control stormwater quality and quantity from this subsurface culvert. Available space in this area is approximately 40 feet wide by 200 feet long, which would be sufficient to control for stormwater quality using the proper structures.

**Recommendation - Option 2:** Utilizing the front of the Queensbury Cemetery property, a vegetated stormwater detention basin could be constructed to accept the stormwater from this same section of Route 9. This basin could be vegetated with selected species of plants to allow for improved nutrient uptake, which would improve upon the subsurface structure recommendation above. However, the winter and spring dormant plant season will not be able to provide this benefit.

**Recommendation:** Create a high quality stormwater wetland at the site of the current outlet, and build enough capacity in this wetland to allow it to have water quality improvement qualities. A berm/riser system could be built at the exit of this wetland to provide for larger capacity and retention time, allowing for nutrient uptake and sediment removal.

**Recommendation:** There is a fairly extensive floodplain for Halfway Brook in front of the Lowe's Warehouse, which could be utilized as a filter for stormwater. The two drainage pipes could be rerouted to outlet into this floodplain, where the stormwater would spread out across this vegetated area and infiltrate into the soil. Building a low berm before the stormwater flow reached the bank of Halfway Brook would allow for a longer retention and infiltration time. This solution would be a relatively simple means to address this issue at this location.

**Recommendation:** There is a fairly extensive floodplain for Halfway Brook in front of the Lowe's Warehouse, which could be utilized as a filter for stormwater (much like item 6 above). The two drainage pipes could be rerouted to outlet into this floodplain, where the stormwater would spread

out across this vegetated area and infiltrate into the soil. Building a low berm before the stormwater flow reached the bank of Halfway Brook would allow for a longer retention and infiltration time. This solution would be a relatively simple means to address this issue at this location. This section of Bay Road drains somewhat of a smaller area than the northern section, and the development is less intensive. To undertake one of these two projects, we would recommend undertaking the northern section (item 6 above).

1. Hannaford Plaza – the stormwater detention area which was created for control of stormwater coming off of this development could be easily improved at a minimal cost. The outlet culverts are at approximately the same elevation as the inlet culverts, providing for very little capacity in this basin. By installing a simple riser structure at the outlet, the retention time of this basin and its infiltration capabilities would be significantly improved.

**Recommendation:** The flow from this drainage goes under the Sunoco station adjacent to Halfway Brook. Installing a subsurface stormwater improvement structure at this location (either on the Sunoco lot or in the DOT right of way) would control for almost all of the flow from this three-acre section. With the potential for petroleum-laden runoff from the gas station and auto repair center, a solution which can improve water quality relating to these contaminants (such as Aquashield™) would be recommended.

**Recommendation:** At the outlet of the culvert which drains the Northway, a berm could be constructed which would route the stormwater and any sediment away from the Brook and into the surrounding woods. There is plenty of area to have this stormwater dissipate into these woods whereby essentially no stormwater would enter the Brook from the Northway. This would be a very simple and quick fix to a primary stormwater input into the Brook.
