# *West Brook Stormwater Mitigation Project*

## *Final Report*

Warren County Soil and Water Conservation District

February 3, 2004

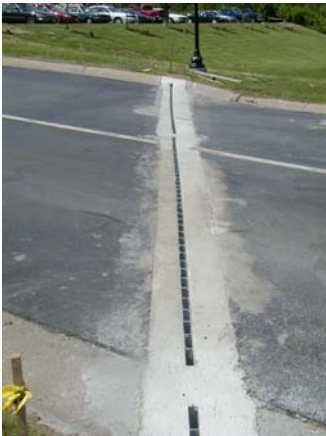
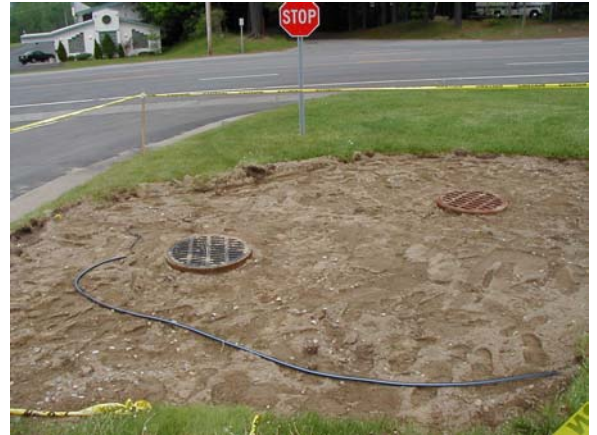
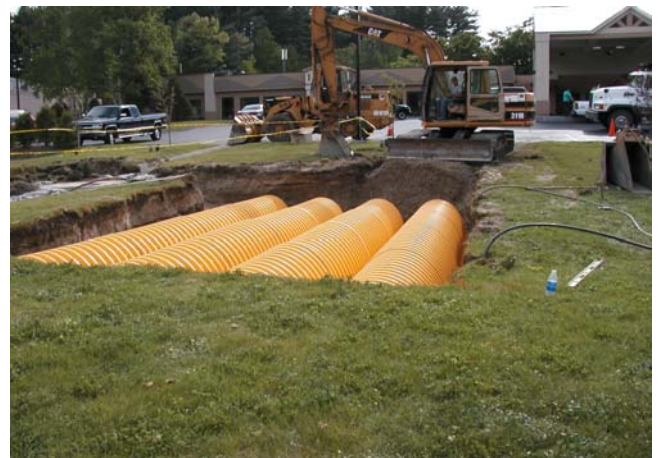
### **Site A (Entrance Driveway)**

**Site summary:** A trench drain was installed across the driveway, directing water into two subsurface dry wells 4' high by 8' diameter, infiltrating the first three quarters of an inch of runoff from a storm event.

Installed a trench drain across driveway to collect and direct water to installed dry wells that act as infiltration structures for stormwater.  
 System sizing: 8 foot diameter, 4 foot high well = 200 cubic feet of water capacity  
 Therefore, 2 – 4'x8' drywells were needed to accommodate flow.  
 Stone pad under dry well (10' wide x10' wide x2' deep), plus the stone to backfill the hole around the drywell, @ 40% porosity (#3 stone) accommodates 240 additional cubic feet of water, bringing the total storage up to 740 cubic feet of volume.

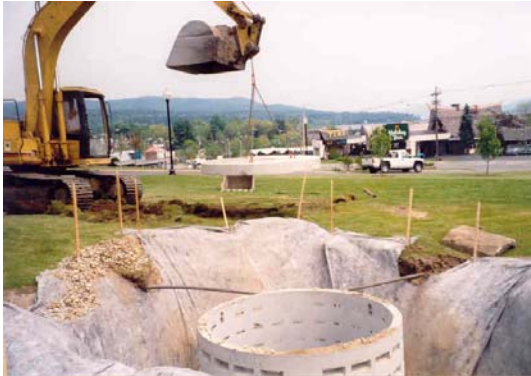
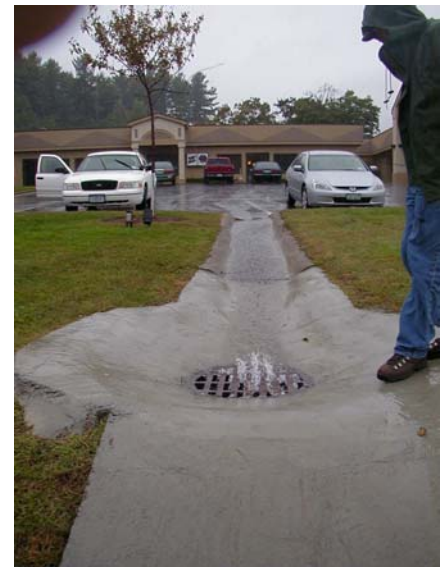
### **Site B (Main Parking Area in Front of Motel)**

**Site summary:** Stormwater flows into a new dry well (8' deep by 8' diameter) that acts as pre-treatment and infiltration. Outflow from this well goes into an infiltrator chamber bed system for infiltration and final treatment of the first three quarters of an inch of runoff from a storm event.

Existing drainage patterns bring all stormwater to one point in the parking lot, which flows directly into a concrete bowl shaped area which drains through a grate into the new dry wells below.

Dry wells were installed to act as a pre-treatment system, reducing the volume of particulates (sand and silt) which would enter final treatment system (infiltrator chambers). The dry wells will also act as infiltration structures for stormwater. Pre-treatment is two 4 foot high by 8 foot diameter dry wells stacked on top of each other, with a grate inlet and an 8" outlet pipe. The outlet pipe leads to four six-inch pipes which feed the infiltration chambers for final treatment. The stone pad under the dry well (10' wide x10' wide x2' deep), plus the stone needed to backfill the hole around the wells, @ 40% porosity (#3 stone) accommodates 240 additional cubic feet of water, adding additional storage and infiltration capacity to system. The majority of stormwater infiltration will be through the

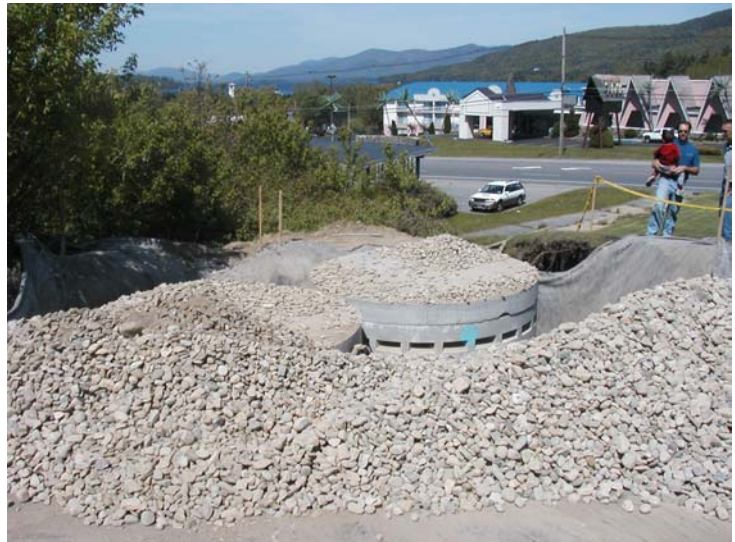
Site D (Northeast Lower Parking Area)

Site summary: Stormwater flows into a series of two dry wells (8' deep by 8' diameter), which infiltrates the first half to three quarters of an inch of runoff from a storm event.

Existing drainage pattern brings all stormwater largely to one point, which was modified with infiltration improvements. Installed dry wells will act to infiltrate the stormwater at this site. No outlet pipe was installed, and overflow will act in the same way as it previously did.

Stormwater structures are 2 – 8' diameter x8' deep dry wells. The stone pad under the dry well system (25' wide x10' wide x2' deep), plus the stone needed to backfill the hole around the wells, @ 40% porosity (#3 stone) accommodates 680 additional cubic feet of water, adding additional storage and infiltration capacity to system.

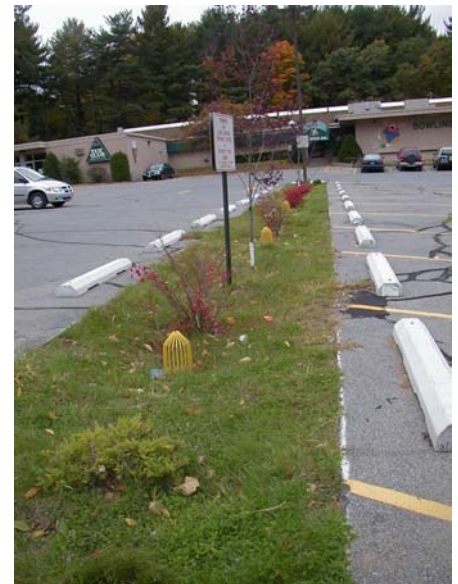
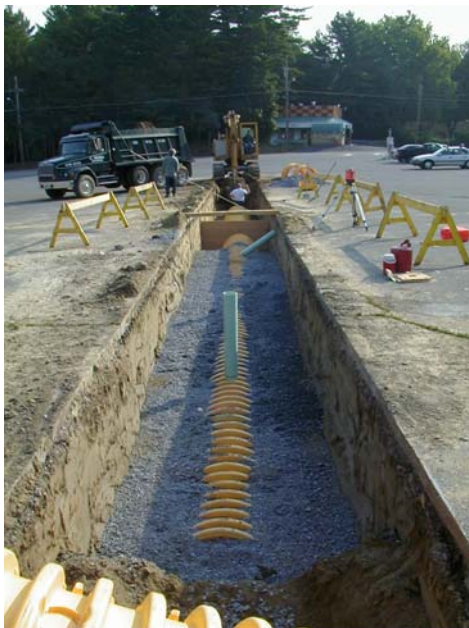
**South Median**

This site consists of a 164' long x 7' wide stormwater median, underlain with #3 stone and 18 infiltration chambers, to collect and infiltrate stormwater from the south portion of the parking lot.

The top of the median was depressed below the surface of the parking lot so that runoff will flow into and remain in the median. Small berms were constructed within the median to impede surface flow down the center line of the median, allowing for a longer retention time. To facilitate stormwater entry into the subsurface chambers during storm events, six inch diameter pvc riser pipes were installed from the chambers to the surface at specified locations. Upright bar guards were installed at the top of the risers to prevent clogging of the inlets.

Marine plywood cutoff walls were installed subsurface within the median at specified locations to hamper lateral subsurface flow, and the chambers were capped with end caps at specified locations for this same reason. The

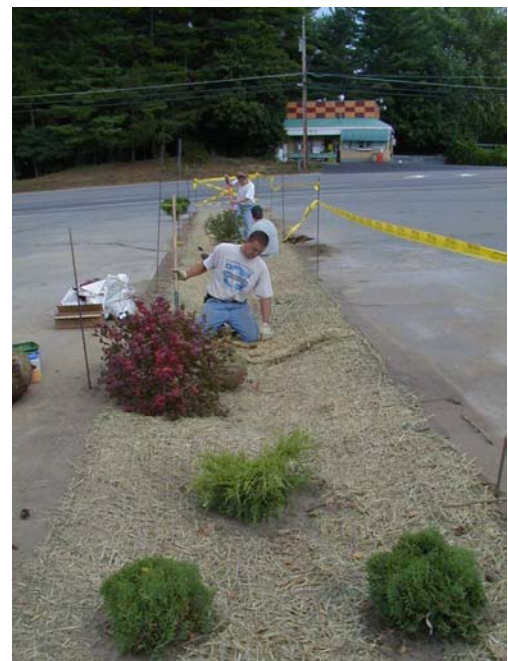
**North Median**

Installed a 208' long x 7' wide stormwater median underlain with a bed of #2 stone, along the northern property line to infiltrate stormwater from the northern most portion of the parking lot. The original design included the installation of subsurface stormwater chambers. However, during construction it was noted that this median is underlain by a ductile pipe water line. Although UFPO was contacted four days prior to construction, the Village of Lake George Water Department did not come out to the site to mark the line. To avoid disturbance and possibly breach of this line, the chambers were eliminated in favor of simply backfilling the trench with #2 stone. This stone layer was overlain with a one-foot thick layer of #1 stone, to minimize piping of material through the stone.

The top of the median was depressed below the surface of the parking lot so that runoff will flow into and remain in this area. Eight (6") diameter riser pipes were installed from the stone bed to the surface at specified locations in the median to allow for the conveyance of water directly into the subsurface stone bed under high flow conditions. Upright bar guards were installed at the top of the risers to prevent clogging of the inlets. Small berms were constructed within the median to impede surface flow down the center line of the median, allowing for a longer retention time. The surface of this median was landscaped with native shrubs, seeded, and protected with North American Green® SC-75 erosion control blankets.

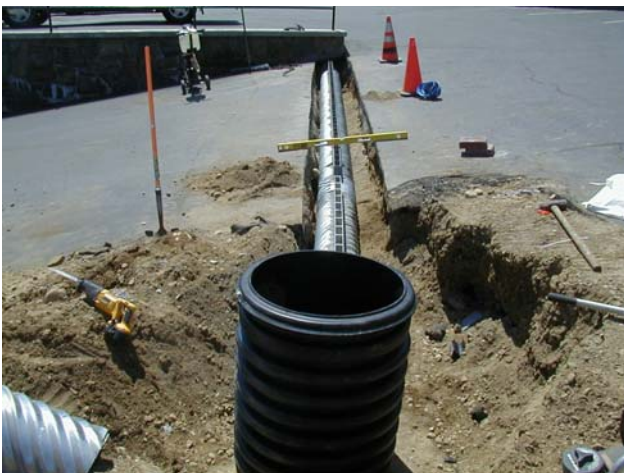
Site A (South) Summary

24 feet of slotted trench drain pipe (12" diameter) was installed across the asphalt driveway, set into concrete to grade with existing blacktop. The slotted pipe is then connected to a standard 12" diameter corrugated metal pipe which is approximately 4 feet long. This pipe then outlets into a 30" dia. piece of HDPE, mounted vertically on top of the first dry well (6' diameter x 4' high) above the hole in the concrete cap on the well. There is a manhole cleanout at the surface of the blacktop. The well acts as a settling basin. An eight inch diameter schedule 40 pvc pipe was installed from this well into the area of the infiltration chamber bed. Six-inch diameter pvc pipe laterals, branch perpendicularly from the 8" line, at the location of the new infiltration chambers. Two-foot sections of 6" diameter pvc pipe outlet into the end of each chamber. There are four chamber trenches (capped at each end) consisting of four SC-740 StormTech® chambers in each trench,

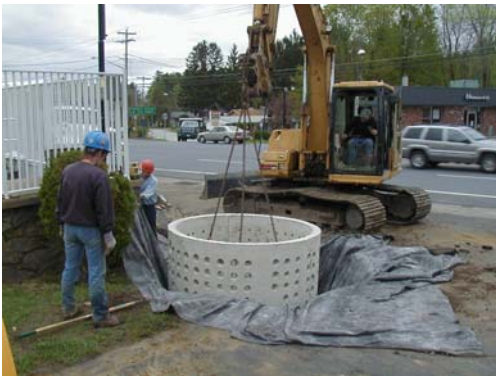
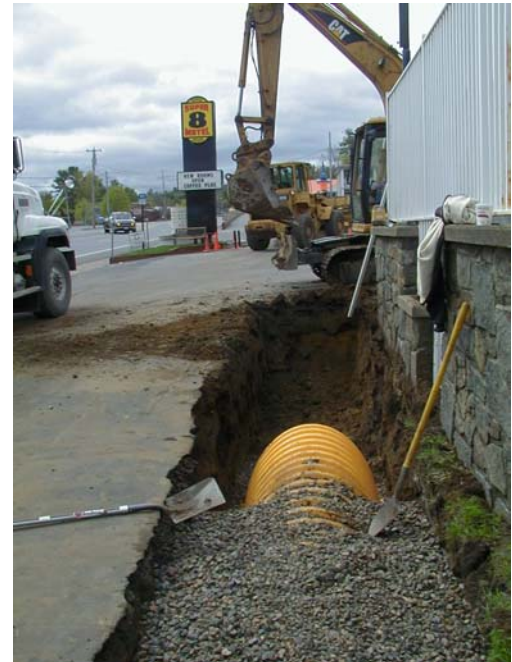
Site B (Middle) Summary

One six-foot-diameter, four-foot-high dry well was installed in the driveway at the location shown on the plans. This dry well acts a settling basin. An 8" diameter schedule 40 pvc pipe then conveys the water to a infiltration bed of 6 StormTech® SC-740 infiltration chambers. The drywell and chambers were underlain with 6" of #2 stone. The side walls of the trench around the drywell were covered with filter fabric to minimize soil piping. The well was covered with an 8" thick concrete traffic cover with an offset grate hole. The hole was overlain with a grate frame and traffic grate.

The area surrounding the dry wells and chambers was backfilled with #2 stone up to the top of the well and chambers. This area will was then covered with filter fabric. Blacktop was placed over the drywell area, and shaped like a shallow bowl such that the runoff will be captured and flow into the grate. The area above the infiltration bed was overlain with fill, 12" of topsoil, seeded and mulched.

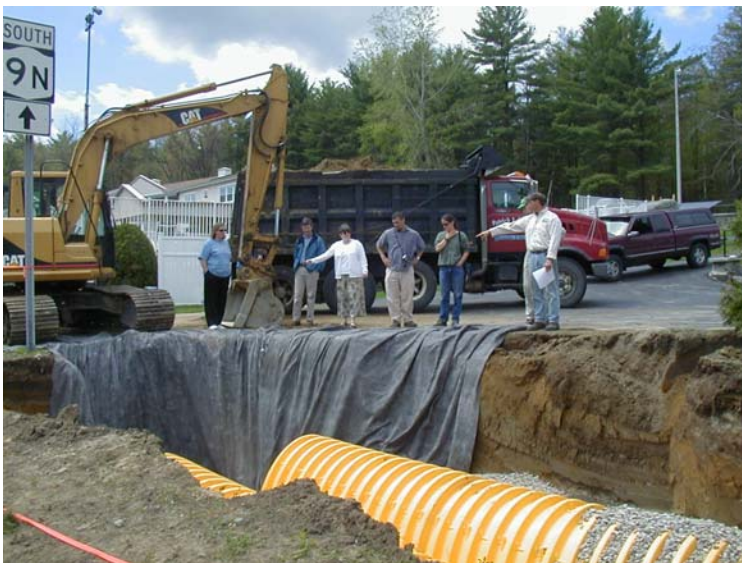
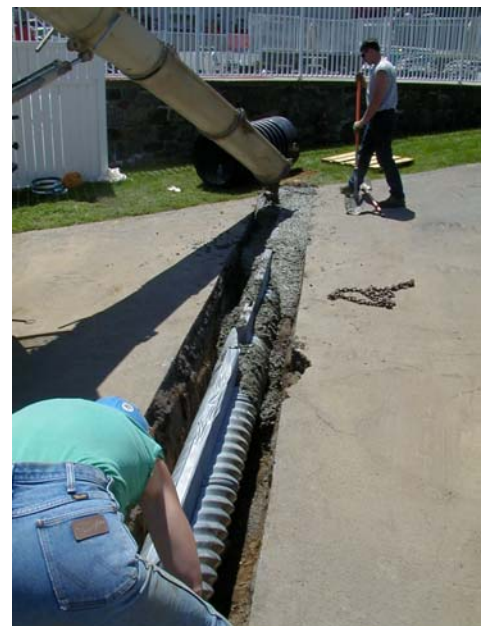
*Site C (North) Summary*

Twenty nine feet of slotted trench drain pipe (12" diameter) was installed across the asphalt driveway, set into concrete to grade with existing blacktop. This directs water to the new stormwater infiltration structures (dry well and infiltration chambers). Water flows from the slotted drain pipe into a non-slotted section of 12" diameter pipe as it reaches the grassed area. The pipe outlets into a 30"

The 8 foot diameter, 5 foot high dry well, will accommodate 250 cubic feet of water. Twelve StormTech® SC-740 chambers will accommodate 900 cubic feet of water (75 cubic feet per chamber). Fifty yards of #2 stone used to underlay and backfill the chambers and drywell will add additional storage of approximately 540 cubic feet. This brings the total storage up to 1690 cubic feet, which will handle more than 0.5 inches of rainfall on capacity alone.

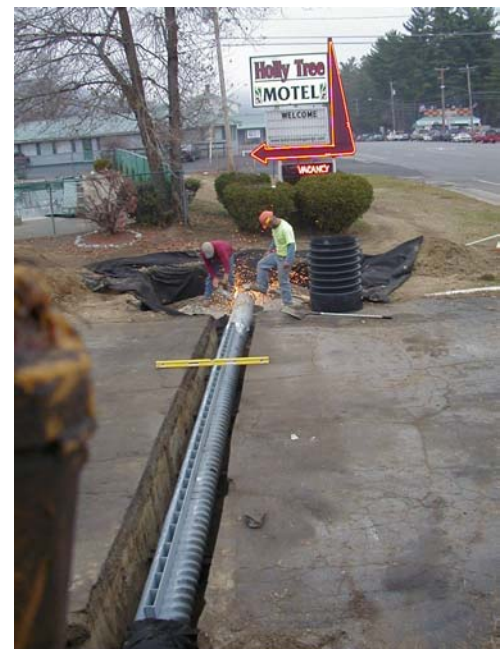
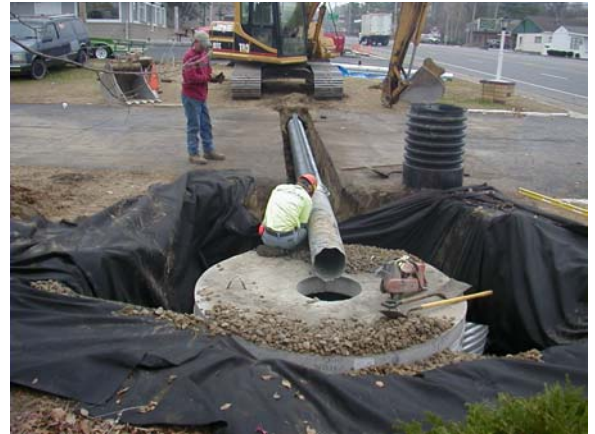
20 feet of slotted trench drain pipe (12" diameter) was installed across the asphalt driveway, set into concrete to grade with existing asphalt. This collects and conveys stormwater to a new drywell infiltration structure. Water flows from the slotted drain pipe into a non-slotted section of 12"

diameter pipe when it reaches the grassed area. This pipe then outlets into a 30" diameter piece of HDPE mounted vertically on top of the drywell above the hole in the concrete cap on the drywell. The side walls of the excavation for the drywell were covered with filter fabric to minimize soil piping. One foot of topsoil was then used to bring the site back to existing grade, which was seeded and mulched.

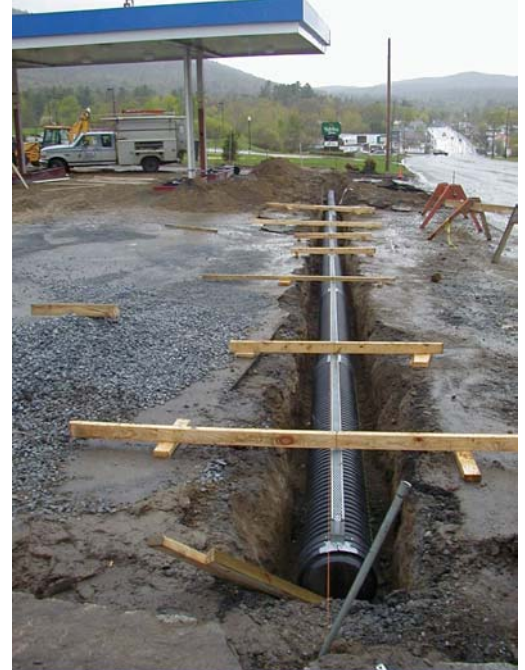
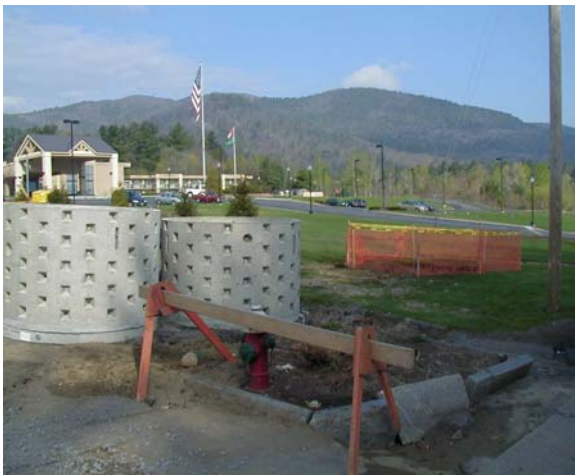
To collect the stormwater runoff as it flows across the pavement of the Mobil station, two fifty-foot long sections of 12" diameter Duraslot® open top slotted trench drain were used. Both sections of pipe were installed parallel to Route 9 approximately fifteen feet in from the roadway on the Mobil property. The sections of pipe were separated by a large planter in the center of the parking lot.

The first pipe flows into the second pipe, which then flows to a short section of standard 12" diameter corrugated metal pipe. This pipe outfalls into a riser set upon a large drywell system which is located on the adjacent Holiday Inn Property. The drywell system includes approximately 18" of #2 stone under two dry wells (dimensions 8 foot wide by five foot high). The hole in which the dry wells are placed is lined with filter fabric to minimize piping of soil into the system, and then the hole surrounding the wells was filled with #2 stone. A non-traffic concrete cover was placed on the top of the well, and then a 30" diameter, two foot high section of high density polyethylene (hdpe) pipe was placed on that. The 12" corrugated metal conveyance pipe carrying the stormwater outlets into a hole in the side of the hdpe pipe, which then falls into the wells for infiltration.

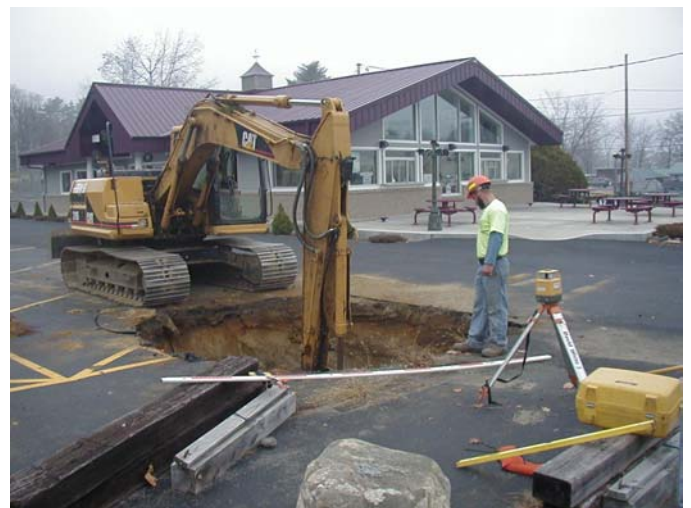
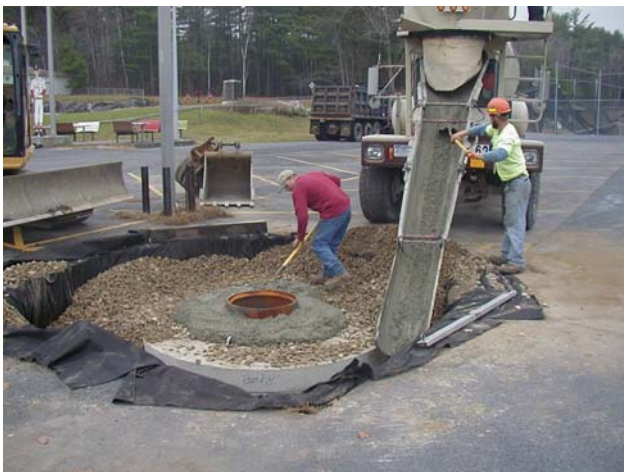
Installed was a 5' high x 8' diameter drywell with a traffic cover, grate and frame. Water flows across asphalt parking area into drywell for storage and infiltration. The side walls of the excavation for the drywell were covered with filter fabric to minimize soil piping. Asphalt was then placed on top of the drywell in such a way as to act as a bowl to collect water and funnel it into the drywell.

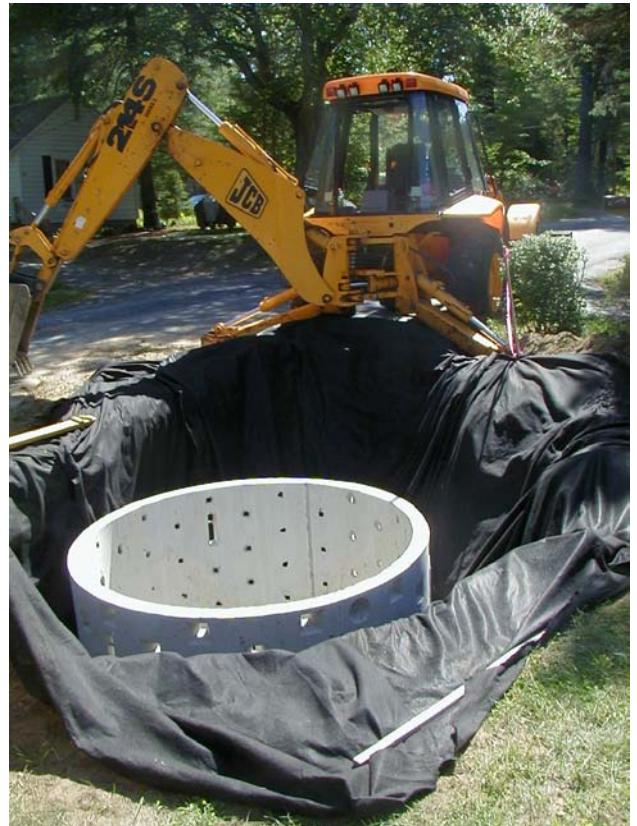
Installed were 3 stacks of 2, 4' high x 8' diameter drywells, with traffic covers (with offset holes), grates and frames. Water flows along the asphalt gutter and into the drywells for storage and infiltration. The side walls of the excavations for the drywells were covered with filter fabric to minimize

soil piping. Asphalt was then placed on top of the drywell in such a way as to act as a bowl to collect water and funnel it into the drywell. The last stack of 2, 4' x 8' drywells will be installed in April 2004.
