Lake Sunnyside Watershed Assessment

Prepared by the
Warren County Soil and Water Conservation District

September 1999

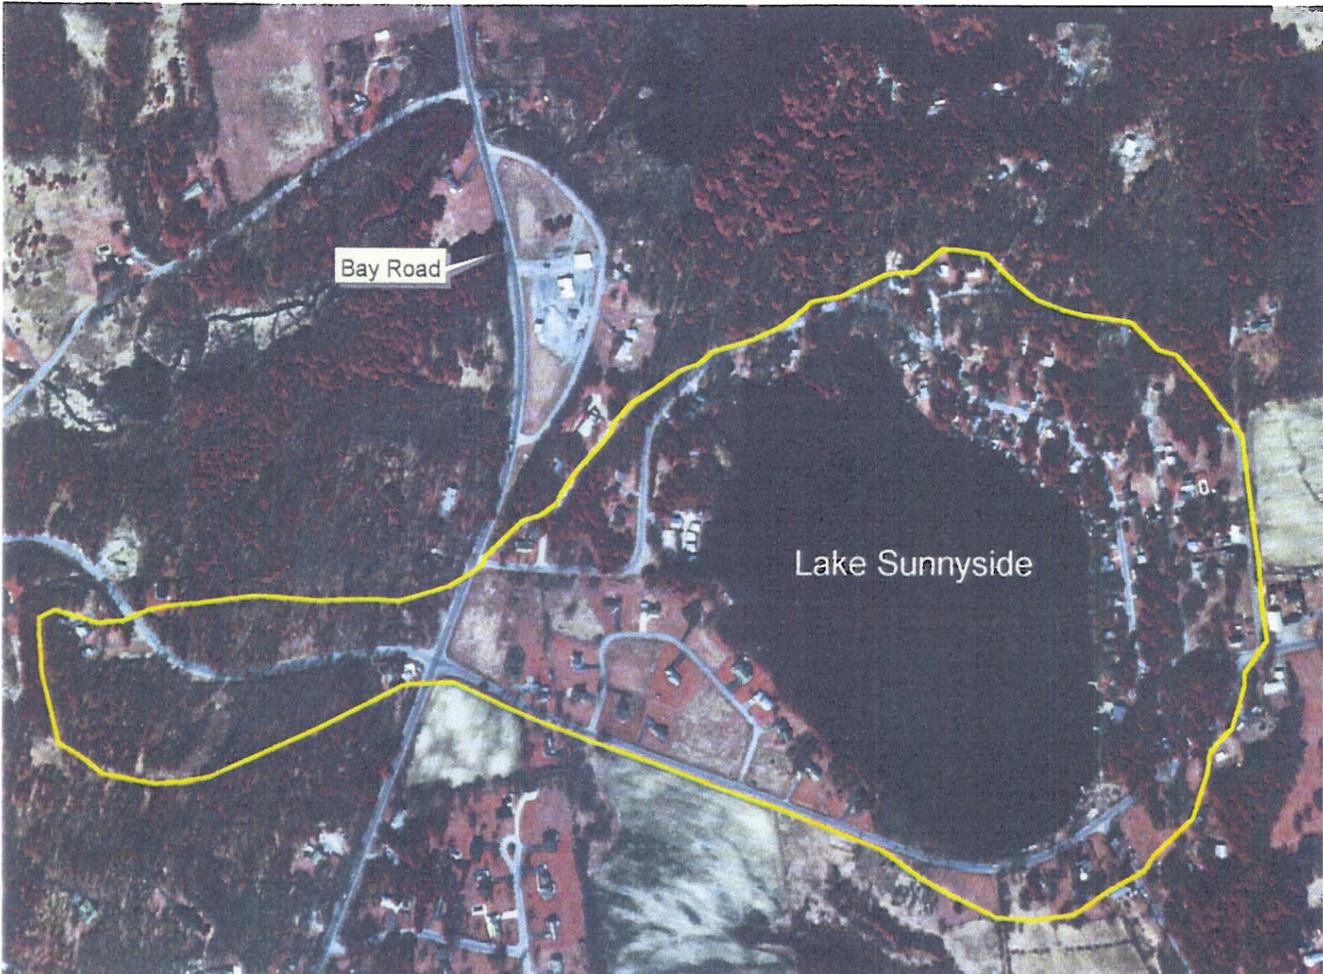
As stated above, there are approximately 40 residences along the shoreline of Lake Sunnyside, all of which have a yard to some degree. Appendix 2 is a color infrared aerial photograph of the Lake Sunnyside watershed, and land use can be identified on this photo. As can be seen, the shoreline is densely developed, with many lawns which abut the lake. This in itself is not a concern, as the grasses in a lawn actually slow the flow of runoff and allow for infiltration of stormwater runoff. Where it does become a concern is when landowners over-fertilize in an attempt to create the perfect lawn.

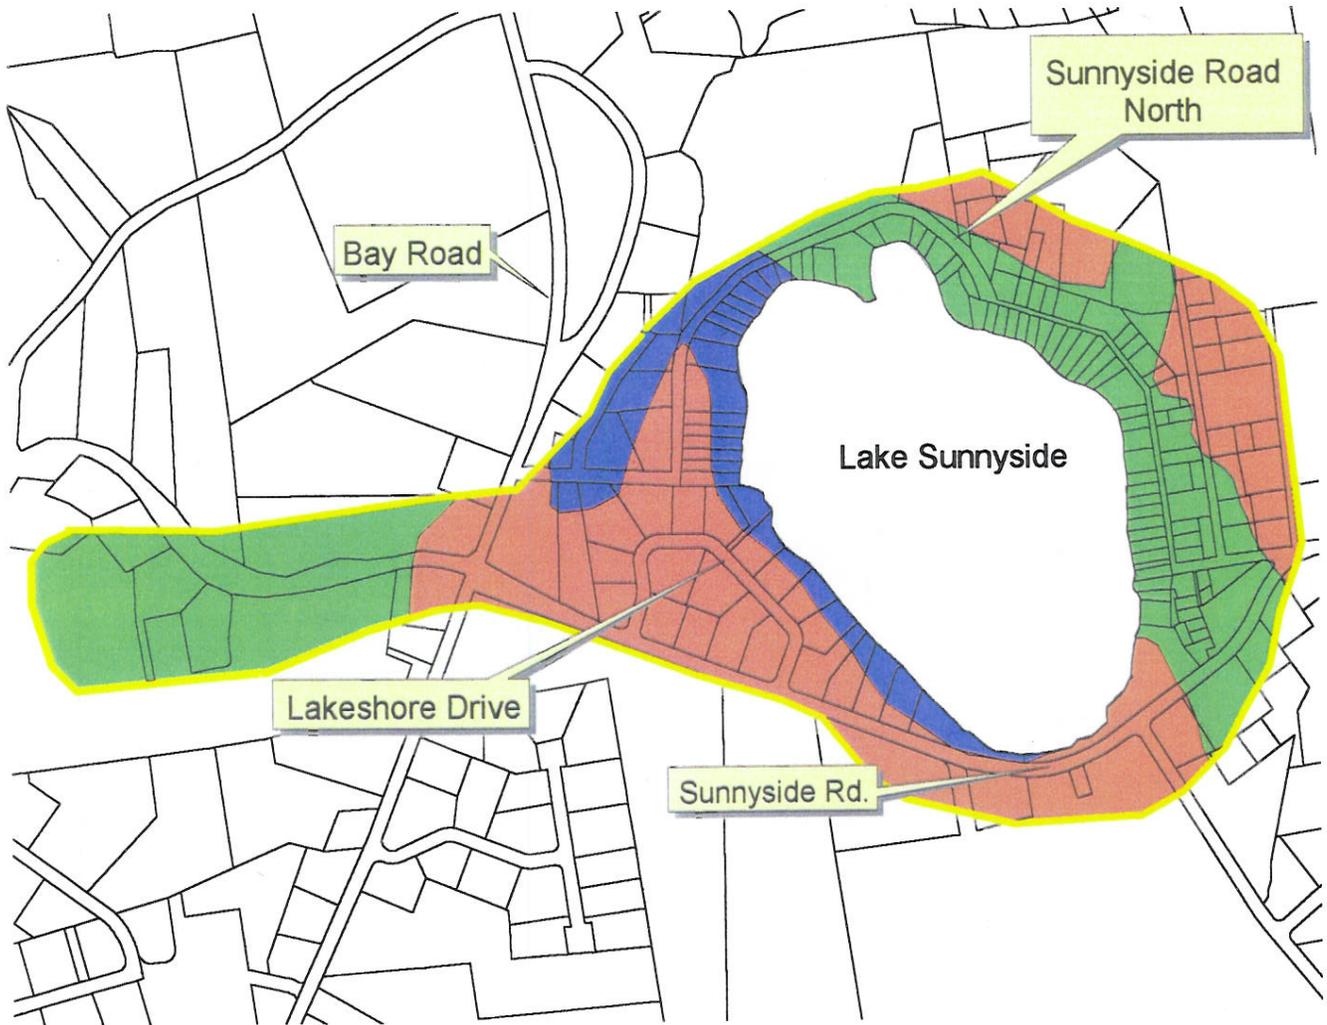
Appendix 3

The Lake Sunnyside watershed has three different soil types: Oakville, Hinckley and Plainfield (see Appendix 3). All of these three soil types are either well drained or excessively drained (very sandy). These types of soils present difficulties with location and functioning of septic systems due to the poor filtering capacity of the soil. This is primarily due to the short contact time that septic effluent has with the soil, due to the rapid flow through the sandy material. A more detailed description of the soils within the watershed is as follows:

Hinckley – 8- 15 percent Slopes, 42% of Lake Sunnyside watershed soils- This is a sloping, excessively drained soil. The rate of water movement in the soil (permeability) is rapid in the surface layer of the soil, and very rapid in the substratum. The surface runoff is medium, and capacity to store water for plant growth is very low. Although this soil is suited for most types of urban development, if the soil is used for sanitary waste disposal systems, such as septic system absorption fields, ground water contamination is a hazard because of poor filtering of effluent. Septic systems on shoreline property are often close to surface and ground water. The direction of groundwater flow near the shoreline is towards the lake, and in very permeable soils partially treated effluent is likely to enter adjacent lakes.

Plainfield- 8-15 percent slopes; 11% of Watershed soils. A sloping, excessively drained soil type with slow to medium surface runoff. Permeability is moderately rapid in the surface layer and rapid in the subsoil. The slope and sandy texture of the soil are its main limitations when used for development, primarily it is a concern for use as septic tank absorption fields, as ground water contamination is a hazard because of permeability in the subsoil.

Oakville- 8-15 percent slopes; makes up 47% of Watershed soils. This is a sloping, well drained soil. Permeability of this soil is very rapid, with slow to medium surface runoff. The soil does not hold water well, and is not very well suited for use as septic tank absorption fields. The result is poor filtering of effluent, which could cause ground water contamination, leading to contamination of the lake.

Lake Sunnyside Soils

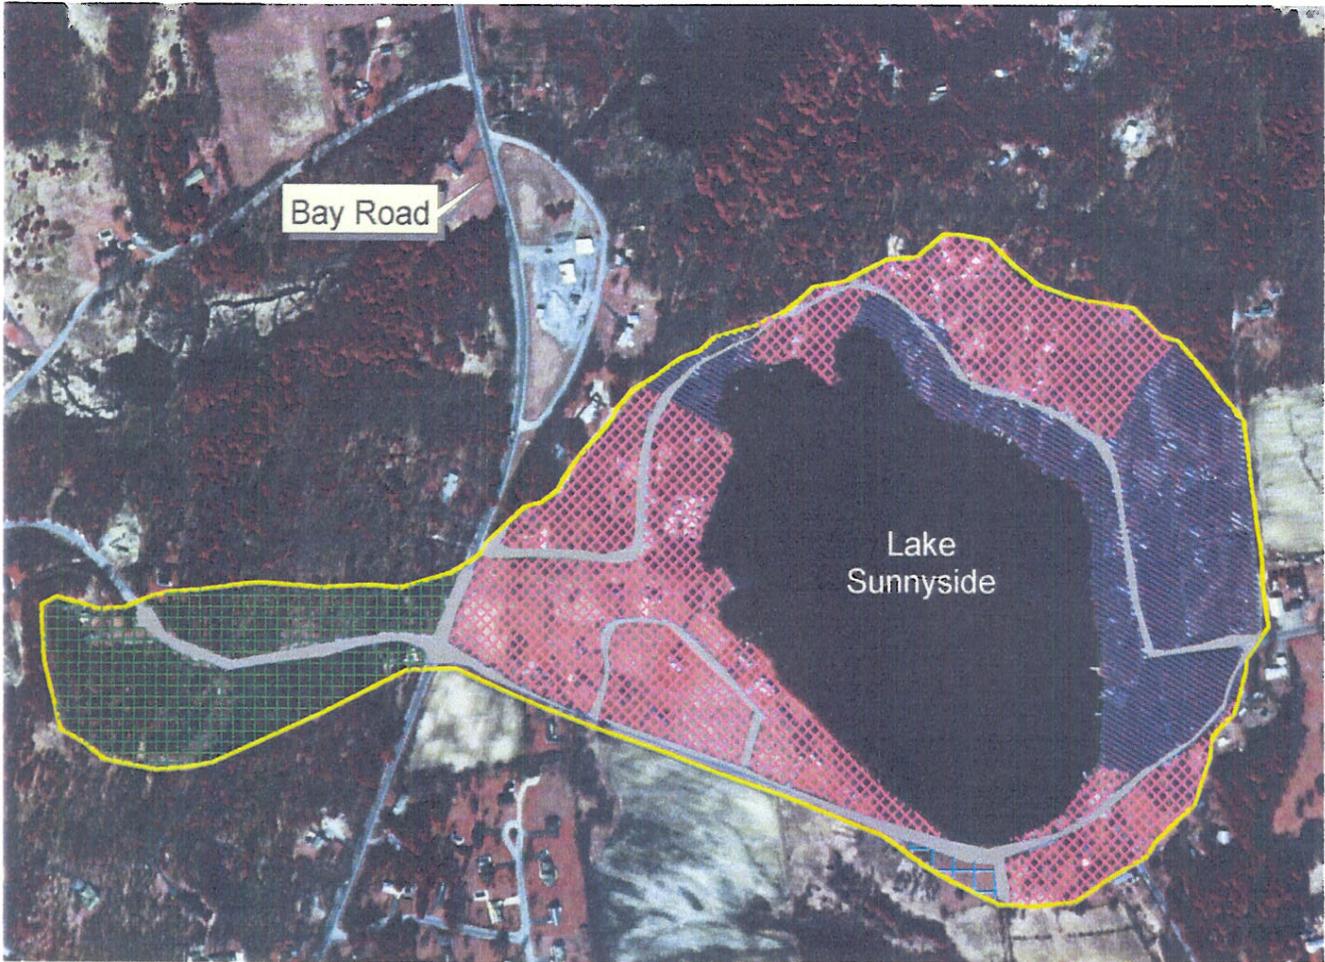
Appendix 4

To determine the land uses within the watershed, a geographic information system (GIS) was employed to develop a coverage related to these various uses (see Appendix 4). Once the watershed was delineated on a USGS 7.5 minute topographic map, 1995 digital aerial photography was used to determine the land uses within the watershed. When these categories were developed on the GIS, they were then confirmed with field reconnaissance to check accuracy. Land use information is very important when characterizing the watershed and determining potential impacts to water quality.

The strong majority of the Lake Sunnyside watershed is generally residential, however there are five different types of land uses within the watershed. The total acreage for the land area of Lake Sunnyside's watershed is 98 acres. The following is a breakdown of the land uses within the Lake Sunnyside watershed:

Light/Moderate Residential: This category accounts for 47 acres within the watershed.

Dense Residential: There are 31 acres of dense residential area within the watershed. (32% of watershed area).

Forest: There are 17 acres of forest in the watershed. (17% of watershed area).

Roadways: There are 1.5 acres of roadway in the watershed. (1.5% of the watershed area).

Cemetery: The cemetery on Sunnyside Road is 1.5 acres. (1.5% of the watershed area).

Lake Sunnyside Land Use

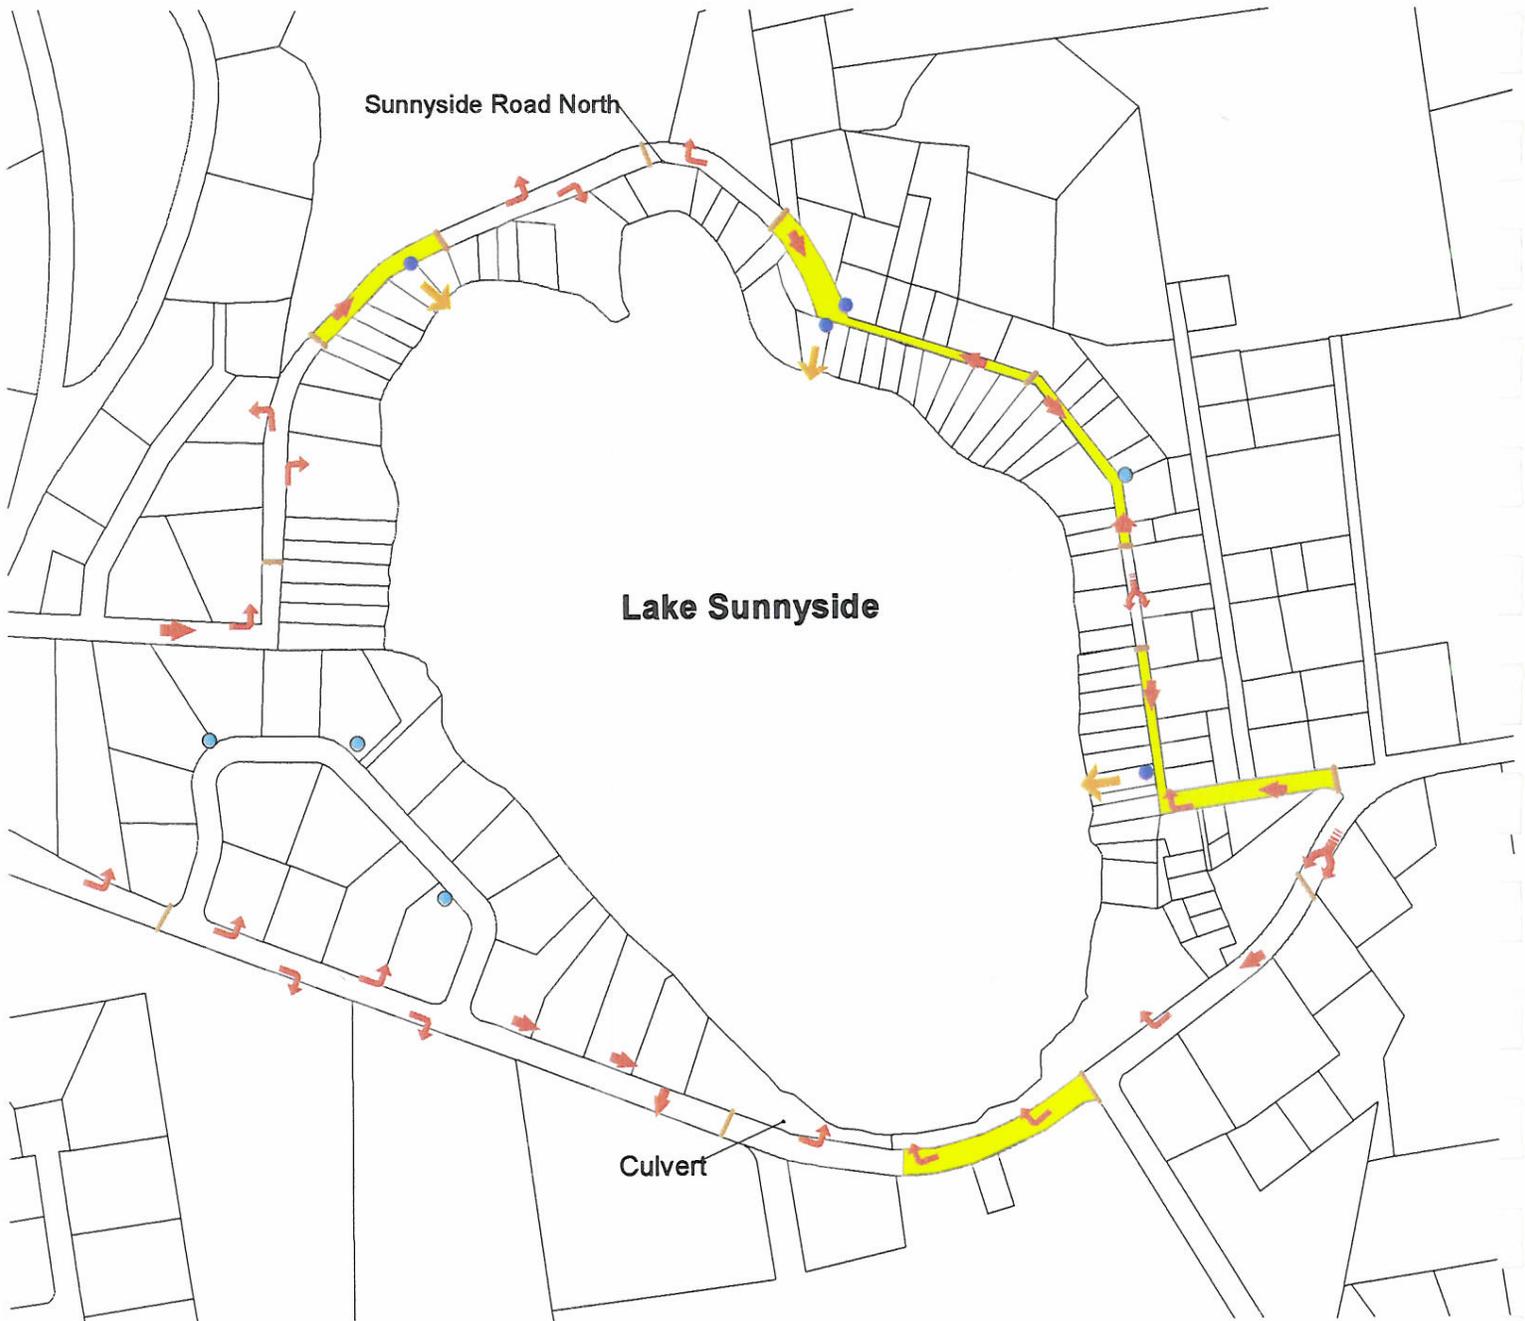
Appendix 5 Lake Sunnyside Existing Stormwater Drainage

Approximately one half of Sunnyside North drains directly to Lake Sunnyside through culverts. There are three culverts which outlet road runoff directly into the lake from Sunnyside Road North, and these culverts are shown on Appendix 5 as orange arrows that point to the lake. The concern regarding this is primarily from winter road sanding operations, as this sand gets carried with runoff from a storm event into the lake. The three culverts which outlet directly into the lake are described as follows:

1. In the area of 104 North Sunnyside there are two drop inlets, connected across the road, which run straight to the lake through an old culvert. Sediment such as road traction material, which has flowed out of the drop inlets throughout the years, has created a small delta at the outlet into the lake.

2. The drop inlet located next to 150 North Sunnyside is no longer doing its job, the pipe which runs the stormwater from the drop inlet to the lake is broken, and the water is spilling out before it reaches the lake.

3. Another drop inlet, at 52 North Sunnyside, drains a significant part of the road, however the pipe which connects the drain to the lake is broken, and ends in the yard of the house on this site. While surveying the stormwater for the lake, we talked to the persons renting the property at the time, and they reported that during a rainstorm there is a large flow of water coming out of the pipe, which then flows down into the lake, taking with it sand and other yard material.

1. Install catch basins at the location of the three drop inlet structures on Sunnyside North: These three locations are where the culverts are directly entering the lake. These drop inlet structures should be retrofitted or replaced with structures which have the capacity to act as catch basins to remove road sand and debris from road runoff before it reaches the lake. Work with the Queensbury highway department to have this undertaken.

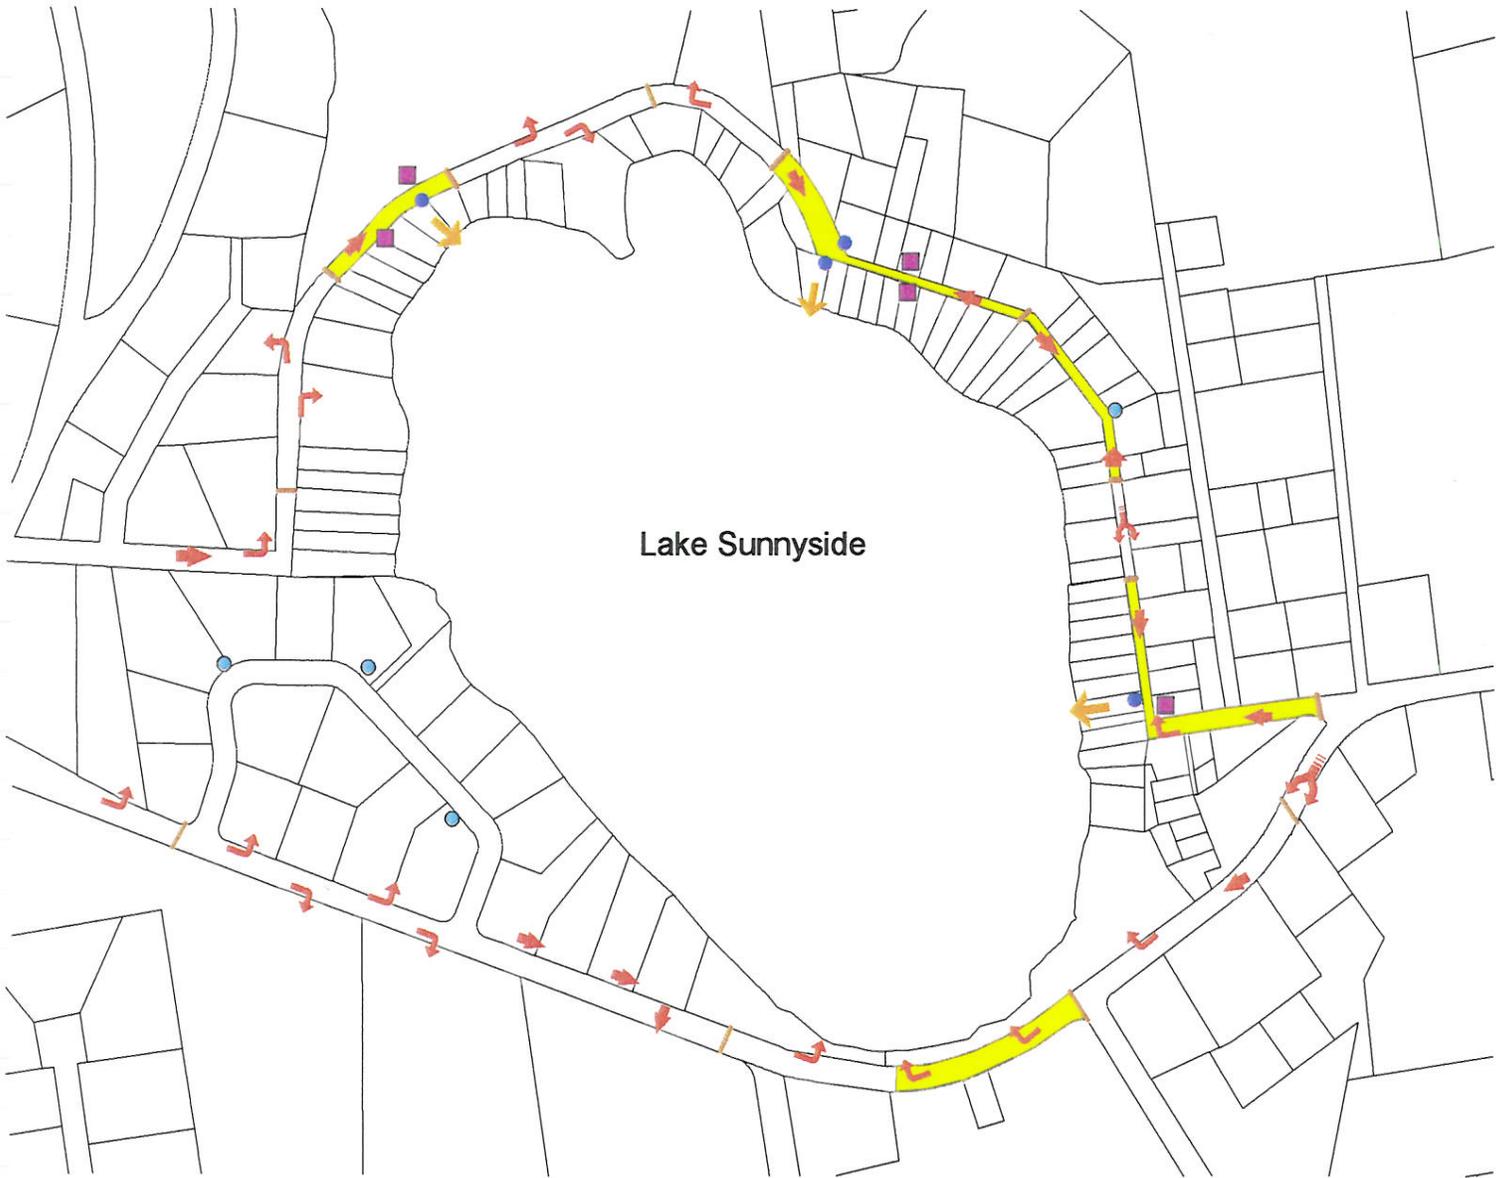
Appendix 6

Lake Sunnyside Recommended Stormwater Drainage Improvements

2. Install infiltrators at locations specific locations on Sunnyside North, as seen on Appendix 6. These infiltrators will cut down on the amount of surface runoff reaching the lake, and will also decrease the maintenance/cleanout of the roadside catch basins. Work with the Queensbury highway department to have this undertaken.

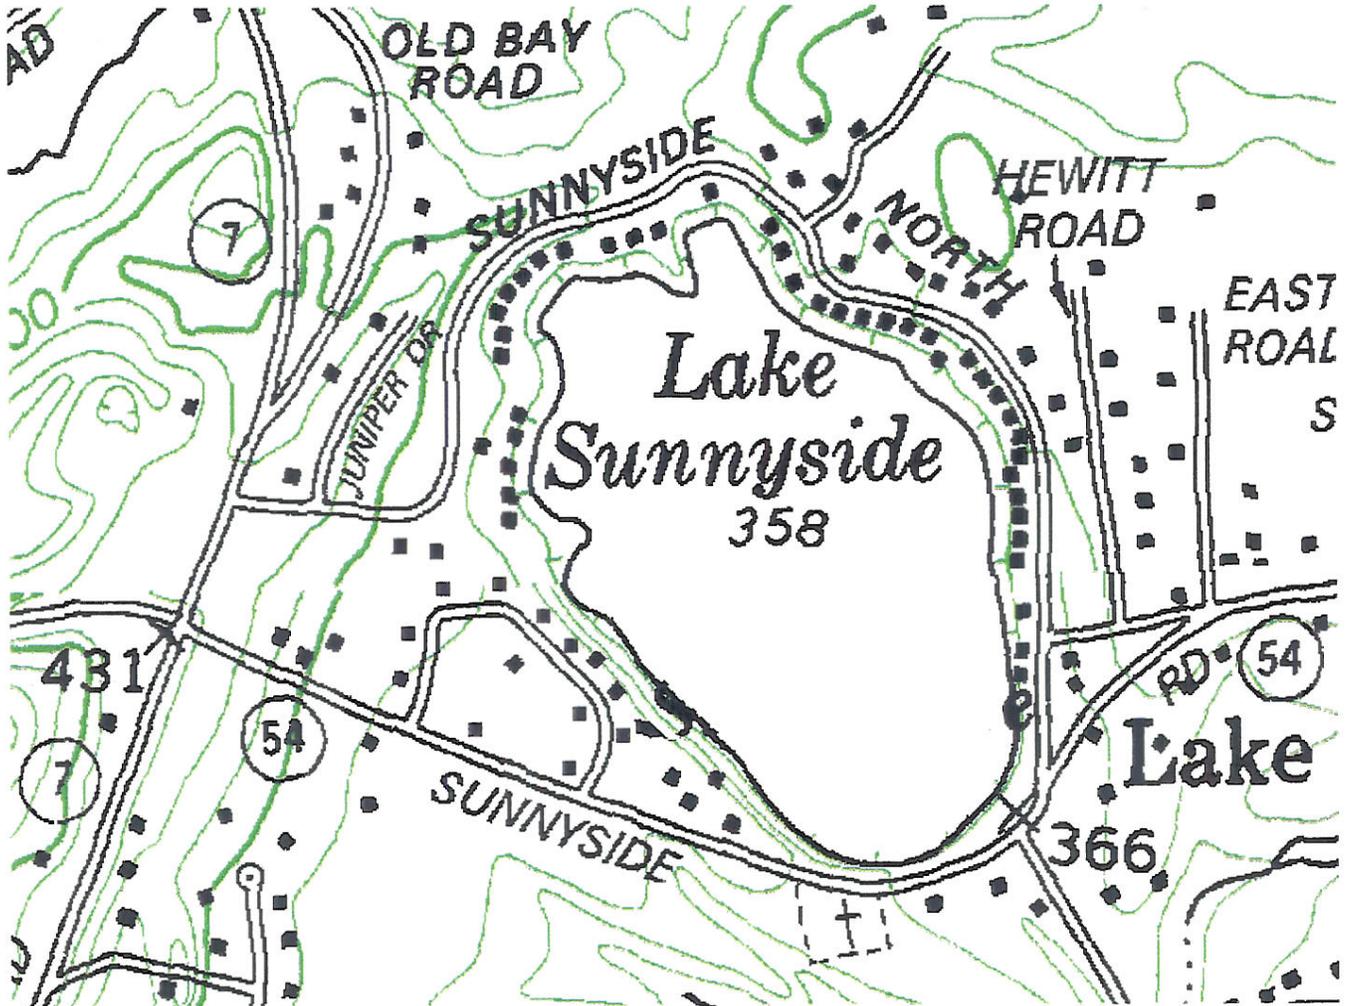
Appendix 7

As stated previously, Lake Sunnyside has numerous year-round residences and camps upon its shoreline (see Appendix 7). Many of these residences were built in the mid 1950's and 1960's, and less concern was given to the potential development impacts upon the water quality of the lake than is today. The building lot sizes around the northeastern side of Lake Sunnyside are relatively small, with camps and small homes built close to the shoreline. As many of these structures were seasonal camps, the septic systems were designed as such and generally consist of small septic tanks and seepage pits. There is little room on most of these lots for a standard leach field type system, and therefore very few exist. The issue that arises out of this is that the level of treatment that the septic effluent receives may not be as high as on a larger lot with a leach field system because the effluent is localized in a seepage pit. Discussions with many of the landowners on the lake have identified this issue as a concern, in that their small lot size is not capable of supporting an upgrade to a standard septic system. In addition, many of the residents on the lake do not know exactly what type of septic system is located on the property. This is a concern also because if they do not know what type of system is on the property, then there is little likelihood that this system has been properly maintained.

Shoreline Development and Topography around Lake Sunnyside
