Crystal Lake Watershed Stormwater Assessment

Prepared by the
Warren County Soil & Water
Conservation District

For the Crystal Lake Homeowners Association
November 2013

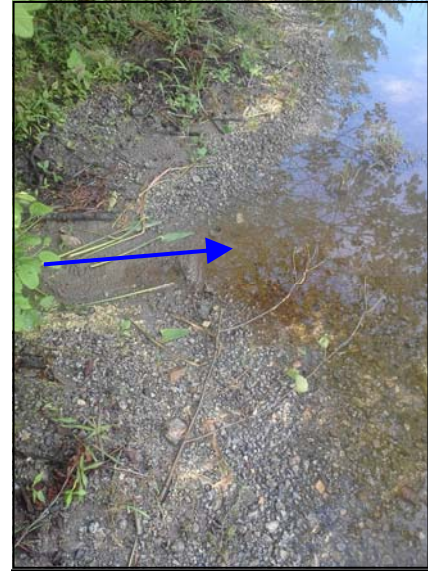
Sediment deposition in Crystal Lake from Burnt Hill Road stormwater runoff

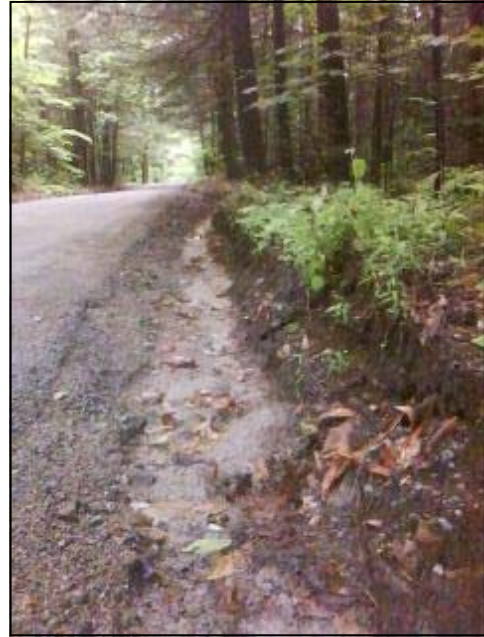
Location 1: Burnt Hill Road is an unpaved road at the southern end of the watershed. Burnt Hill is a well maintained road with ditching and turnouts along the entire road. The three most southern mapped points of concern on Burnt Hill are on steep slopes and have some ditch and bank erosion. With the larger and more frequent rain storms we have been experiencing in the northeast, it is important to protect roadside ditching to keep sediment and stormwater pollutants from migrating to a water body. Properly established roadside ditching will also stabilize the road by preventing erosion.

Location 1: Burnt Hill Road ditch erosion

Establishing protected ditching on steep slopes in heavily forested areas will require rock lined ditches. Fractured rock is used to line ditches due to its ability to lock together preventing it from migrating during larger storm events. The fractured rock will also slow stormwater velocity preventing erosion, increasing infiltration and allow for suspended solids to settle out. It is also recommended that check dams be installed to assist in slowing stormwater velocity and adding to ease of maintenance when cleaning the ditches. The stormwater turnouts along Burnt Hill road also need protection. The outlets should be rock protected and also maintained when they fill with sediment. When installing rock lined ditching and rock protected outlets, a layer of filter fabric under the rock as a base will prevent the rock from sinking into the sandy soils and will be additional stabilization adding to the longevity of the road and ditching.

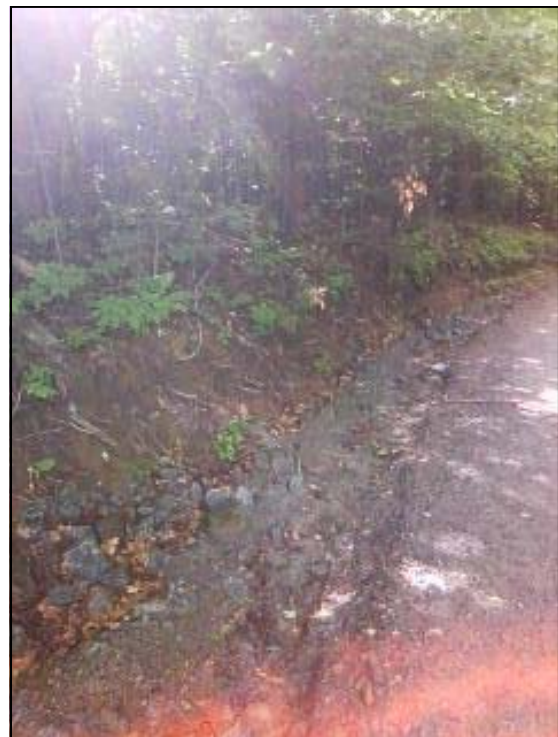
Location 2: One hundred feet south of the intersection with Hayesburg Road, Burnt Hill Road has a steep section that allows for increased stormwater velocity and erosion which outfalls into the lake through a culvert.

The runoff from the last 100' of the unpaved Burnt Hill Road flows over the intersection of Hayesburg Road and eventually to the lake. The Burnt Hill runoff that does not flow to the east or west ditching flows across the Road and builds up sediment on the lakeside bank and

Location 2: Burnt Hill Road ditch before intersection with Hayesburg Road

shoreline creating a small delta. There are multiple site limitations in this location. The ditching on the east and west of Burnt Hill Road drains to the lake, the steep slopes of the unpaved road, the close proximity to the lake and maintenance needed in this location to maintain and limit the sediment migration towards the lake.

Due to all of the limitations in this location, the following recommendations would need further research before a project is implemented. Depending on groundwater elevation in this area, a drywell at the intersection may be feasible but would need yearly maintenance due to the large amount of sediment that would be flowing into it from Burnt Hill Road. It is recommended that the maintenance to clean out the behind the check dams and the ditching in this location take place every year in spring or early summer to prevent sediment from draining to the lake and to encourage vegetated growth.

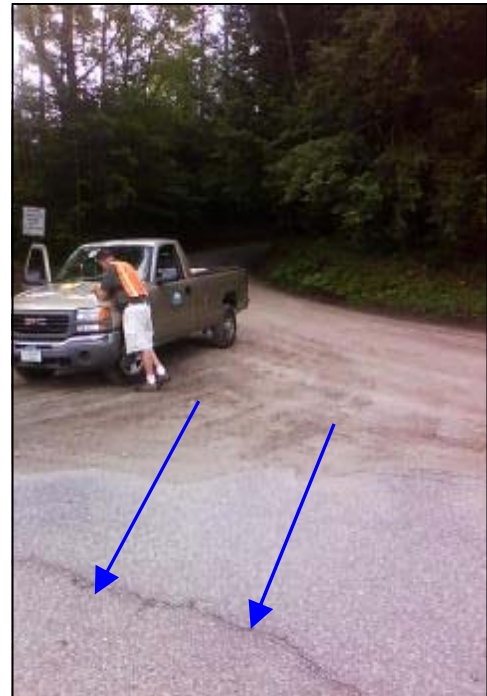
Location 2 recommendation: Burnt Hill Road runoff across Hayesburg Road to lake

A second recommendation to assist in remediating the Burnt Hill Road runoff is the retrofit and maintenance of the ditching on the west side of Burnt Hill Road that flows onto Hayesburg Road. This ditching flows to a small stream, which drains to the lake. The image on the right shows the ditch with sediment that flows into the stream and lake. To improve this ditching, it is recommended that fractured rock check dams be installed as well as yearly maintenance to clean out the sediment build up from behind the check dams and within the ditch. This section of Hayesburg Road has saturated soils and may be a regulated wetland. Further investigation and a site visit from the Adirondack Park Agency (APA) and U.S. Army Corps of Engineers will be necessary. Maintenance should be performed in spring or early summer to encourage vegetated growth in the ditching and the banks should be left to grow freely for additional stabilization.

Stabilizing the ditch and turnouts south along Burnt Hill Road within the Crystal Lake Watershed will greatly reduce migrating sediment north to these more sensitive areas that outfall to the lake. Breaking up stormwater in multiple areas is much more effective than trying to fix and capture everything at the problem location. Multiple retrofits throughout a drainage area will prevent a failure during a large storm event due to the ability to capture the stormwater in multiple locations.

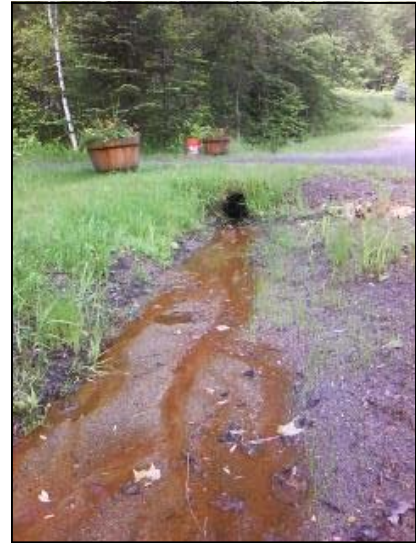
A 12" corrugated metal culvert (cmp) located at the intersection of Hayesburg and Burnt Hill Road outfalls directly to Crystal Lake. The ditching leading to the culvert on the east side of the road is in need of maintenance and stabilization. The ditch currently has a significant amount of sediment covering the majority of the rock lining.

Burnt Hill Road intersection:
ditch to stream & lake

The recommended retrofit for this last 100' stretch of road is to clean and reestablish the stone lined ditching. It is also recommended that the straw bale is removed from the ditch and proper check dams installed according to the New York State Standards and Specifications for Erosion and Sediment Control guide, known as the *Blue Book* -<http://www.dec.ny.gov/chemical/29066.html>.

The check dams and rock lined ditches on the east side of Burnt Hill Road will assist in reducing stormwater pollutants from draining to the lake by capturing the sediments and suspended solids behind the check dams. Lining the ditch with filter fabric before armoring the ditch with fractured rock will stabilize the ditch and prevent the rock from sinking into the fine sandy loam soils in this location.

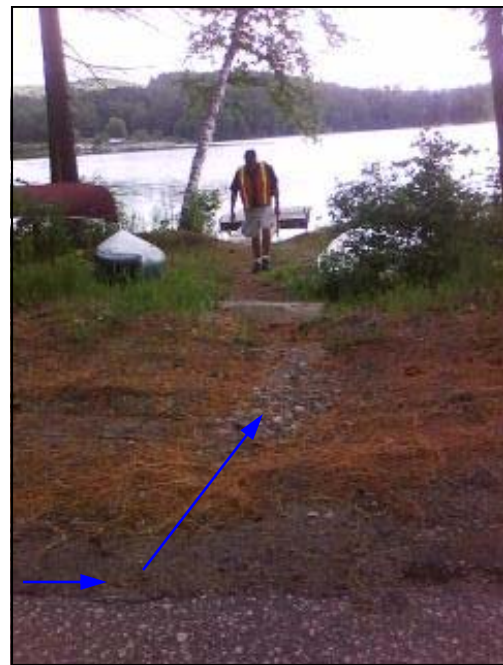
On the western side of the watershed on Hayesburg Road, there is a small head cut that is starting to erode towards the lake. The head cut is forming due to stormwater drainage flowing east down Hayesburg Road combine with driveway runoff. If head cuts are not addressed, they will continue to grow by continually eroding away soil especially with the heavy rains we have received this summer. Preventing head cuts from forming requires breaking up any concentrated stormwater flow.

Hayesburg Road west side:
head cut towards lake

To assist in reducing the volume of stormwater runoff to the head cut, it is recommended that a vegetated turnout with a protected outlet be installed west of the head cut on the north side of Hayesburg Road. A turnout will give the stormwater a place to settle out and infiltrate, reducing runoff volume. Since this is not an established ditch and the turnout would be going towards private property, the property owner would have to be contacted and worked with on this project. The recommended project area west of the head cut on Hayesburg Road is currently heavily forested and is down slope from any houses. Prior to this project, the wells in this location will have to be identified to establish proper buffers and retrofit locations. The turnout will have a protected inlet from Hayesburg Road and a protected outlet. The outlet will mainly serve as an overflow point for the vegetated turnout.

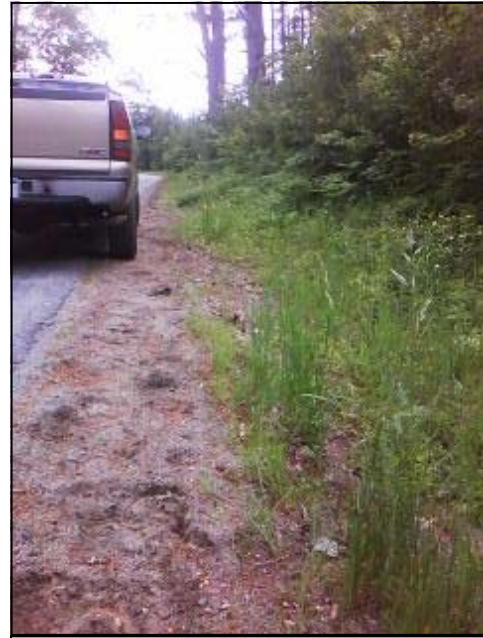
An outfall directly to Crystal Lake is located on the east side of the watershed on Hayesburg Road. This outfall currently has a damaged 10" c/p in an unpaved ditch. The ditch in this location is full of sediment from the sandy loam soils in this area and road-side runoff from deicing materials. The culvert is located in a low point in the topography and has a sediment build up that flows to the lake during storm events.

Hayesburg Road east outfall

Preventing stormwater pollutants from reaching the lake is one of the main goals of this assessment. This outfall is not the top priority area of stormwater pollution but it is an area of concern and does outfall directly to the lake. The sediment in the ditches and in front of the culvert needs to be removed. It is recommended that rock check dams be installed to capture sediment before it enters the culvert and flows to the lake. This adds to easier maintenance by capturing sediment and other debris behind the dams. It was noted that this culvert is beginning to deteriorate and is partially crushed. A maintenance schedule should be established to clean out the sediment build up in the ditch and behind the rock check dams.

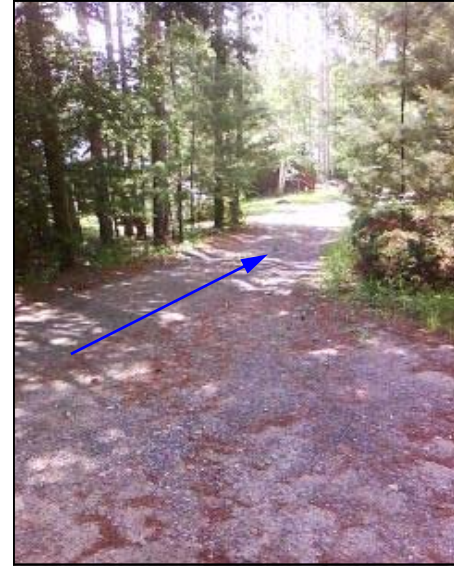
Spruce Drive is a very steep, narrow unpaved road on the north west side of the lake. Spruce drains south towards the lake and is showing signs of erosion. This is a difficult location to retrofit and the only solutions may be water bars with protected turnouts into a wooded area and/or the establishment of a ditch lined with fractured rock and check dams, if feasible. Depending on the side of the road chosen for ditching, the driveways would need culverts if ditching were to be installed. The limitations of a steep, narrow, unpaved road with houses will need additional research and planning to determine a solution that will work best in this location.

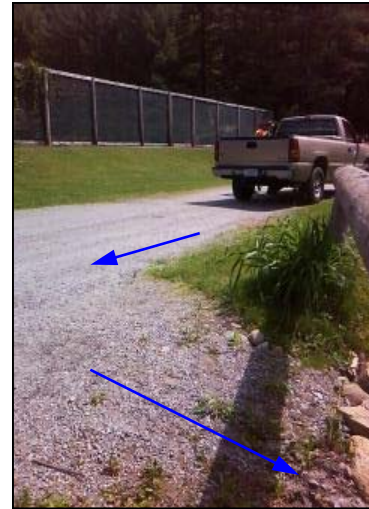
A tributary flowing to Crystal Lake crossed Crystal Lake Road located at the Lake Association beach and tennis courts. The stream crosses through a 24" corrugated HDPE culvert under the unpaved road. Above the culvert's head wall is a turnout from the road that drains stormwater directly to the stream. Crystal Lake Road drains from east to west with a portion of the stormwater flowing to the stream.

Crystal Lake Road tributary

The turnout from the road to the tributary needs regrading and vegetation. Both sides of the tributary are already vegetated and will benefit from connecting the vegetation on both sides of the tributary. With the vegetated area by the tributary graded to distribute the stormwater away from the stream, the stormwater will be able to splay out and infiltrate in the larger grassed area to the west.

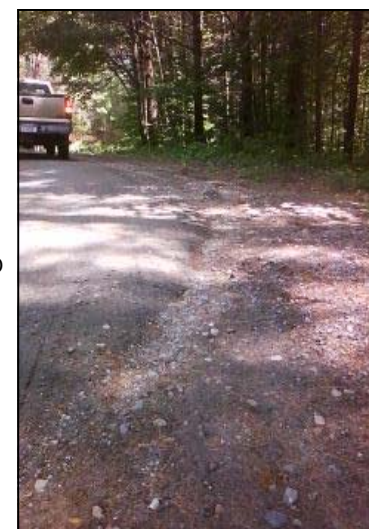
The western most mapped point on Crystal Lake Road is an area of the road that has some erosion. This section of the road does not have established ditching and is on a steep section of unpaved road. The erosion is located where Crystal Lake Road takes a turn towards Summit Road and the stormwater forms a concentrated flow to the center of the road, causing the migration of road material down slope towards the lake and tributaries.

Crystal Lake Road erosion

A turnout on the east side of the road will infiltrate the stormwater in a forested area and prevent concentrated flow from forming erosion issues on the road as shown in the photo on the right. The turnout will need a rock protected outlet and will need to be installed in a location where concentrated flow will not form and create a head cut. The turnout needs to flow to an area that will allow for the stormwater to spread out, drop suspended solids and infiltrate into the ground.

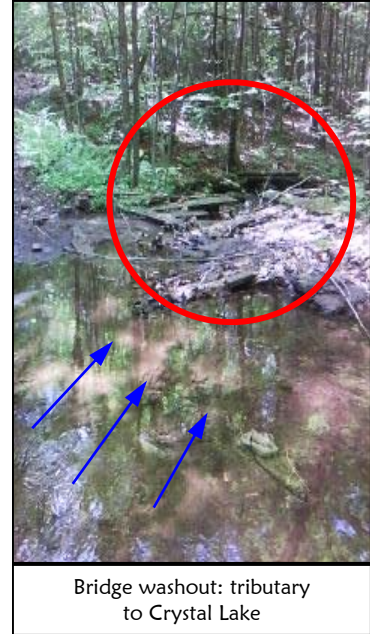
The main inlet to Crystal Lake is a tributary that flows in on the north eastern end of the lake. Approximately 1,700' north of Crystal Lake on the tributary is a bridge that has been washed out. Currently the bridge has collapsed into the stream and is clogging a section causing scouring in this area. The bridge appears to have been used to connect recreational trails through out this area.

The bridge debris should be removed to prevent anymore scouring of the stream and stream banks. Once the debris is removed, the stream should reform to a stabilized section. Any soils disturbed during debris removal should be seeded and mulched for stabilization.

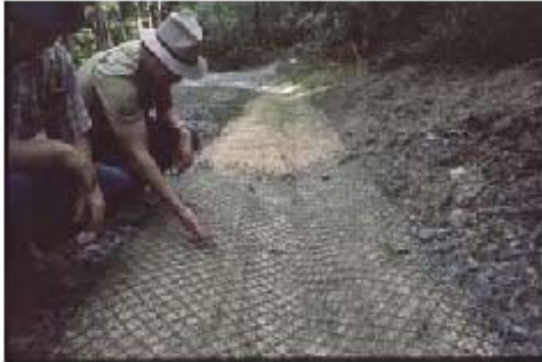
STANDARD AND SPECIFICATIONS FOR VEGETATING WATERWAYS

Definition

Waterways are a natural or constructed outlet, shaped or graded. They are vegetated as needed for safe transport of runoff water.

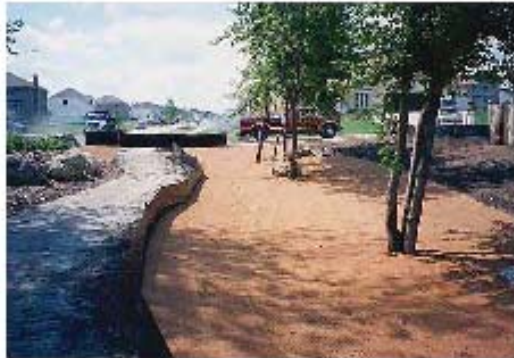
STANDARD AND SPECIFICATIONS FOR PERMANENT CRITICAL AREA PLANTINGS

Definition

Establishing grasses with other forbs and/or shrubs to provide perennial vegetative cover on disturbed, denuded, slopes subject to erosion.

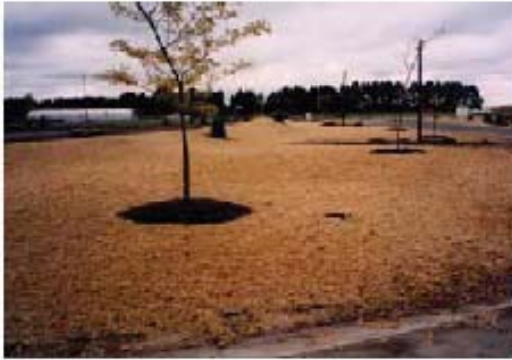
STANDARD AND SPECIFICATIONS FOR MULCHING

Definition

Applying coarse plant residue or chips, or other suitable materials, to cover the soil surface.

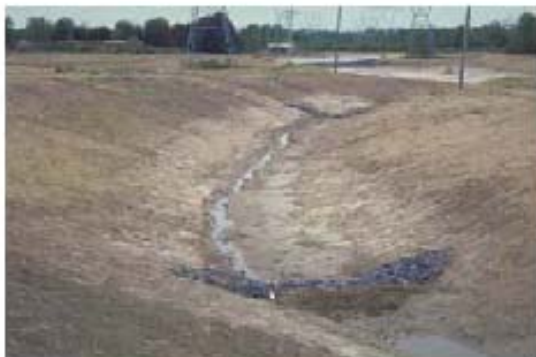
STANDARD AND SPECIFICATIONS FOR CHECK DAM

Definition

Small barriers or dams constructed of stone, bagged sand or gravel, or other durable material across a drainage way.

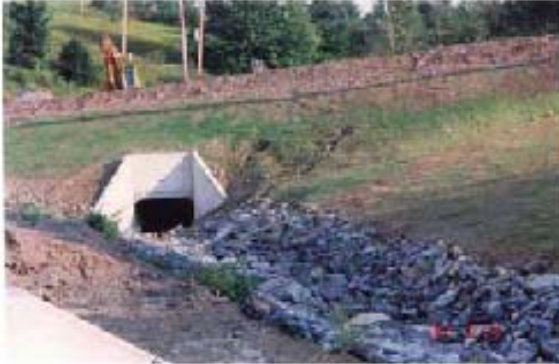
STANDARD AND SPECIFICATIONS FOR LINED WATERWAY OR OUTLET

Definition

A waterway or outlet with a lining of concrete, stone, or other permanent material. The lined section extends up the side slopes to the designed depth. The earth above the permanent lining may be vegetated or otherwise protected.

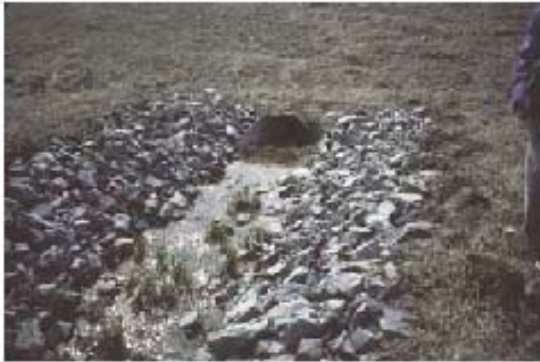
STANDARD AND SPECIFICATIONS FOR ROCK OUTLET PROTECTION

Definition

A section of rock protection placed at the outlet end of the culverts, conduits, or channels.
