Echo Lake Water Quality Assessment

For the Town of Warrensburg

August 2016

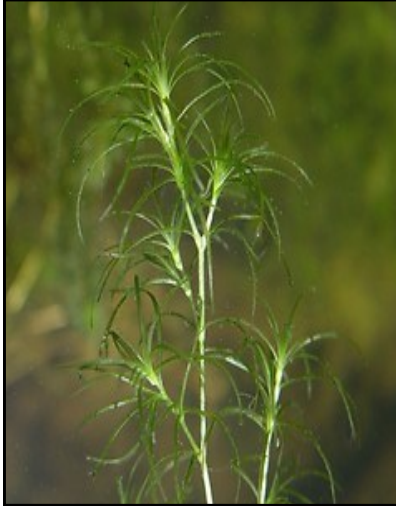
Najas flexilis

The limited number of aquatic species found in our survey were all native plants found in most waterbodies locally. The only invasive plants noted was the Common Reed (*Phragmites australis*), which was found along approximately 20% of the shoreline. Native plants obtained during the survey were Floating Leaf Pondweed (*Potamogeton natans*), Narrow Leaf Pondweed (*P. pusillus*), American Pondweed (*Stuckenia pectinata*), Water Nymph (*Najas flexilis*), Needle Spike-rush (*Eleocharis acicularis*) and a macro-algae known as muskgrass or stonewort (*Chara sp.*).

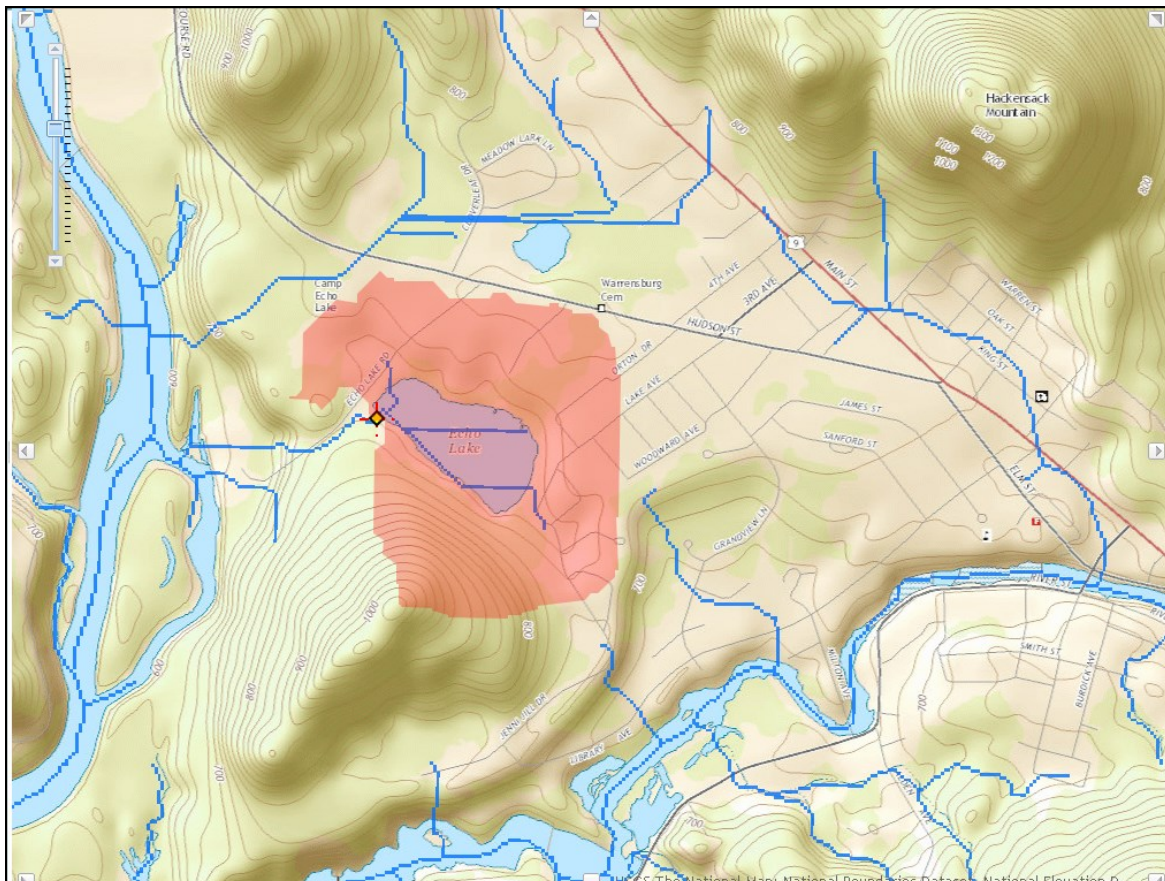
Echo Lake Watershed Map From USGS StreamStats

Echo Lake is located in central Warren County, New York. The 0.28 square mile (180-200 acres) watershed covers a small portion north of the Hamlet of Warrensburg. The lake is bounded on three sides by roads; Lake Avenue to the east, Echo Lake Road to the west and well away to the north, Golf Course Road. (see watershed map and aerial photograph in appendix)
