Town of Hague Stormwater Outfall Evaluation Report

*Prepared by the
Warren County Soil and Water
Conservation District*

*For the Town of Hague and the
Lake George Park Commission*

November 2012

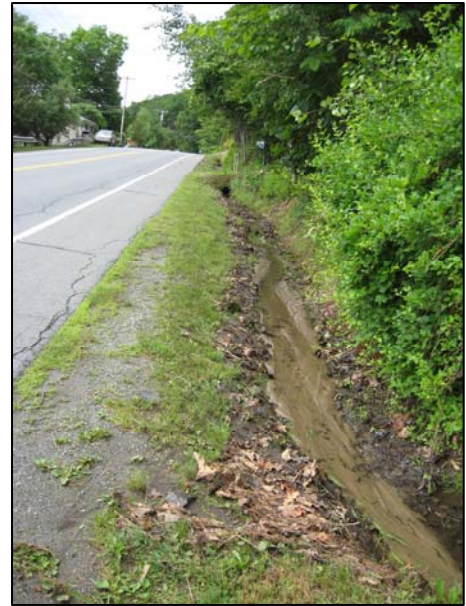
Rt. 9N runs north-south along the shoreline of Lake George making it an area of constant concern when it comes to stormwater runoff. It was determined that nearly half of the outfall points mapped on Route 9N, drain directly to Lake George or to a tributary to the lake. Most of these ditches were in relatively good condition with stable slopes and heavy vegetation. Obvious sediment issues can arise when vegetation is stripped from the ditches for routine state maintenance.

The majority of the outlets from Rt. 9N to the lake are located on private property making it difficult to collect data on the health of the lake at each outlet location. It would be extremely important for the Town and the LGPC to work with the downstream landowners to allow data collection of these tributaries to see what impacts to the lake are occurring below Route 9N. In addition, the Town should begin discussing what maintenance activities are planned by the NYSDOT within the boundaries and if there are any planned improvements that may be modified to improve the stormwater runoff situation.

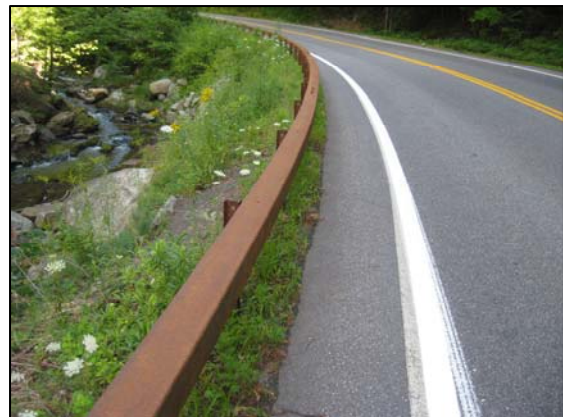
Route 8 has several areas that are of concern. The largest area is near the town center where nearly all stormwater that flows off of Rte 8 is discharged to Hague Brook. This stormwater system begins at the town hall and continues to the intersection with Route 9N. There are few effective alternative treatments at this time, as this area is built out (both roadway and buildings). There are several parking lots that are between Route 8

and Hague Brook where test pits could be done to determine if the soils would be conducive for infiltration. While not a town issue (state route), this is something that the town should investigate to determine if there are any benefits.

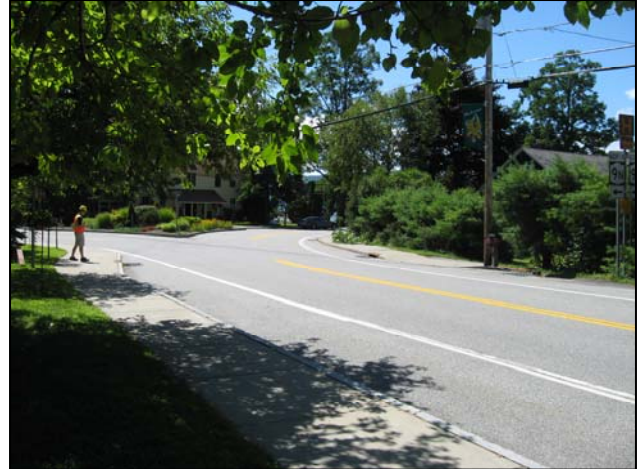
Likely the worst area for stormwater in the town is the intersection of Rte 8 and 9N. Within 100 yards there are 5 significant outfalls into Hague Brook, all contributing stormwater from the state roads. As mentioned in the Route 9N write up, this is an area that needs to be discussed in detail with the NYSDOT to determine what can be done to reduce water quality impacts. The DOT would likely not do anything unless there was a capital project involved. The Town should engage the DOT at this time to see if there any proposed work plans for this location or any capital projects.

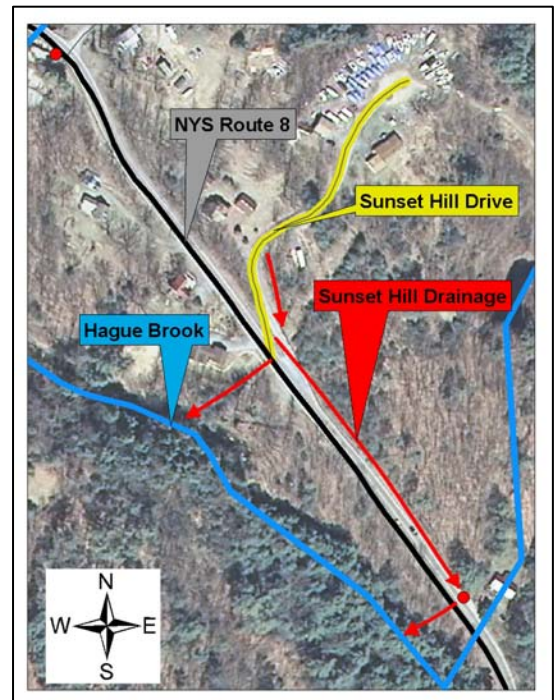
Sunset Hill Dr. is a 650', fairly steep town road that drains to NYS Route 8 (Graphite Mountain Road). The location where Sunset Hill connects and drains to Rt. 8 is an area of significant concern, with Hague Brook flowing alongside Rt. 8 directly to Lake George. Sunset Hill drains approximately a ¼ acre of stormwater to combine with Rt. 8 which is draining over a ¼ acre section of road along Hague Brook. The additional drainage from the mountainside Sunset Hill is built on has been calculated into the stormwater volumes from the road, but has not been fully measured due to relatively small amount of contributing runoff in our wide spread study. Sunset Hill has well vegetated ditches on both sides of the road with steep slopes which enables the stormwater to reach a high velocity. With high velocity stormwater draining south, the runoff does not infiltrate properly, enabling the flow to travel a greater distance and end up in Hague Brook. As Sunset Hill and Rt. 8 merge, half of the stormwater drains into a drop inlet on the eastside of Rt. 8, which outlets directly to Hague Brook. The other half of Sunset Hill drains to the west side of Rt. 8 where the stormwater has eroded small sections of the road creating drainage outlets directly to Hague Brook. In addition, on the eastside of Rt. 8 there is an additional 550' to another drop inlet that outlets directly to Hague Brook.

Sunset Hill currently has two collapsed culverts that if functioning properly, help slow the velocity and disbursement to assist with stormwater infiltration. These culverts are

approximately located 100' and 350' uphill from the intersection of Rt. 8 and Sunset Hill. Due to the high bedrock located 1' under the surface elevation in this area, stormwater infiltration systems are unable to be installed. In an area with high bedrock and well vegetated ditches, the recommended stormwater retrofit for Sunset Hill is to replace the two 12" culverts.

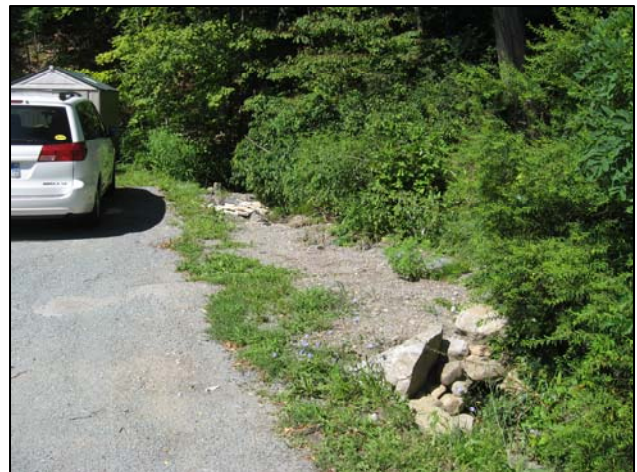
During this assessment, it was discovered that a small culvert towards the rear of the Post Office property was overwhelmed by stormwater from Route 8. Stormwater runoff flows through this area and into a vegetated swale leading to the Darrin sediment basin. At this time the culvert has failed and is contributing additional sediment into the system.

A design should be done to determine the proper size of the culvert which would be placed to handle the water volume for Route 8 while including the consideration that this is a parking area and a minimum amount of fill necessary over the pipe.

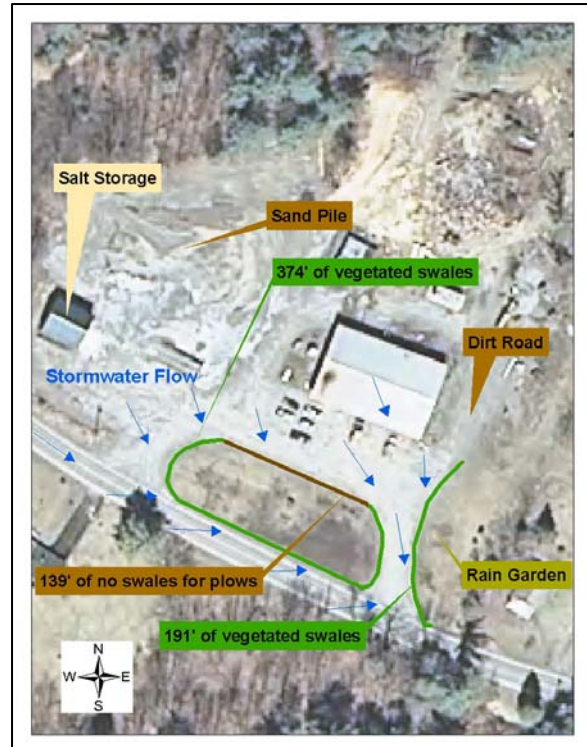
The Town of Hague Highway Garage located on West Hague Road takes a significant amount of stormwater from West Hague Road the highway garage parking lot and

driveways. To the south of the highway garage is a 1/3 acre plot of grass situated between driveways and borders West Hague Road (see diagram). The entire 1/3 acre grassy plot is encompassed by eroded edges from stormwater runoff. In addition, the southeast corner of the highway garage property receives significant stormwater runoff from the driveway, garage roof, and dirt road. The stormwater runoff from this location continues to flow east to a tributary of Hague Brook.

This is an ideal location for a rain garden to capture and infiltrate stormwater runoff. Also, constructing vegetated swales around the highway garage driveways would prevent eroding ditches and added sediment to stormwater runoff. Vegetated swales around the 1/3 acre plot of grass would slow and infiltrate stormwater while collecting pollutants. An estimated 565' of vegetated swales with check dams would be necessary to collect the stormwater from West Hague Road and the highway garage. In addition, check dams will slow stormwater velocity allowing for increased infiltration. At the northern end of the 1/3 acre grass plot, 139' section should not have vegetated swales due to winter plowing.

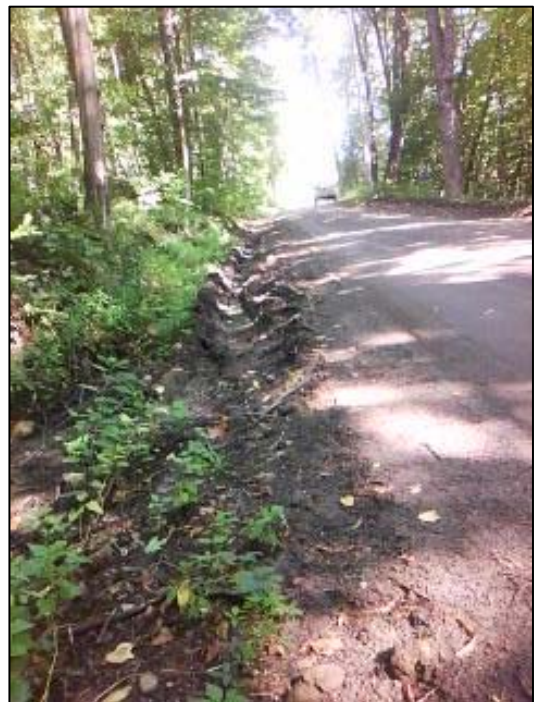
Stemming east off NYS Route 9N (Lake Shore Drive) is Pudding Island Road, an unpaved road where the Arcady Bay sediment basin is located. The basin is located approximately 700' south of the intersection of Rt. 9N and Pudding Island. The basin receives water from a concrete culvert running under Rt. 9N, and from ditches along Pudding Island Road. The sediment in the basin has risen to the bottom of the outlet culvert permitting sediment to flow out towards the lake. Once sediment fills the basin to 50% capacity, the basin should be cleaned out to become functional and prevent sediment from migrating downstream.

The outlet flows to a stone-lined ditch that meanders east directly to Lake George. North of the sediment basin, the first 80' of ditch is vegetated and filled with sediment, followed by 350' of roadside erosion with steep banks. The last section of ditch is 270' is well vegetated with

grassy slopes. The existing ditch is approximately 4' wide by 1½' deep. Stone-lined ditching is needed along the west side of Pudding Island Road to stabilize the roadside and bank, and prevent erosion from flowing into the sediment basin.

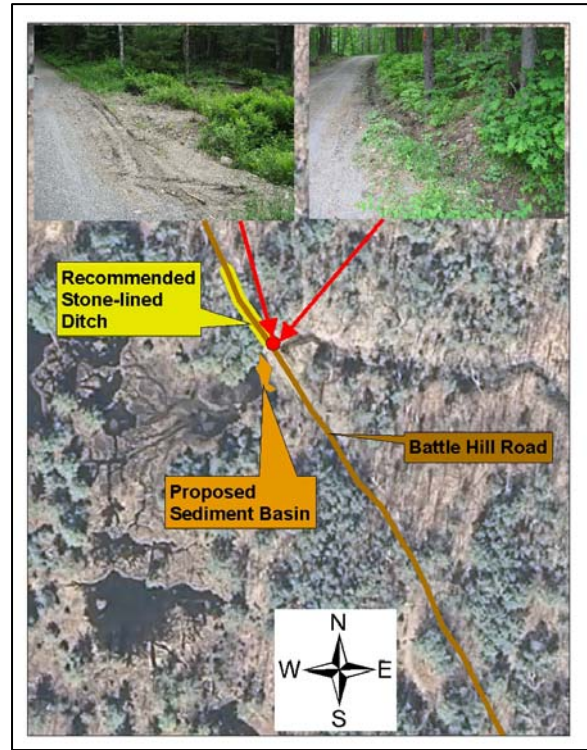
Battle Hill Road is a narrow unimproved town road and is an area of concern due to the fact that it is located upstream of Lake George and has erosion issues. The road crosses the outlet of a pond/wetland complex and forms the headwaters of an unnamed tributary that flows to Lake George. This crossing is severely impacted by flooding and road runoff.

Flooding of this crossing occurs during severe spring runoff, because the culvert is undersized in capacity. In addition, the town has had issues with beavers obstructing the culvert. Sediment from the east reaches the stream as vehicles continually wear away at the soft sides of the road and form ruts that scour during heavy rainfall events. The town has attempted to temporarily fix the situation, however more solid solutions are necessary.

Approximately 100' of stone-lined ditching is needed on both sides of this section of road. The stone-lined ditching will help with the stabilization of the road and permit stormwater to infiltrate, reducing roadside erosion. In addition, the town should consider replacing this outlet with a larger culvert to increase volume capacity. The APA would need to be involved as this is most likely a jurisdictional wetland.

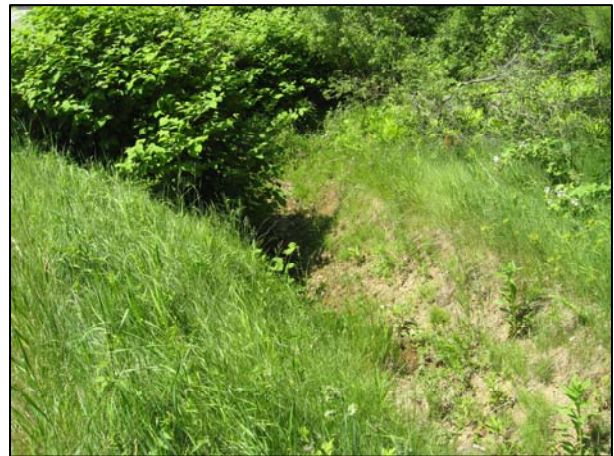
The north side of New Hague Road, east of Coldwater Canyon Road has a significant head cut that has formed, which has begun eroding the sides of the ditch. A section of the non-eroded ditch bottom should be lowered and lined with filter fabric. Compactable material should then be placed on the cut in a consistent positive grade towards the outlet from the headcut. Angular stone fill (4-6") should be backfilled into the bottom of the ditch where the filter fabric lays (Appendix Design1).

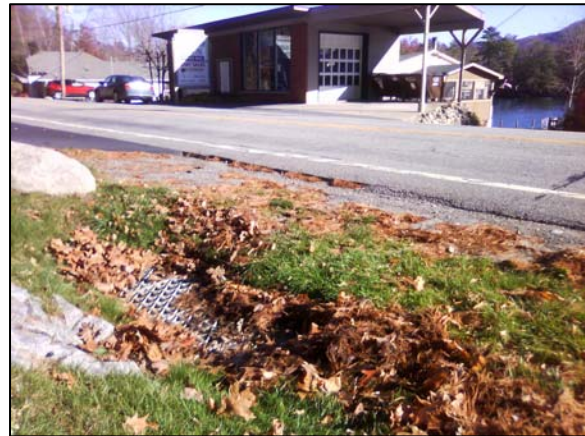
Upon meeting with the Hague Committee, it was explained there were two drop inlets of concern in the Snug Harbor area of Rte. 9N. During the data collection for this report, District staff did not observe any discolored water from these outlets, which may only be seen during storm events.

Monitoring this area and photo-documenting the discolored water would be important to note the issue. It may be challenging to reduce the impacts, as bedrock and high water tables are found in this section of 9N.

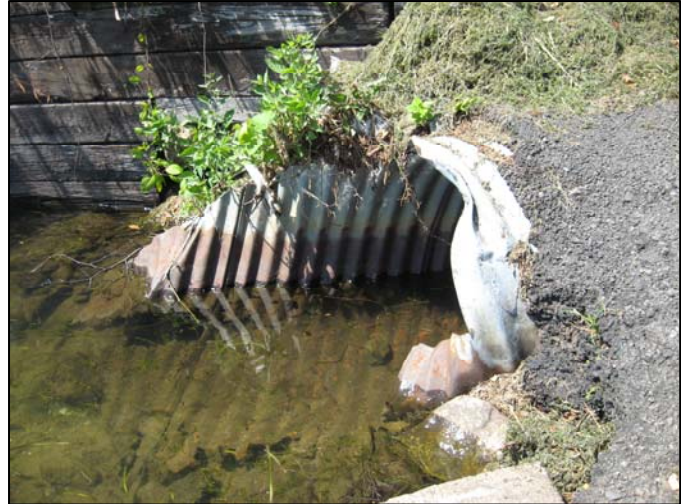
An unnamed inlet from natural drainage and stormwater runoff from Route 9N to the Hague Boat Launch

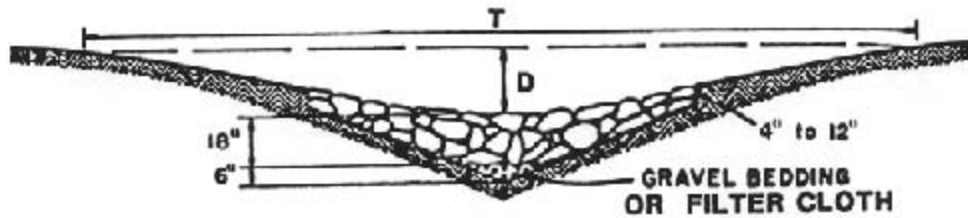
Figure 5B.8
Typical Waterway Cross Sections

Waterway with stone center drain. "V" section shaped by motor grader.

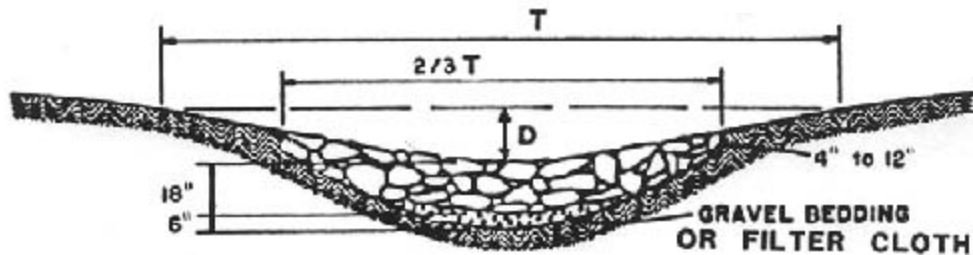
Waterway with stone center drain. Rounded section shaped by bulldozer.
