Town of Queensbury Stormwater Identification Project

Prepared by the
Warren County Soil and Water
Conservation District

For the Town of Queensbury under the Lake George Park
Commission Community Stormwater Grant Program

March 2013

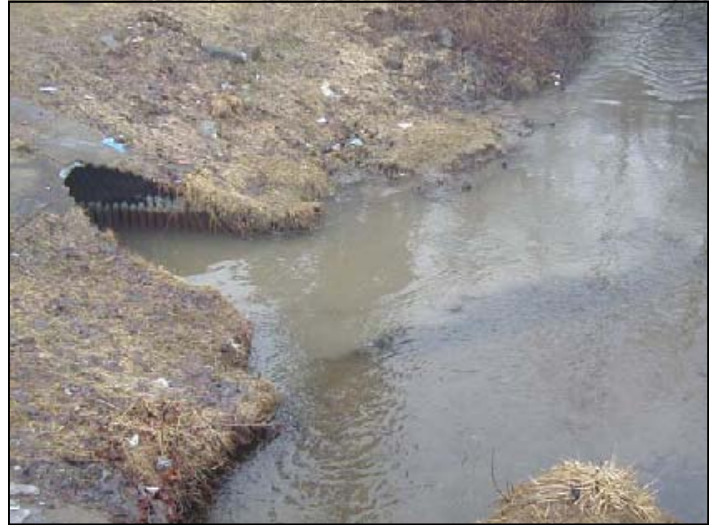
Stormwater outfall entering trout stream during a rainfall event

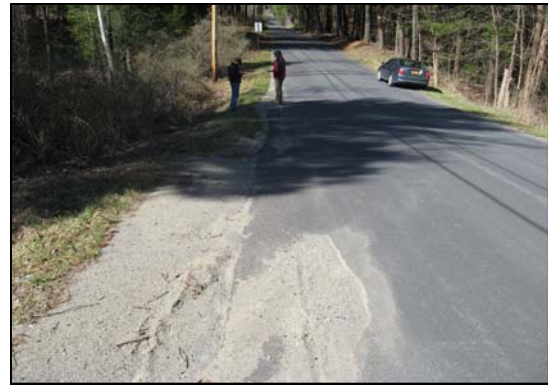
Approximately 400 feet of Pickle Hill Road drains to an unnamed tributary of the Lake George Watershed. This location drains from west to east causing stormwater to collect and deposit sediments at the stream crossing due to the low point in the topography. Pickle Hill Road crowns in the center draining roughly 4000 square feet of roadside drainage to the stream.

Depending on depth to bedrock, depth to water table and soil types, a 4'x8' drywell will catch and infiltrate the first flush of stormwater (containing the highest concentration of pollutants) and allow sediments to settle out before running off into the stream. A drywell in this location will also assist in reducing the amount of thermal pollution in the stream resulting from super heated stormwater running off the asphalt road during the summer months. One drywell could certainly handle a 1/2" storm for this section of road. Runoff from a 1/2" storm on this section of Pickle Hill Road would be 1,247 gallons and a 4'x8' drywell has the volume capacity of 1,503 gallons. A 1" storm can be captured with a double stack drywell or two drywells side by side, if site location constraints allow. An infiltration system able to handle a 1" storm in Warren County will capture 90% of stormwater pollutants and events. If bedrock is a limiting factor, a vegetative swale with check dams may serve as the best alternative. Benefits of vegetated swales are, cost effective, allows for stormwater infiltration, removal of roadside pollutants, and reduces stormwater velocity.

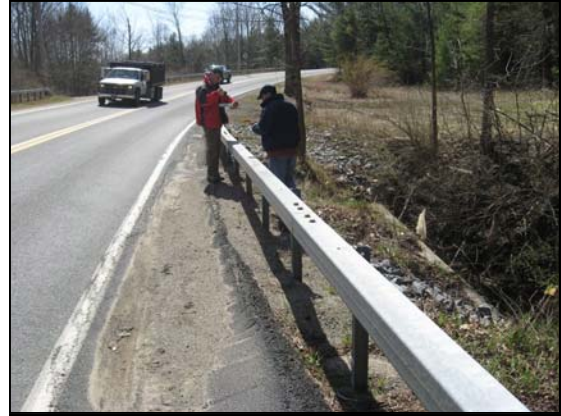
Just north of Pickle Hill Road on Bay Road is a culvert that conveys a significant amount of water to an unnamed tributary of Lake George. At this location, Bay Road is constructed to drain to the west side of the road and stormwater is conveyed to the lowest point, being the stream flowing through the culvert under Bay Road. Paved swales along the west side of Bay Road increase stormwater volume and velocity out-letting directly to the stream at the culvert location.

The best way to deal with stormwater in a watershed is to break it up by retrofitting sections to prevent runoff into a waterbody through infiltration. The recommendation for this location is two 4'x8' drywells north and south of the culvert on the west side of Bay Road. The drywells will collect sediments, and infiltrate stormwater minimizing stormwater pollutants from entering the stream and eventually flowing to Lake George. Also, with further planning in this location, vegetated swales may be another possibility to reduce stormwater pollutants and velocity during conveyance.

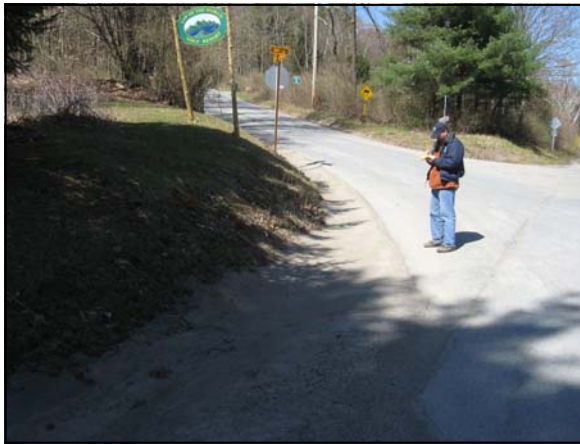
The intersection of Bay and Lockhart Mountain Road receives a significant amount of stormwater from both roads. As seen in this photo, stormwater settles in this location and drops a significant amount of sediment. During a large storm event, the deposited sediment will continue to flow approximately 600 feet south to the tributary crossing at the Bay road culvert discussed in the previous section. The stormwater conveyance south of the intersection of Bay and Lockhart Mountain Road to the tributary is constructed of vegetated swales with no issue, and paved swales that increase stormwater velocity and sediment transportation. Paved swales increase stormwater velocity due to the impervious surface preventing infiltration, and the channelized flow prevents sheet flow which also concentrates stormwater runoff.

An infiltration system (dry well) in this location will break up the stormwater runoff and the collection of sediments and pollutants from entering the tributary to the south on Bay Road. By replacing the paved swale with vegetation, a significant improvement in stormwater conveyance will be achieved through decreased velocity and increased

infiltration. Another benefit of increased infiltration aside from a cleaner, healthier watershed, is groundwater recharge. It is important to replenish groundwater because like all reservoirs, if they are not recharged, water is used and depleted, leading to a drop in the water table. Ground water is also an important water supply for our streams, lakes, rivers, and wetlands.

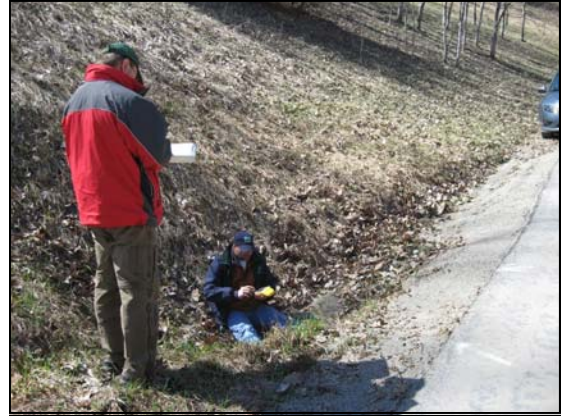
A quarter mile north of the Bay and Lockhart Mountain Road intersection on Lockhart Mountain Road is an 18" corrugated metal culvert that drains to an unnamed tributary

of the Lake George Watershed. Approximately 700 feet of roadside drainage flows to this tributary. The majority of the this stormwater conveyance consists of vegetated swales.

Vegetated swales are ideal conditions except the steep topography in the area creates high velocity runoff enabling transportation of sediments through the vegetation. Check dams installed in the vegetated swales are an economical fix that will slow stormwater velocity allowing the sediments to settle out behind the dams which also allows for ease of maintenance. A careful analysis of this drainage and road elevation would be needed as to not cause road flooding during extreme rainstorm or snowmelt events. Also, depending on soil types, a drywell placed north of the culvert will capture large amounts of sediments including the first flush of stormwater containing high amounts of pollutants including de-icing materials and petrochemicals.

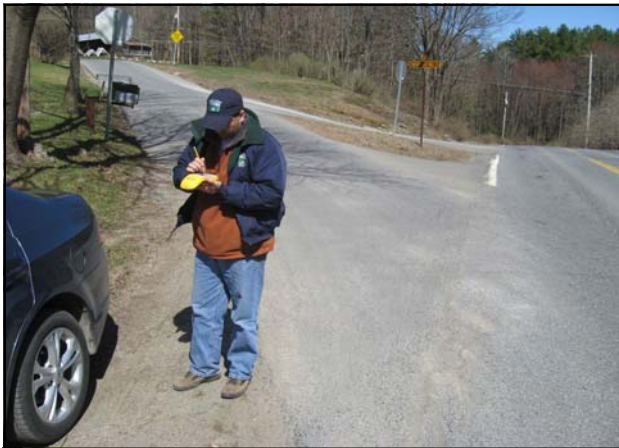
Intersection of Bay and Woodchuck Hill

Approximately 50 feet south of the Bay and Woodchuck Hill Road intersection is a culvert stream crossing under Bay Road. A 1,000 foot section of Woodchuck Hill Road drains to this intersection. While GPS mapping and collecting data, the sediment built up from roadside drainage was clearly visible as an area of concern (photo on left). The sediment build up results from a slowdown and disbursement of stormwater allowing sediment to settle out on the level topography of Bay Road in this location. During larger storm events,

stormwater is able to build up high velocities flowing south on Woodchuck Hill, enabling it to carry sediments and other pollutants to the unnamed tributary of Lake George running under Bay Road. This unnamed tributary, similar to the majority of the Lake George Watershed tributaries, is a NYS Department of Environmental Conservation classified AA-S stream. One of the best usages for a classified AA-S stream is drinking water and must be held to the highest standards when it comes to overall stream health.

The ideal retrofit for this location would include the installation of a 4'x8' drywell north of the stream and on the west side of Bay Road. Barring construction location constraints, it should be located at the confluence of stormwater from Woodchuck Hill and Bay Road. To pinpoint this location, there would need to be further research and

a survey of the area. If all factors work in favor of infiltration, the retrofit would maximize the amount of stormwater captured, resulting in a healthier stream/ Lake George Watershed.

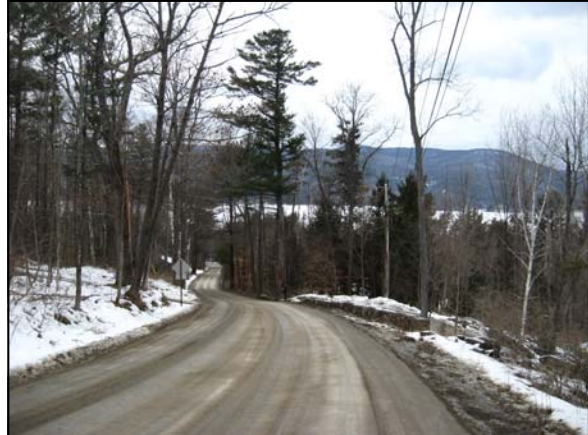
Lockhart Mountain Road
(Southeast of 9L)

The intersection of Lockhart Mountain Road and 9L receives a significant amount of stormwater and de-icing material. Lockhart Mountain road drains 800' of road north through vegetated ditching to 9L. This section of Lockhart Mountain Road has very steep slopes requiring large amounts of de-icing materials, to keep the road safe for travel, and are deposited west on 9L ditching.

The ditching on the west side of the intersection of 9L and Lockhart Mountain Road is in need of maintenance due to the significant amounts of material deposited in this location by stormwater. The installation of check dams in the ditch intersection will slow stormwater allowing sediments to be deposited adding to ease of maintenance. Areas behind the check dams collect the sediments and need to be cleaned out as opposed to the entire ditch needing maintenance.

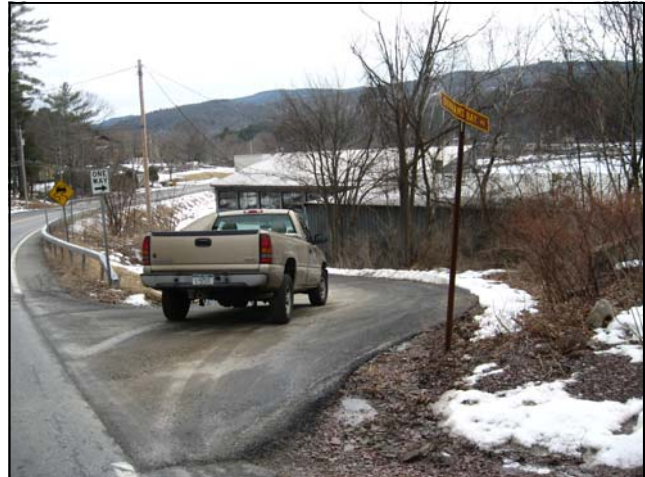
Intersection of 9L and Dunham's Bay Road

The Dunham's Bay Road outlet is located a quarter mile east from the intersection of Bay Road and 9L. The outlet collects stormwater from 9L and Dunham Bay Road

where it discharges directly to the lake. Because there are several drainage areas that combine in a relatively small area, we split up the sections into two: Dunham's Bay Road and 9L. The 9L section of this drainage is not a top priority because it is conveyed through vegetated swales along 9L, but it is still may be an area of concern due to the direct discharge to Lake George and the fact that it is a state route.

Dunham's Bay Road drains to a drop inlet at the bottom of the road slope that discharges directly to Lake George. During this report, the Town of Queensbury was planning on repaving this road and asked for any potential water quality improvement projects. The town installed a stone lined trench along the roadway, where feasible to reduce stormwater velocities and allow sediment to drop out of suspension. Infiltration may not be ideal as there is bedrock in this area. 9L drains 315' of road south through mostly paved ditching to Dunham's Bay Road. In this location, the entire 20' width of 9L is paved to drain to the west side of the road which receives 3,927 gallons of stormwater during a 1" storm.

The use of a rock lined infiltration trench is probably the most feasible retrofit that would assist in reduction of sediments to Lake George and ease of maintenance. Ideally, a drywell to capture and infiltrate stormwater would be the best recommendation in this location (Qsby. Highway Dept. installed trench in 2012).

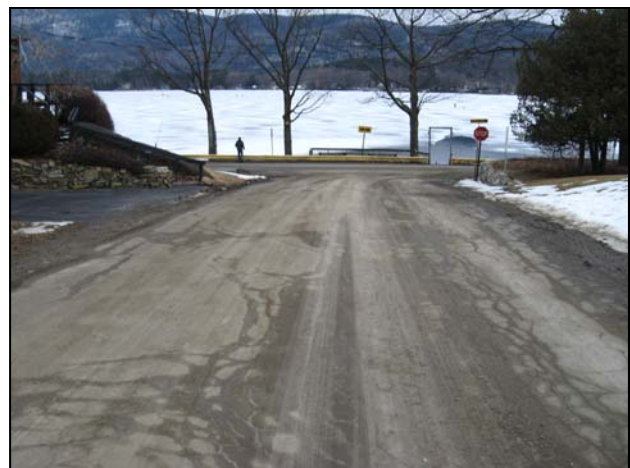
Intersection of Sunset Lane and Assembly Point Road

There are two drop inlets located at the intersection of Sunset Lane and Assembly Point Road that receive 150' of roadside runoff from Sunset Lane. Stormwater draining to these drop inlets continues to flow east and is conveyed through a 12" corrugated metal pipe directly to Lake George. The entire 24' wide road is capture by the two drop inlets that receive

2,244 gallons of stormwater during a 1" storm. Sunset Lane also receives heavier amounts of de-icing materials necessary to keep travel safe due to the steep slope of the road.

A drywell retrofit on the north side of the intersection of Sunset Lane and Assembly Point Road would prevent a significant amount of stormwater from draining to Lake George. An infiltration system in this location would capture roadside pollutants (salts, sands, petrochemicals) and also assist with groundwater recharge. The feasibility of this project depends on site constraints such as, depth to bedrock and groundwater near the intersection.

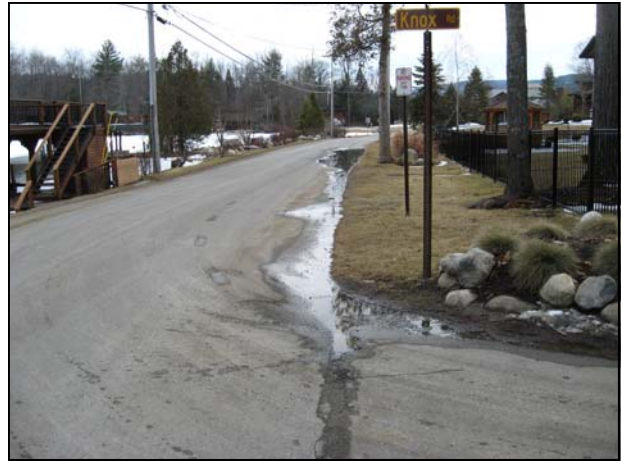
Intersection of Knox Road and Assembly Point Road

Another outfall to Lake George is located at the intersection of Knox Road and Assembly Point Road. This intersection receives approximately a 150' of stormwater runoff from Knox Road and is conveyed through a 12" corrugated metal pipe east across Assembly Point Road to an outfall at the lakes edge.

Depending on site constraints in this location, Knox Road has a good location for a drywell and infiltration chambers shown on the right hand side of the photo on the right. This intersection has the space for an infiltration system but a test pit is needed to check the soils and groundwater.

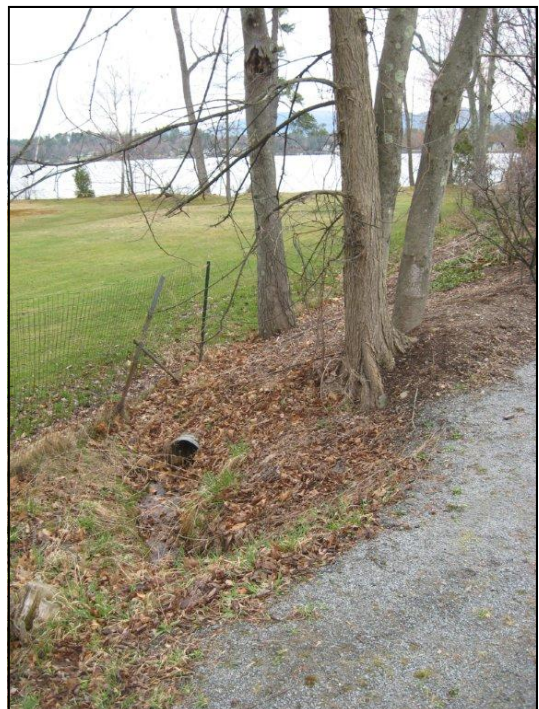
Mason Road location

Mason Road located off Cleverdale Road currently has a drop inlet that conveys stormwater from roadside drainage to a 12" shallow corrugated metal culvert leading directly to Lake George. From the drop inlet on Mason Road, the pipe runs 100' under the road where it flows into the pipe of concern that discharges it directly to the lake.

water to infiltrate out reducing the input into the lake and recharging groundwater. Another possible retrofit would be a shallow vegetated swale with check dams to slow the velocity of stormwater and allow sediments to settle out behind the dams. The DEC recognizes that successfully developing a vegetative cover will reduce sediment inputs by up to 90%. A general seed mix that works successfully in the Lake George Watershed is comprised of creeping red fescue, Kentucky bluegrass, chewing's fescue, and perennial ryegrass. It is also advisable to add annual ryegrass, which will germinate quickly for short term vegetated cover, die and decompose supplying a higher organic load to the area.
