Lake George Basin Reservoir and Sediment Basin Cleanout Program: History and Status

December 12, 2005

Dave Wick, CPESC, District Manager

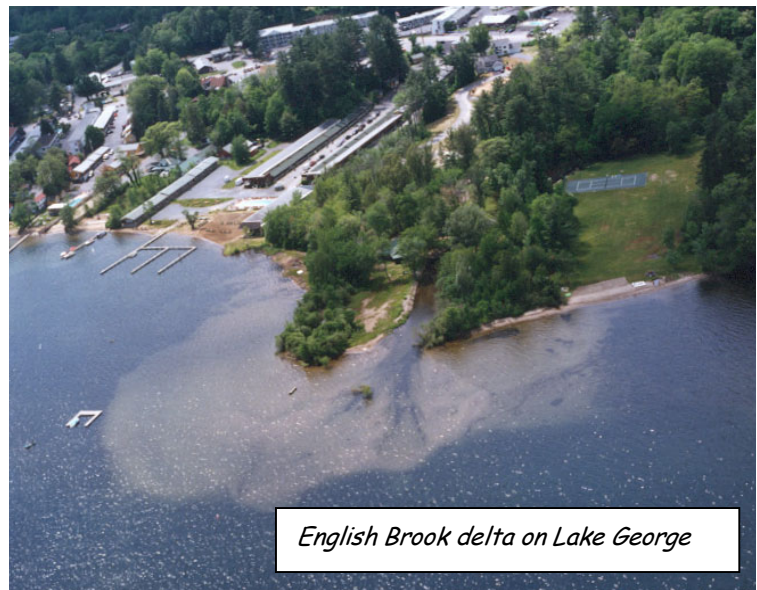
English Brook delta on Lake George

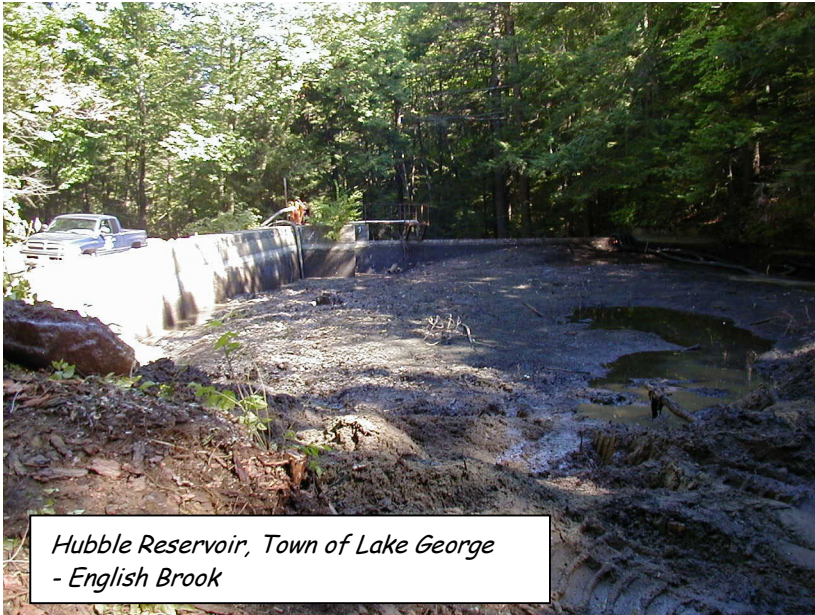
Sediment had accumulated in this reservoir since its last maintenance cleanout in the 1960's or 70's, and was completely full to capacity (approximately 1,000 cubic yards). As such, there was no slowing of the stream, and no in-stream sediment was being captured.

*Hubble Reservoir, Town of Lake George
- English Brook*

To undertake the cleanout effort, the stream was first contained and redirected by sandbags towards the far side of the reservoir and over the dam. Following this, a pump was used to draw down the remaining clean water in the reservoir and pump it into the stream below the dam. Once the reservoir was dewatered, employees of the Town and Village of Lake George went in with heavy equipment (loader and excavator) and removed the sediment and organic detritus. This material was hauled offsite to the Lake George landfill, which was a site approved of by the Adirondack Park Agency (APA) and the DEC.

This was a cooperative effort between the Warren County SWCD, the NYS DEC, the Town and Village of Lake George, and the Lake George Association. By excavating as much sediment and material as possible from this basin (approximately 700 cubic yards), it once again had the capability of slowing flow and collecting in-stream sediment. The actual construction timeframe was four days, including sandbagging, excavation, and cleanup.

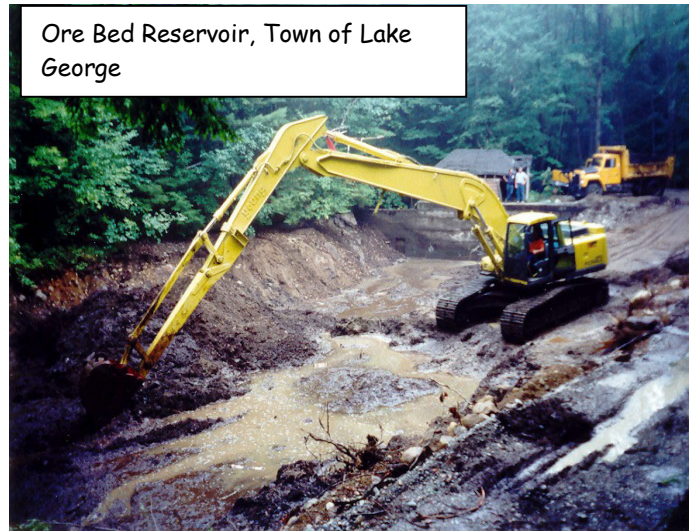
The second reservoir cleanout to be conducted through this new initiative was also within the Town of Lake George. Ore Bed Reservoir on West Brook, also a man-made structure with a hybrid concrete and stone/mortar dam, was the site of the second cleanout. Ore Bed is located within the West Brook watershed above the location of the Lake George transfer station, and is owned by the Village of Lake George. Like Hubble Reservoir, Ore Bed was another old water supply for the Village of Lake George, prior to its abandonment when the Village began taking water directly from the Lake. This reservoir was also completely full of sediment and was in need of cleanout during the mid 1990's.

Ore Bed Reservoir, Town of Lake George

This project was conducted in much the same way as Hubble Reservoir, as a joint effort between the District, the Village and Town of Lake George, and the LGA. The District undertook the permitting, planning, and project management, the Village and Town provided heavy equipment operators and trucking, and the LGA financed the rental of the excavator. The roles outlined in the Ore Bed project work well for these initiatives, and largely continue to this day in the reservoir cleanout program.

Ore Bed is dewatered with the use of an off-line ditch adjacent to the reservoir. This ditch is lined with stabilization fabric or plastic liner in order to support the stream flow, which is then blocked and diverted into this ditch; eventually outletting back into West Brook below the reservoir. Once the stream is diverted, the water in the reservoir is either pumped out or released with the sluice gate at the bottom of the dam.

Following dewatering, a long-reach excavator enters the reservoir and excavates the material directly into trucks which haul the material away. As the reservoir is adjacent to the landfill and transfer station, the excavated material is usually stored there and utilized afterwards for fill material.

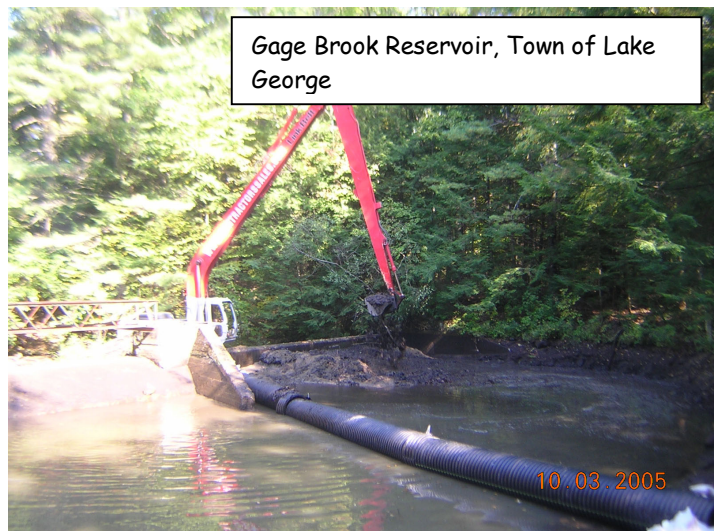
Gage Brook Reservoir, Town of Lake George

Gage Brook Reservoir still captures a significant amount of sediment and debris on an annual basis (up to 200 cubic yards per year). This reservoir has been the most consistently maintained under this sediment basin program, due to the speed at which it fills with sediment and the relative ease of cleaning it out.

The first cleanout of Gage Brook was in 1996, following permit issues with the Adirondack Park Agency. Once resolved, the groups worked together and successfully undertook this project within a two day timeframe. As with the cleanout of Ore Bed Reservoir, the methodologies employed on the first effort have remained relatively unchanged in all of the subsequent cleanout efforts. As of 2005, Gage Brook Reservoir has been cleaned out more than any other reservoir (six times in 10 years), totaling over 1,600 cubic yards of sediment and debris. When coupled with the 1,350 cubic yards removed in the three Ore Bed Reservoir cleanouts since 1996, this totals approximately 3,000 yards of sediment and debris. That is a significant volume of material which has not reached Lake George and thus has not been added to the delta.

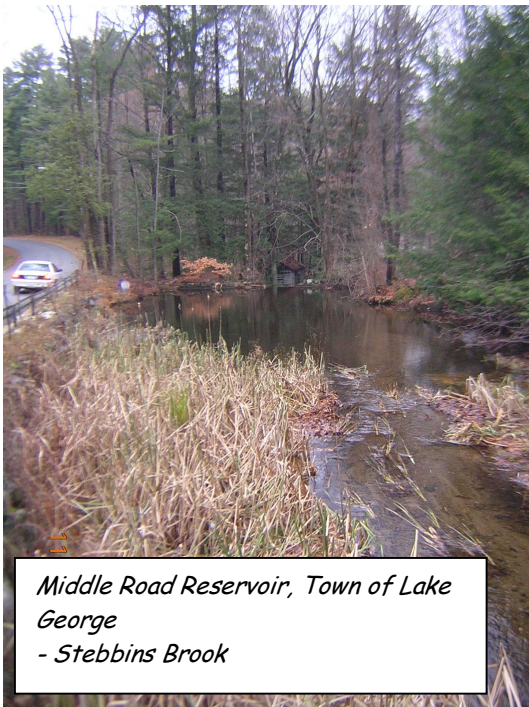
Middle Road Reservoir is a small, former in-stream reservoir on Stebbins Brook in the Town of Lake George located on Middle Road. Like the other reservoirs, until its abandonment in the late 1950's or '60's this reservoir used to be maintained and cleaned out regularly. This reservoir is completely full of sediment and could act perfectly as another in-stream sediment detention structure.

*Middle Road Reservoir, Town of Lake George
- Stebbins Brook*

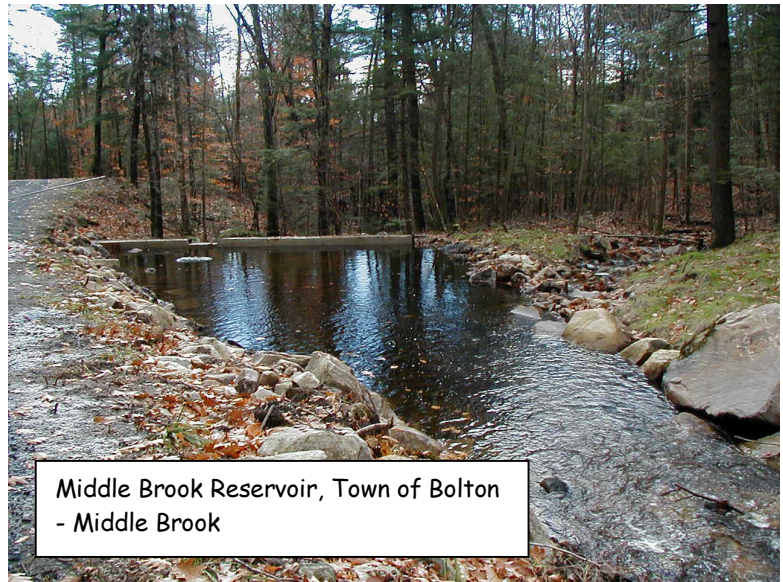
Middle Brook Reservoir, Town of Bolton
- Middle Brook

Early in the Fall of 2005, permits and landowner permission were obtained and the project moved forward. A private contracting company was hired to undertake the work, which began and was completed in October of 2005. Approximately 200 cubic yards of material were removed from this reservoir, which regained much of its original capacity. In addition to the reservoir cleanout, the dam and spillway were reconstructed to provide a more stable structure for future cleanout events. This project was funded by the LGA.

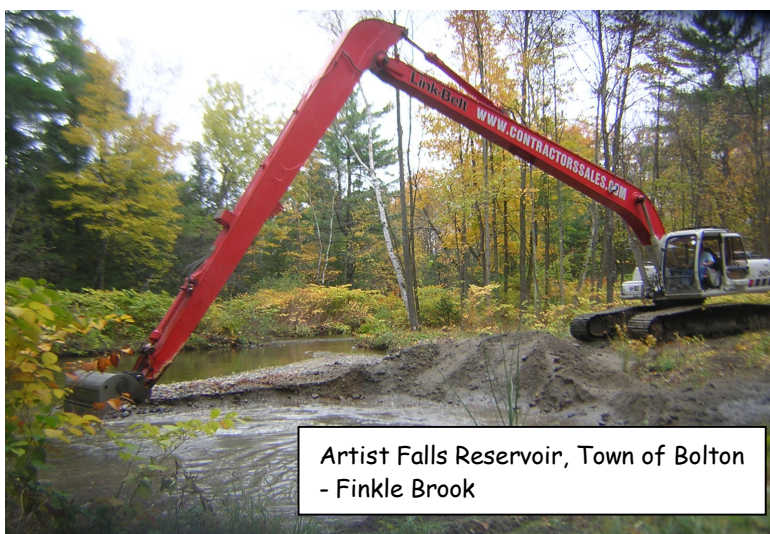
Artist Falls Reservoir, Town of Bolton
- Finkle Brook

This reservoir was abandoned in the 1950's (according to verbal accounts), and it was no longer maintained and cleaned out. This was a relatively sizable reservoir at approximately 1.5 surface acres in size, and has a stone and mortar dam currently in marginal shape. This reservoir is completely filled with sediment, such that there are sizable trees, shrubs, and other vegetation growing on solid ground currently.

Realizing that it would be cost prohibitive to re-establish the original capacity of the reservoir (tens of thousands of yards), a project was proposed to excavate only a small portion of that reservoir and create a

sediment pond on the stream. With the questionable structural integrity of the dam itself, this pond was proposed to be located at least 100 feet upstream of the dam. Work began to initiate this project. The Warren County SWCD worked with Don Lake, P.E. on the design and plans for this basin beginning in 1996, and completed them within one month's time. The basin proposed constituted a 50' wide, 160' long, 8' deep basin based upon the hydraulics and retention time of the system. This sediment pond is designed to be "off-line", meaning that it was constructed adjacent to the existing stream. Following construction of the basin, the stream was re-routed into the new basin and back into the stream after it. This simplifies future maintenance, as the stream can simply be routed back into the old stream channel during maintenance cleanouts, and routed back in once complete. This minimizes impacts to the stream from turbidity and potential erosion during cleanout activities.

In the summer of 1999, following three years of administration and permitting, the project was constructed in a total of three days. The newly constructed in-stream sediment basin has served its purpose very well, collecting more than 1,200 cubic yards of sediment and keeping it from Lake George. The original project was funded by a \$6,000 mini-grant from the NYS Soil and Water Conservation Committee to the Warren County SWCD, and was undertaken by the Town of Bolton. The SWCD provided construction oversight and administered the project until closeout.

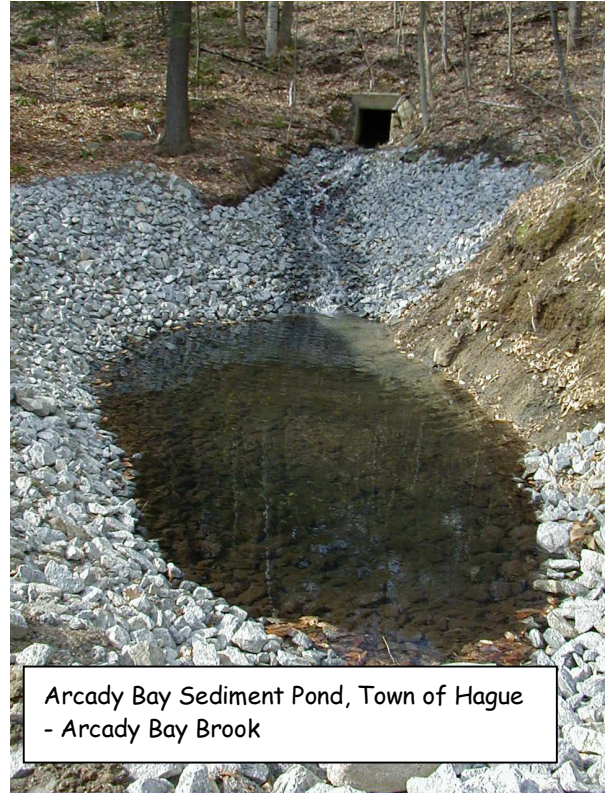
This basin was constructed in two days' time, and now acts to collect sediment from upland sources within the watershed. The relatively steep sidewalls (based upon site conditions) were stabilized with rock and over 400 crownvetch plants planted by SWCD staff. The capacity of the basin is considerably smaller than it could be, as no riser was installed on the outlet pipe to raise the effective water level in the basin. This was a result of concerns of the Arcady Bay Association regarding liability and an open water source. While the actual probability of a liability event appears minimal, it nevertheless was the deciding factor in keeping a lesser volume in the basin.

Arcady Bay Sediment Pond, Town of Hague
- Arcady Bay Brook

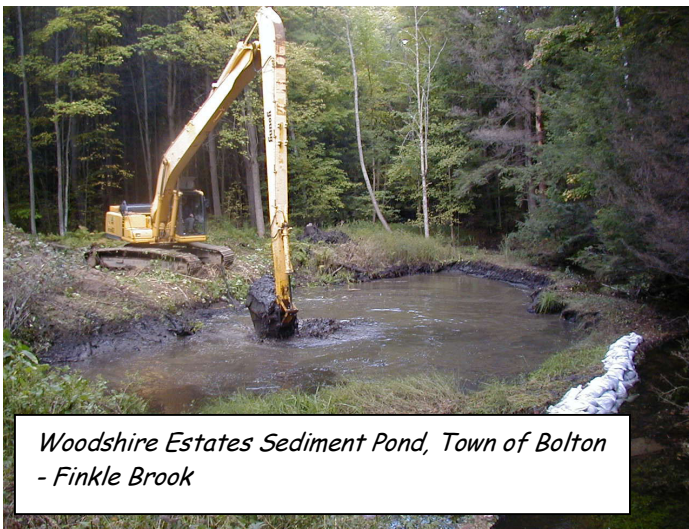
Woodshire Estates Sediment Pond, Town of Bolton
- Finkle Brook

The site was dewatered with hundreds of sandbags (see picture), and excavation began the following day. It took two days to excavate over 600 cubic yards of material from this old pond and reclaim it to similar original dimensions, regaining its capacity and ability to retain in-stream sediment. Like other efforts of this kind, project management was conducted by the SWCD, the LGA paid the rental cost of the excavator, and the Town conducted the excavation and trucking work. Following excavation, the site was seeded and mulched by the SWCD, and reports were filed with the Corporation and the regulatory agencies involved.

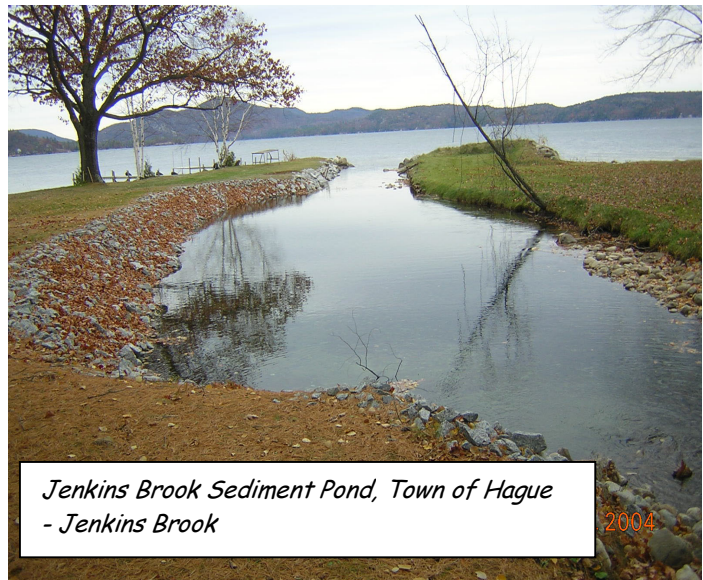
The District met on-site with Supervisor Belden and the President of the Association to discuss the history of the problem and potential solutions. District staff walked approximately two miles upstream to determine sources of sedimentation to the brook, and found no such large sources. Much like other streams within the basin, the sediment largely appeared to be generated by undercut streambanks along the corridor, or perhaps prior logging jobs (although this is unconfirmed).

Once agreements were signed, construction began in September of 2004. District staff dewatered the site with 24" diameter hdpe culvert pipes and turbidity curtains, and an excavator was rented from Finke Equipment. The excavation/creation of the sediment pond took approximately three days, including stabilizing the north side of the basin with small riprap. Once the basin was completed, the highway department restored the grounds around the basin and the District hydroseeded the grounds to revegetate them.

Once completed, the basin dimensions were approximately 100' long, 40' wide and 5' deep. The volume of the basin is approximately 400 cubic yards when side slopes and other dimensions are factored in. The total
