Dream Lake Watershed Assessment

Warren County Soil and Water Conservation District

November 2007

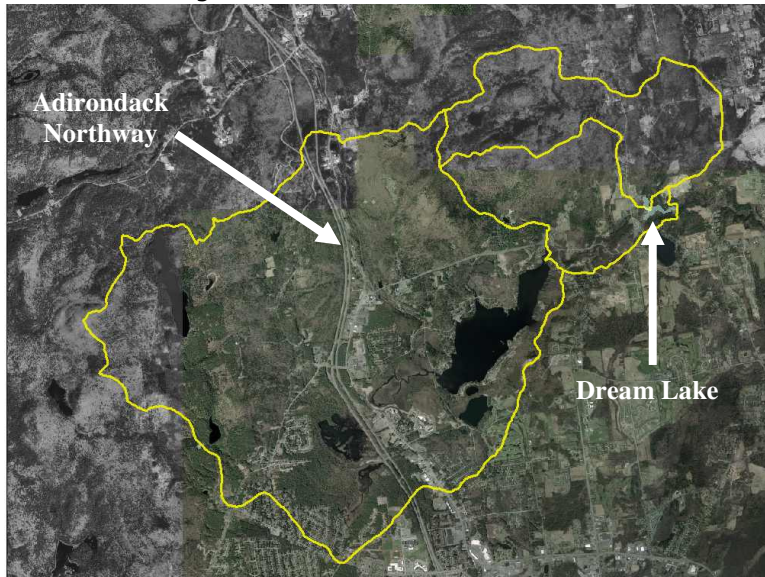
Figure 2: Dream Lake Watershed aerial view

The entire Dream Lake watershed is approximately 10,300 acres and has a lake to watershed ratio of 0.0007, which is not a very typical lake surface/watershed ration in the area. By comparison, Loon Lake is 0.07 and Schroon Lake is 0.01 (these numbers are just for comparison). This lake is an artificial one, since there is a dam installed as an outlet structure. This lake is very out of proportion with its watershed.

There are two main streams that contribute to the lake, one of which starts at the outlet of Glen Lake in the west and the other begins at Bear Pond in the north. Numerous wetlands are found in this watershed as well.

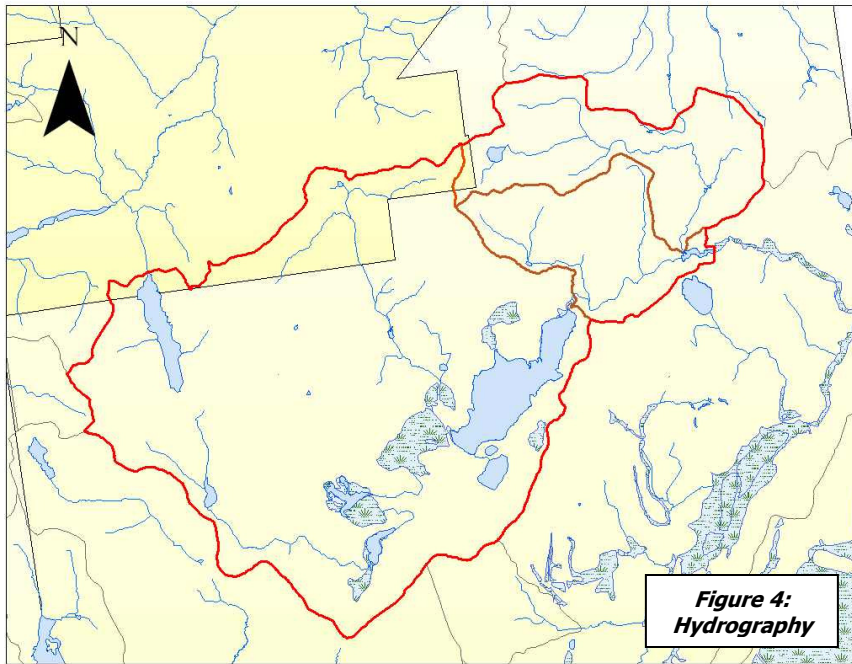
Dream Lake has two main tributaries in its watershed, which comprises most of the concentrated flow to the lake. No volumetric sampling has occurred to this point, but regardless these are two areas that should be kept as clean as possible and future development and land use changes taken into consideration with careful planning.

Streambank erosion can contribute sediment and phosphorus to lakes and occurs more readily around areas of human disturbance. At the inlet from Bear Pond there appears to be a significant amount of sandy material that has accumulated on both sides of the under road culvert. From personal communications with local landowners it

was stated that years ago this was not the case and that it was significantly deeper in this section of water way. The property upstream is privately owned and would require permission from the landowners to investigate possible erosion sources. By utilizing the District's Geographic Information System (GIS), it is determined that the likely source of this sediment is within 0.6 mile of the outlet into Dream Lake. Looking at the aerial imagery, approximately 0.6 mile upstream is a wetland/shallow pond that would act as a settling basin for sources above that area. Between the pond and outlet there are two road crossings, which may also be contributors to the sediment load.

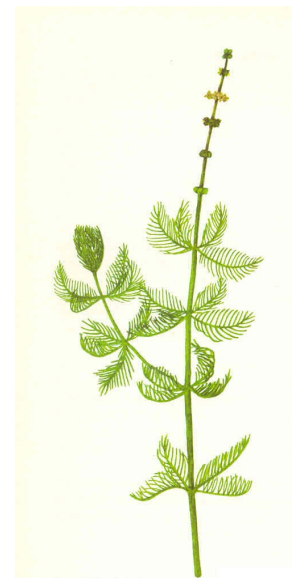
Figure 5: Eurasian Watermilfoil

It is known that Glen Lake has infestation of EWM. It is not unlikely that if EWM is not already in Dream Lake, then it will make an appearance. In this lake, EWM would be catastrophic as EWM will colonize water depths up to 16', as most, if not all of this lake is less than those depths. There is no real way to eradicate Eurasian milfoil, however it can be successfully managed by hand harvesting, mechanical, or chemical means. All in-

As there are a number of native milfoil plants that are similar in appearance to Eurasian milfoil, proper identification is a must. Milfoil appears when there is a disturbed site, generally where native plants are not aggressively growing or have been killed. That is why it is important to identify and understand the life history of Eurasian milfoil. Milfoil can also colonize with just a small piece of plant matter. If a plant is harvested incorrectly, or gets chopped up in a propeller, these pieces may float through the water column and establish a new plant in other areas within the lake. It is imperative to understand Eurasian milfoil, as it has the ability to affect a great amount of Dream Lake. Completion of an aquatic plant survey can help a lake association monitor and manage their aquatic plant issues.

3. A milfoil management strategy should be developed which includes education and management of milfoil as well as other invasive/nuisance species. Eurasian watermilfoil is found upstream in Glen Lake, and it is not a stretch to envision it arriving in Dream Lake.

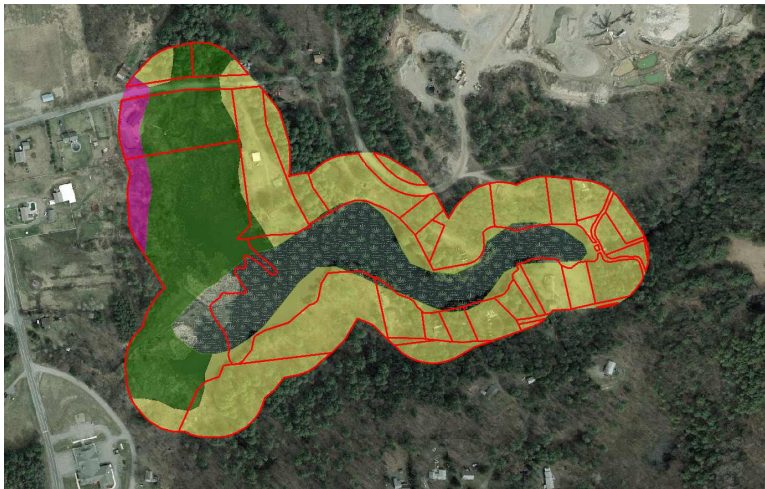
Figure 6: A close up view of properties 200' around Dream Lake. The yellow colored areas represent Hydrologic Soils Group A, which provide "poor" filtering of septic effluent as defined by the Warren County Soil Survey.

Within the Dream Lake watershed, the soils around Dream Lake are of concern, due to coarseness of the soils and the proximity of on-site wastewater treatment systems to the lakeshore. In order to better grasp the soils situation on the lakeshore, the Warren SWCD has buffered the digitized soils and generated computerized maps for the area within 200' of the lakeshore (Figure 5). Most of the soils (62% or about 21 acres) within this 200' buffer of the lakeshore are primarily sandy soils, and are listed being in hydrologic soil group "A". This indicates that these soils have a high infiltration rate when wet and have a low runoff potential. They are mainly deep, well drained and sands or gravel (Warren County soil Survey).

The majority of the remaining soils (31%, about 10.5 acres) is identified as a Wareham, a loamy sand, and are classified as hydrologic soil group "C". This description indicates that this soil is less infiltratable (tighter) and has a high water table most of the year. Both of these soil groups are of concern for septic systems. According to the 1986 Warren County Soil Survey, these two soil series may not be readily suitable for septic system leachfields, and these soils constitute 93% of the soils found within 200 feet of the lakeshore. Groundwater contamination is listed as a hazard, primarily due to rapid infiltration rates within the "A" soils and a high water table in the "C" soils, which results in poor effluent treatment.

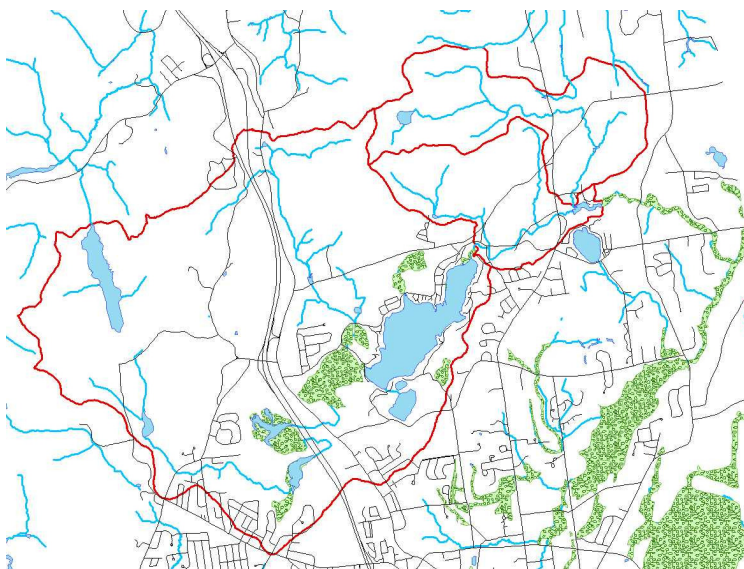
Figure 8: The Dream Lake Watershed, roads network and hydrology

Dream Lake, like most other developed lakes, has a roadside drainage network throughout its watershed. The road system within the Dream Lake watershed was evaluated, on site, for potential road runoff impacts to Dream Lake. Even with the extensive road network, fortunately there are only a few areas of concern. For much of the Dream Lake road system, the ditches are grassed or stoned, and as being such tend to cause few problems. If a ditch is vegetated, then the material will filter out solids (sands, silts) and take up nutrients. If the ditch is rocked, then the solids are removed from suspension as well (Appendix A). Maintenance is the key to these designs, if

there is a build up of material in a ditch, then it would need to be removed, otherwise the sediment could, overtime, be washed into the lake. The following are potential areas of concern within the watershed (fig. 8):

(a) Tributary one of the Dream Lake Subwatershed basin flows at this intersection. On the east side of this intersection, stormwater runoff from 0.3 mile of Route 149 runs down concrete lined channels and grassed ditches on both sides of 149 and is deposited in this tributary. There is no treatment for this runoff which would likely contribute deicing and sanding materials. There is a catch basin on the east side of Martindale Road with an 18" HDPE pipe inletting and an 18" concrete pipe outletting to this stream. There appears to be a considerable amount of algae at this stream junction.

(b) The southwest section drains the same area and is conveyed to the stream through a mix of concrete lined channels, rock lined channels and a small wetland. Stormwater from this section should not be as potentially significant as there appears to be treatment for solids and nutrients with the stone and wetlands. While the rock lining provides no chemical treatment, it does reduce water velocity and allows for particulates to drop out of suspension. Routine inspection and maintenance of this channel should be conducted to ensure that sediment is removed from this system before it migrates to Tributary one.

(a) On the southwest side of this intersection, stormwater runoff begins 0.3 mile from uphill and runs down a grassed ditch and rock lined channel and is deposited in a grassed front yard. Water from below this rock lined area can make it to a drop inlet that outlet's in to the Glen Lake Outlet through an 18" CMP. Stormwater runoff flows untreated into the Glen Lake Outlet from 0.2 mile west on bay Road.

(b) Stormwater runoff from the southeast section of this intersection runs down the side of Bay Road to a drop inlet at the junction of Old Bay Road. This is outletted directly to the Glen Lake Outlet through an 18" CMP.

Both sides of Bay Road on the north side of the stream eventually drain to the Glen Lake Outlet via grassed lined ditches and empty into the Outlet through an 18" concrete culvert. Water from a short section of Walkup Road is included in this drainage as well. Sediment and nutrients may be of concern in this area as it is a short distance between this outlet to Dream Lake.

At this road intersection there is a substantial amount of sediment that flows into a wetland on Dream Lake. This is a dead end road that mainly is used for residential travel and it is suspected that the material found at this location is migrating from up above the road and the road is not contributing a high quantity of nonpoint source pollutants. That being said, typical sanding and salting operations do add to nonpoint source pollution and care should be taken to clean up in the springtime should occur.
