Hague Brook Restoration Project

Final Report

Town of Hague

Final Report to NYS DEC

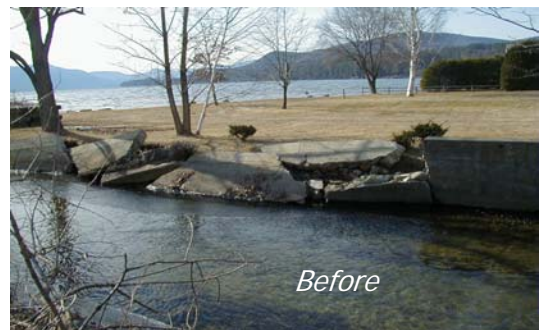
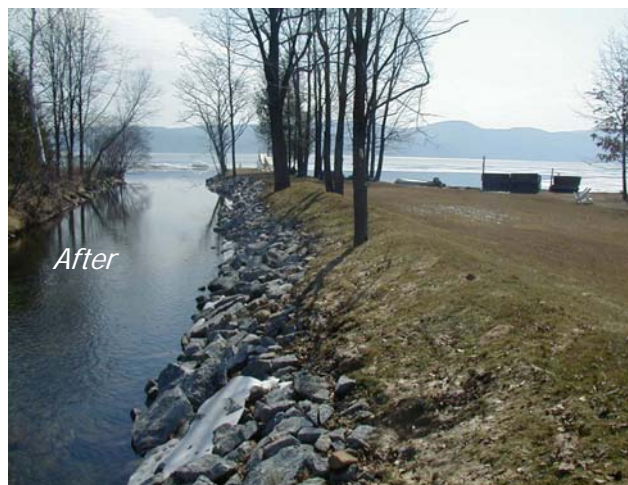
At the outlet of Hague Brook into Lake George, there existed a large concrete retaining wall which had failed over the years, causing exposed streambanks, sedimentation, and safety hazards. To mitigate this, the District worked with the USDA Natural Resources Conservation Service to design a streambank protection project for over 250 linear feet of channel.

undertaken by the Town of Hague highway department and the Warren County SWCD. This project took approximately three weeks to complete, including dewatering the site, wall cutting and removal, bank grading, footer installation, filter fabric installation, riprapping, final grading, and hydroseeding. When all was concluded, streambank protection measures were installed for over 280 feet of streambank, and over 50 feet of shoreline protection was conducted. In addition, a vegetated berm was created to eliminate the property's ongoing spring flooding issue.

This project protects this large section of Hague Brook from undue erosion and sedimentation, and now allows a better transition between the water and the land for improved aquatic and terrestrial habitat. The aesthetics of this highly visible section of brook has been dramatically improved, and the hazards of the large broken concrete wall have been eliminated.

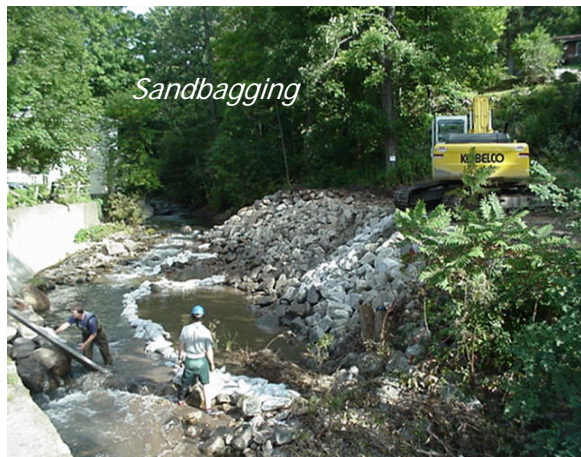
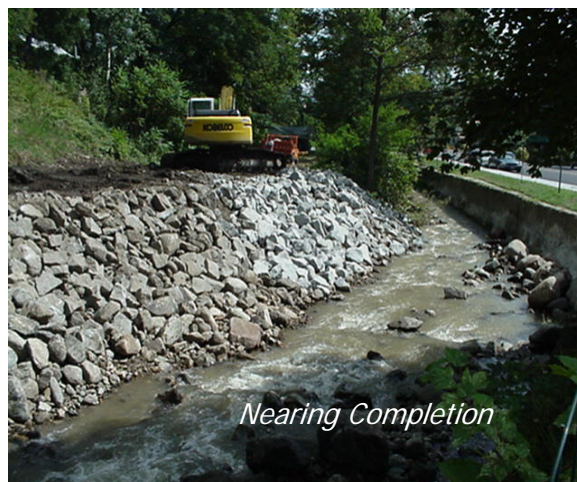
This project took place approximately 200 feet above the intersection of NYS Routes 9N and 8, in the middle of the hamlet of Hague. This section of brook was significantly out of alignment, forcing Hague Brook to flow directly into the concrete retaining wall which supports NYS Route 8. This section of wall was being significantly undermined to the point of where future failure was a serious concern.

To remedy this situation, the project partners worked to design a channel modification to improve the channel alignment and protect the new streambank. The Lake George Association hired Meyers Engineering to evaluate and design the new channel and banks. When all permits and approvals were in place, the Town of Hague rented a large tracked excavator and trucking, and the project began.

Removal of the "point" of land which negatively affected the flow in the channel was the first task. This was completed in approximately 3 days time. Following the channel alignment came the bank protection efforts. Hague Brook has significant flow volume and velocity at this section, so NYS DOT large stone fill was used as the footer blocks, followed by medium stone fill above the ordinary high water mark. The original plans called for a bioengineering plan at two feet above the ordinary high water mark, but this was modified by the engineer during construction. Final construction included a layer of stone all the way up the bank up to the crest of the hill.

The channel at this location no longer threatens the NYS Route 8 retaining wall, and the banks have been stabilized for the future. The Hague highway department and the Warren County SWCD staff undertook all dewatering and construction efforts on this project.

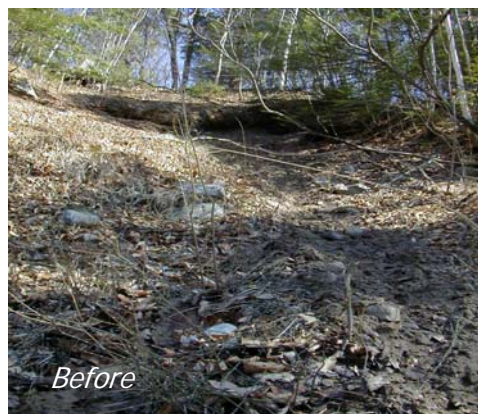
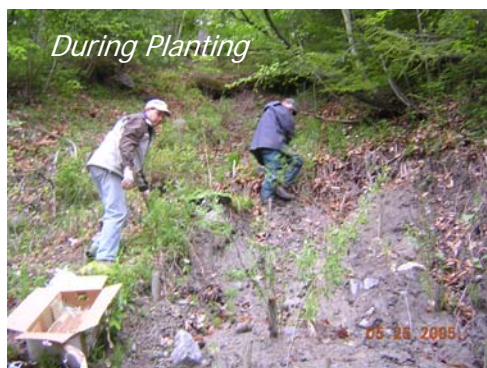
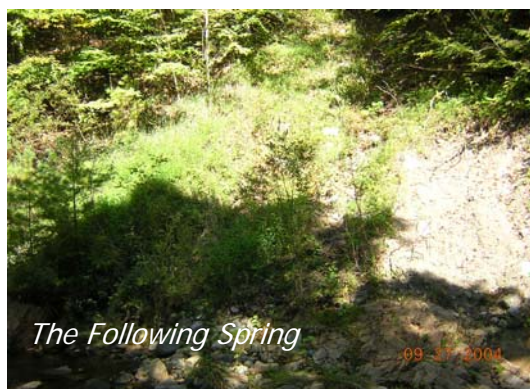
This bio-stabilization project, named "Station 27" is located 2,700 feet above the outlet of Hague Brook into Lake George, and consisted of a very steep and failing clay bank on Hague Brook. Due to the soil structure and steepness of the site, several springs and weeps are present which compromise the structure of the bank. The toe of slope in the stream is bedrock, and as such, left little opportunity for base protection. The solution to address the ongoing surficial and mass-wasting erosion events lay in bioengineering solutions.

Research was conducted on the best plantings and methods for the site, given its heavy clay and wetness constraints. The USDA NRCS Plant Materials Center in New York was particularly helpful. Several plant species were identified which were suited to these soils, which had combinations of lateral and surficial root networks and deep tap root systems.

Crownvetch sprigs, joe-pye weed, dogwood, and many other species were purchased from nursery suppliers, and planting days were set up to address the site. In addition, over 200 willow live stakes were harvested from a site in Queensbury and installed at the project site that same day to ensure viability.

In both late spring and fall of 2004, over 1,000 plants were planted on this highly wet and unstable site. Staff from the Warren County SWCD spent over four days planting the site and surrounding area,

It has been two years since the final plantings were installed, and the site is covered with vegetation and fully stabilized. The vegetative root network acts to stabilize the soils, both surface and subsurface, and the density of the plantings also minimizes direct rainfall impacts to the soils.

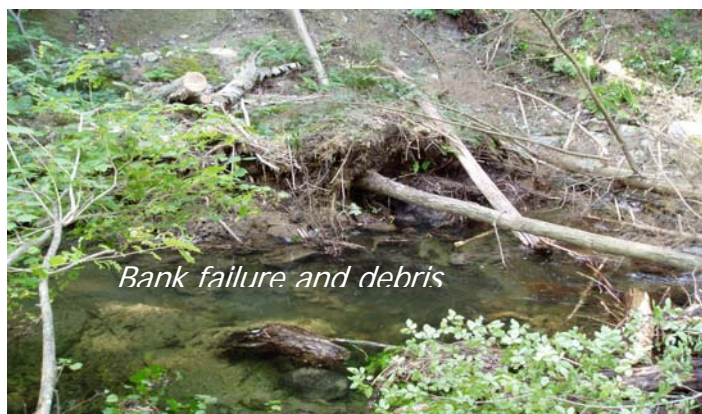
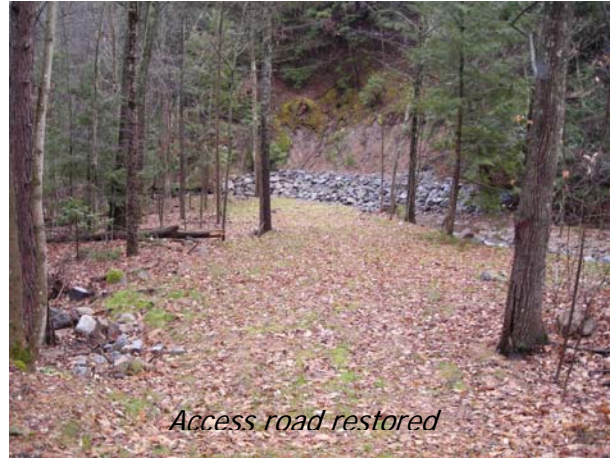
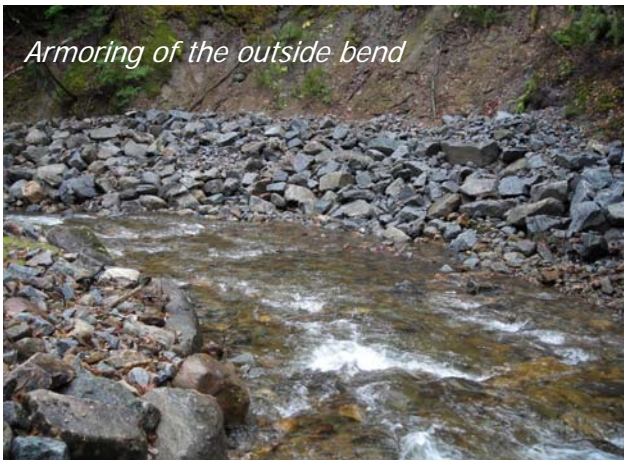
The "Station 31" channel protection project is located on Hague Brook just upstream of the NYS Route 8 bridge, which is approximately 3,100 feet above the outlet with the lake. The stream at this location was experiencing a very large and steep bank failure, which was contributing significant amounts of sediment and debris into Hague Brook. Work had been done adjacent to this site in the late 1970's by the Hague highway department, but the bank failure migrated upstream of that previous stabilization work.

On this subproject, approximately 250 feet of channel was impacted and in need of restorative work.

To remediate this situation, the Warren County Soil and Water Conservation District put forth preliminary plans to dewater the channel, realign it, and provide hard armoring (heavy riprap) on the outside bend of the channel. However, as this project would be partially on state owned property, there were significant logistical hurdles to overcome. Over the period of 18 months, the NYS DEC and the Adirondack Park Agency reviewed and finally approved the workplan for this state funded project.

As the access to the stream at this location was also on state property, a tree removal tally was taken and an access restoration plan was developed. In the fall of 2006, construction began on this project. The Town of Hague highway department and the staff of the Warren County Soil and Water Conservation District conducted all phases of dewatering and construction of this project. Step one was to remove trees and build a temporary access road to the impacted stream segment. Following this, the stream segment was dewatered down an overflow/secondary channel with the use of culverts and woven stabilization fabric. With a dry channel, work began to realign the course of the stream and to armor its outside bank.

The Town of Hague rented a large excavator, which was operated by Highway Superintendent Don Smith. It took approximately three days to realign the stream channel and relocate stream bed material, defining a more natural channel width. After this, over 300 tons of angular stone (24-36" diameter) was brought in from Peckham's quarry in Chestertown to armor the outside bend of the channel at the base of the large slide. This new stone acts to support the weight of the earth above it, and armor the bank against further lateral movement. The entire project was completed in three weeks.

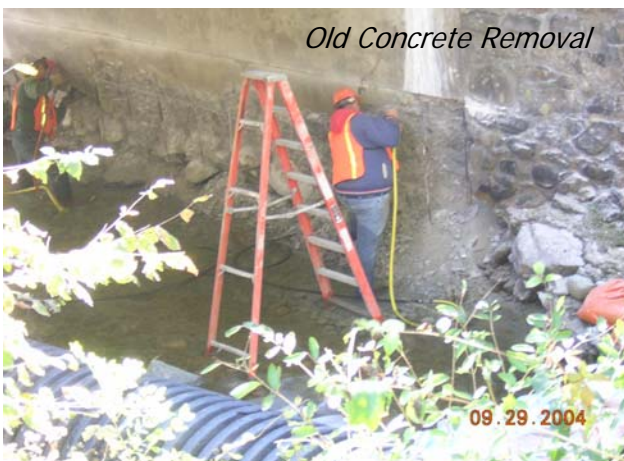
As seen in the photo on the left, the abutments of the Hague Community Center Bridge had been significantly undercut and scoured over the years. As a part of this overall Hague Brook restoration effort, a remediation effort was planned and executed to rehabilitate these abutments and protect it from future scour. The Town of Hague solicited the services of qualified engineers for this effort, settling on Clark Patterson Associates out of Albany (CPA). CPA surveyed and designed the restoration efforts, and put together a bid package for qualified contractors to bid on. A.P. Reale and Sons Construction Company out of Ticonderoga was the successful bidder, and work commenced on this effort in the fall of 2004.

This project consisted of removing the old and compromised concrete and rebar to a minimum depth of six inches, drilling and posting new rebar, and pouring new footers and base of abutment walls.

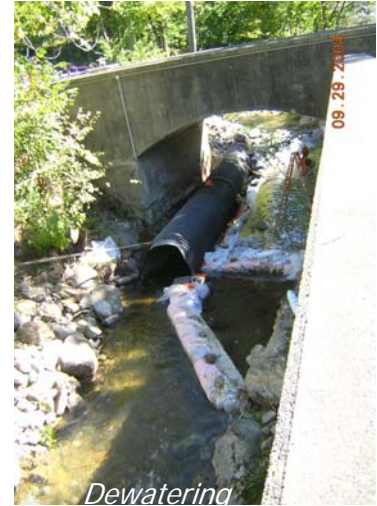
To undertake this work, the project site needed to be dewatered, which was accomplished with the use of a sandbag cofferdam and hdpe pipe bypass system (see picture at right). This system had to be installed twice, once per side of the bridge.

Dewatering

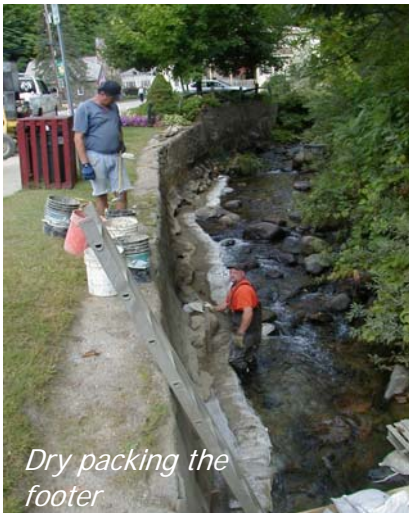
Dry packing the footer

To undertake this work, the wall area was dewatered using hundreds of sandbags and pumps. Once dry, the contractor dry packed concrete mix under the undercut wall. When all voids were filled up, the entire face and base of the wall was covered with sprayed concrete to fill any remaining cracks and seams. Work on this effort took two summer low-flow construction seasons, and ultimately over 1,200 feet of retaining wall was fixed and reinforced under this contract.

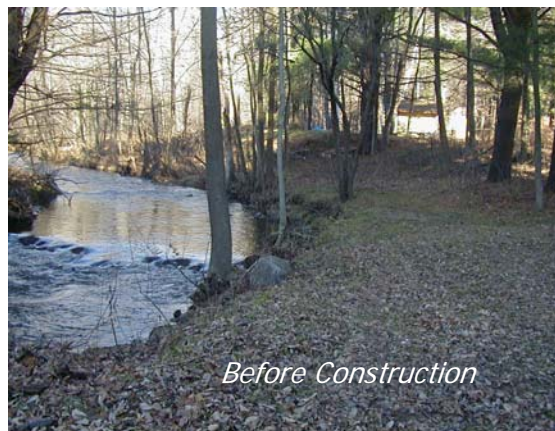
At this location, Hague Brook evidenced an unprotected outside bank which had eroded significantly over many years. During some large flow events, as much as five to six feet of bank were eroded away, moving the stream channel into the campground property. Small-scale attempts by the landowner over the years had not proven successful at preventing the lateral migration of the stream.

The Warren County SWCD and the USDA Natural Resources Conservation Service worked jointly on a bank armoring solution to prevent further lateral movement of the brook.

In September of 2004, the Town of Hague Highway Department began work on this project. Primarily, this effort consisted of establishing an anchored toe of heavy angular stone (riprap), with angular rock above on a stable angle. Much of the larger vegetation on the bank was left in place, as the root network of these trees and shrubs work effectively to help stabilize the soils.

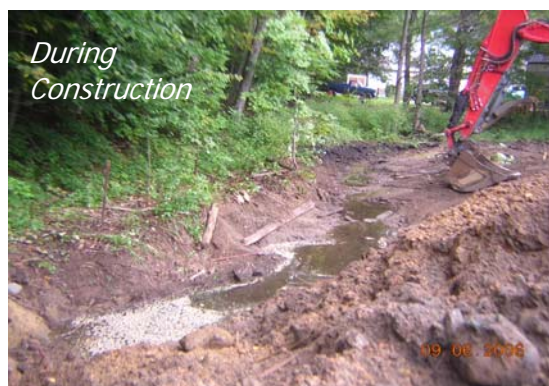
Directly adjacent to the outlet of Hague Brook is a small tributary which outlets into the Town of Hague Boat launch. The Town of Hague has needed to get into Lake George on many occasions over the past few decades to clean excess sediment out their public boat launch from this brook, disturbing the local lake ecology, water quality, and recreational activities.

To help resolve this situation, the Warren County SWCD recommended and designed a small in-stream sediment pond to settle sand and debris out of the stream before it reaches Lake George. The project is located on property owned by David Darrin, and thus was named the Darrin sediment basin. With plans, specs, and landowner approvals in place, the project moved forward.

In the late summer of 2006, the Town of Hague rented an excavator and provided manpower and trucking to create this sediment pond. Clearing and construction of the pond took approximately five days, and construction assistance and oversight was provided by the Warren County SWCD staff. The dimensions of the pond are approximately 25 feet wide by 40 feet long by 4 feet deep, which provides a long enough retention time to settle out sand, gravel, debris, and some silt. It is estimated that the basin will remove approximately 95% of sand and debris, and approximately 25-50% of any silt in the stream column. There is no clay to speak of in that stream corridor system, so fine particulates are not a large issue.

As can be seen from the picture, within only one month following completion the basin had already captured sediment. The Town of Hague highway department will maintain this basin annually with existing equipment, and the landowner has given permanent permission to the Town to undertake these maintenance efforts.

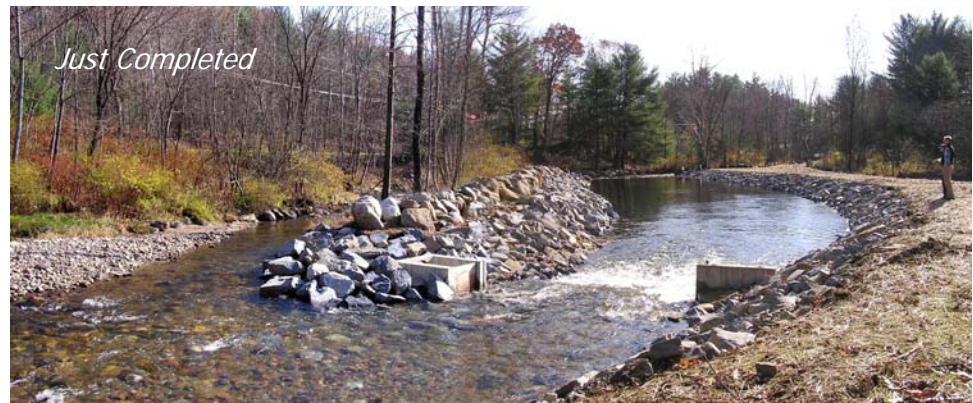
In the picture on page 8, the in-stream sediment pond is to the right and the original channel is to the left. The permanent concrete structures allow the town to block the flow for the cleanout/excavation activities. The sediment pond is lined on both sides with angular stone to stabilize the soils, and the entire site was seeded and mulched upon completion to re-vegetate the site. This project took approximately three to four weeks to construct, and is now fully functional. It is estimated that this basin will need to be cleaned out annually.

In the fall of 2006, the contractor began construction of a basin which was adjacent to the stream channel (off-line). By constructing the basin in this fashion, the stream would not be impacted during construction. When the basin was complete, the contractor installed a permanent concrete flow diversion structure at the inlet to the basin. This structure allows the flow to be easily diverted back to the existing channel when it comes time to excavate the sediment from the basin (see picture). The existing stream flow is split between both the basin and the existing channel, with the majority of the stream flowing through the basin to settle out the sediment in the water.

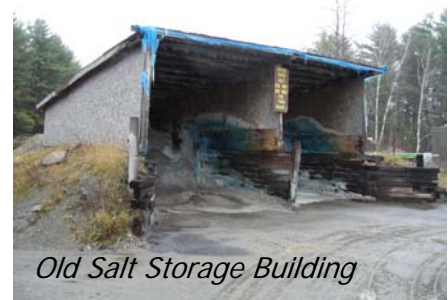
The age and condition of their salt storage structure could best be described as non-functional and even a safety hazard (see picture at right). This structure was not physically sound, and lacked any real storage capacity. As such, much of the Town's salt was stored adjacent to the site, on the bare ground. Also, there was no pavement or concrete under the structure, giving way to potential groundwater contamination. Hague Brook is approximately 200 feet away from the site, and the depth to water table is less than 8 feet. With these issues, it became readily apparent that a new salt storage structure was necessary to protect not only Hague Brook but the aquifer feeding into it.

To provide environmentally proper facilities, the Town of Hague and the Warren County SWCD received DEC approval to add a new salt storage facility within this grant. Thanks to a pre-developed and very cost effective design provided by the Warren County Department of Public Works, there were no engineering costs to the project. In addition, as this same structure was recently completed in the Town of Bolton, the bid packets were already largely developed which minimized those costs as well.
