Loon Lake

Watershed Assessment

Warren County Soil and Water Conservation District

July 2004

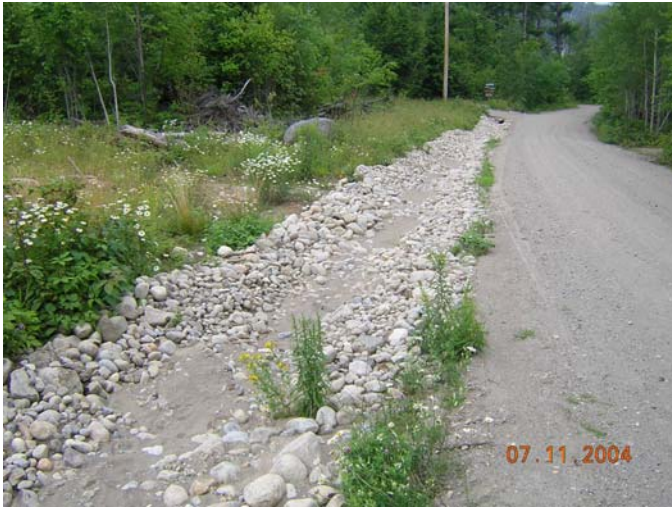
Rock lined trench: This structure is working well, note the sediment dropped from suspension. Routine maintenance of the trench is necessary, as is an investigation of the source.

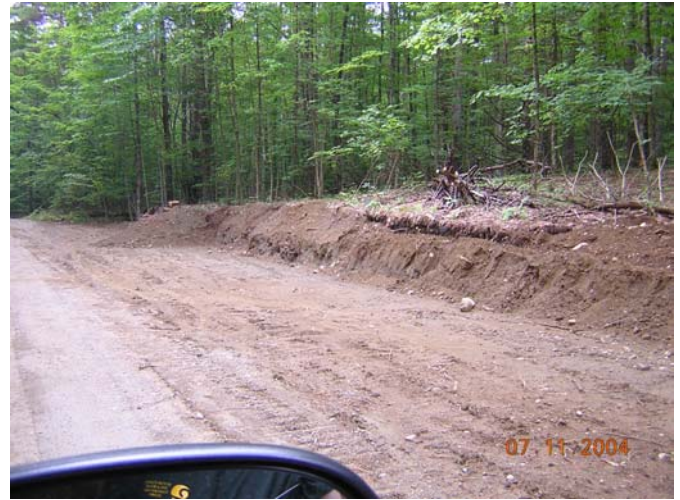
Unprotected Trench: This situation can contribute to sedimentation of a waterbody. Unprotected soils may be carried from a trench and deposited down channel. If the material enters a waterbody untreated, nutrients and sediment can accumulate and negatively affect the waterbody

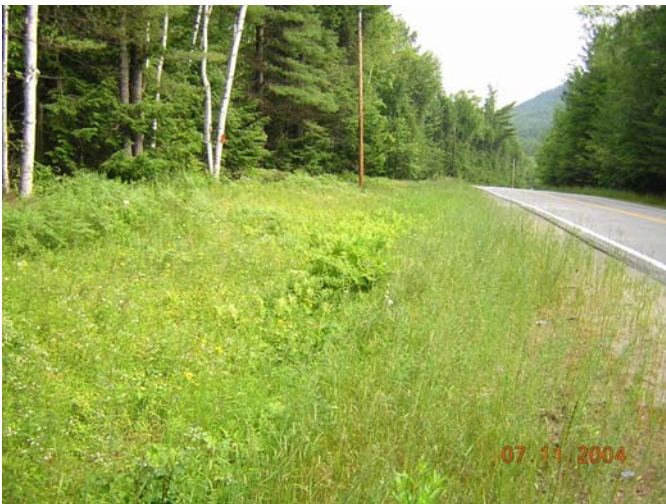
Vegetated Trench: A great example of a vegetated trench. Stormwater will filter through the vegetation and sediment will be deposited. Nutrients are taken up by the plants. Maintenance by removal of sediment and proper mowing will help to reduce the likelihood of nonpoint source pollutants from leaching out.
