English Brook Watershed Assessment

Warren County Soil and Water Conservation District

September 2008

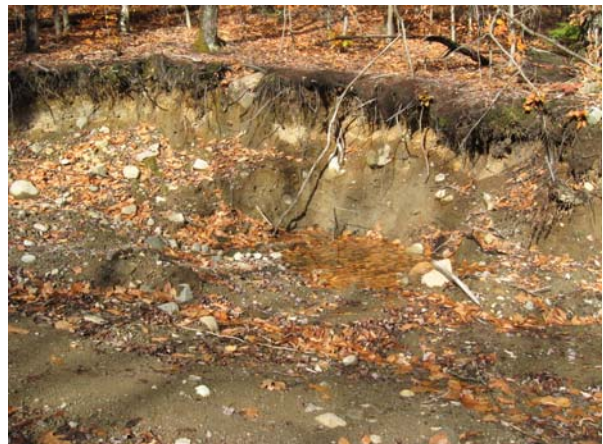
The headwaters of the English Brook lie at the top of what is referred to as the Somerville Branch of the stream. Somerville Road is an unimproved gravel Town of Lake George road that runs parallel to the stream for over two miles. For a seasonally maintained road, Somerville is in fairly good condition. However, there are numerous areas along its length which exhibit drainage problems, erosion, and offsite sedimentation. The second mile of Somerville Road has no development on it, and it simply acts as a seasonal access to the top of the mountain. The Town of Lake George has attempted to abandon and close this road in the past, but local landowners objected and the Town was required to keep it open. Re-grading of this road, adding new item 4 and gravel, replacement of eroded culverts and maintenance of ditches would clearly help to amend many of the concerns along this branch before it meets Route 9.

Estimated Cost: \$30,000 - 50,000

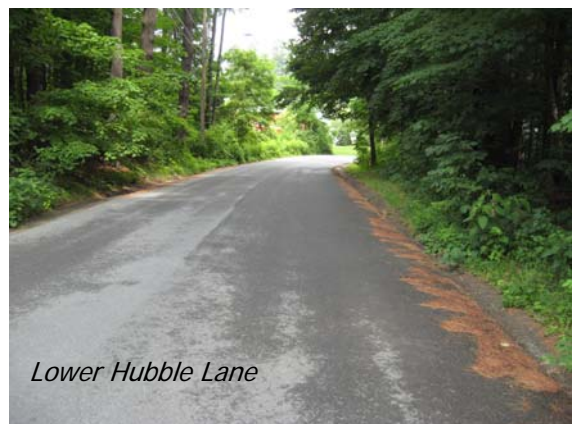
Hubble Lane runs downhill for its entire length of over 500 feet where it intersects with NYS Route 9N. Hubble Lane has no stormwater infrastructure aside from paved swales, and stormwater flows along its length and enters a drop inlet at the intersection of Route 9N. This road has plenty of opportunity to install drywells along the roadside to capture and infiltrate a significant portion of the stormwater runoff from this roadway. Preliminary estimates show that six separate drywells (three per side) would accommodate stormwater from most storm events. The Town of Lake George highway department has successfully installed such systems on Birch Avenue and Michelli Drive in the Town, and could do so here as well. Soil test pits would need to be conducted prior to moving ahead to ensure good soils for these projects. Also, there is a gas line on the south side of the road which would have to be accounted for.

Estimated Cost: \$20,000 - \$30,000

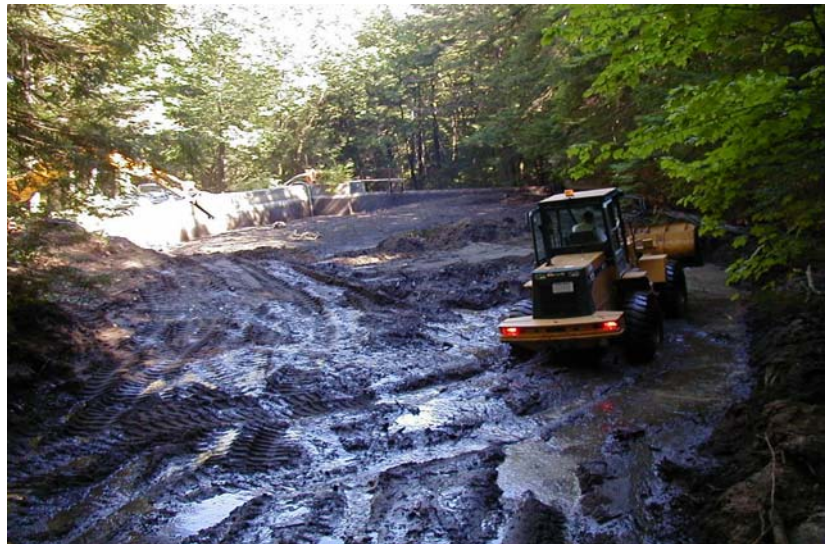
Cleaning out Hubble Reservoir in 1999

Once this reservoir was no longer utilized as a water supply, the regular sediment cleanouts were discontinued. As such, this reservoir has been accumulating in-stream sediment since that time. Historically, the sedimentation of reservoirs was simply a maintenance headache. Now, the fact that these reservoirs capture in-stream sediment is seen as a tremendous asset in helping to manage the growth of the deltas. With approximately 27% of the entire English Brook watershed flows into it Hubble Reservoir, it can be very effective at helping to slow the growth of the English Brook delta. As there is almost no development within that watershed, these sediments are from natural in-stream erosion processes.

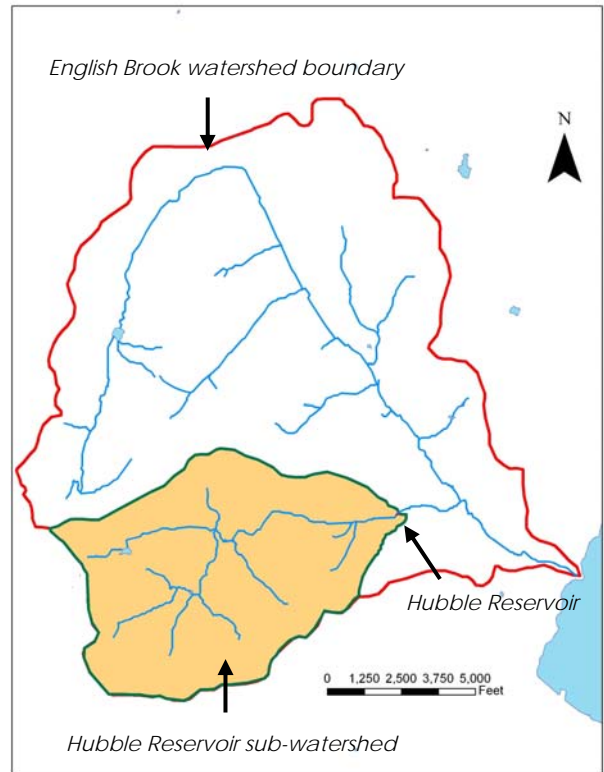
Figure 11. Hubble Reservoir watershed, which captures about 27% of the overall English Brook watershed area

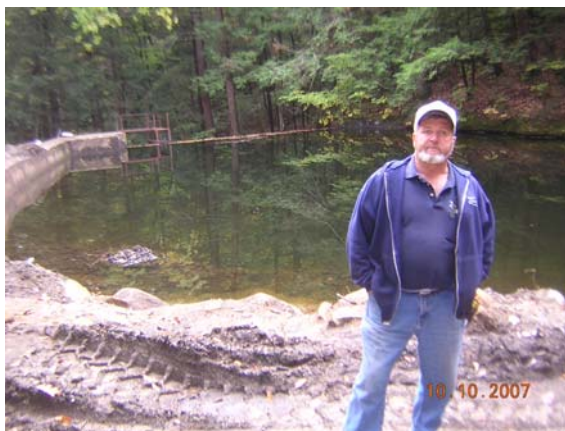
In 1992, the Hubble Reservoir was cleaned out for the first time in many years, to have this reservoir act to catch sediment and keep it from adding to the delta. To excavate the sediments out of Hubble Reservoir, the stream must be diverted and the reservoir dewatered. This has been very difficult to do, without a permanent dewatering pipe to direct the flow into. As the land is owned by New York State, any new structures on the property must be included within an approved Unit Management Plan (UMP). A draft UMP for the Lake George Wild Forest is pending approval, and has been pending approval for the past four years. Included in this UMP is a provision for installing a permanent dewatering system for the reservoir, which will be installed upon final approval of that document by the Adirondack Park Agency and NYS DEC. While the UMP is pending approval, in 2007 the Town of Lake George and Warren County SWCD worked to install a temporary piping system to route the stream around the reservoir during excavation. Following dewatering activities, over 1,400 cubic yards of sediment was then excavated and removed from the reservoir. This was a cooperative effort between the Warren County SWCD and the Town of Lake George, and funded through the Lake George Watershed Conference. By excavating as much sediment and material as possible from this basin (approximately 1,400 cubic yards in 2007, and 1,200 cubic yards in 1999), it once again has the capability of slowing flow and collecting in-stream sediment.

Town of Lake George Highway Superintendent Hoddy Oviitt overseeing the removal of more than 1,400 cubic yards of sediment, leaves and debris from Hubble Reservoir in 2007

1. Ensure that the permanent dewatering provisions included for Hubble Reservoir are still included in the final Unit Management Plan for the Lake George Wild Forest, and provide follow-up with DEC and APA as necessary.
2. Develop a consistent funding stream and clean out this reservoir every 3-5 years as necessary, as the reservoir reaches 75% capacity.
3. Once approved, design and install permanent dewatering structures for the reservoir and fix the broken sluice gate and valve stem in the dam.
4. With the proposed new Dam Regulations in NYS, an inspection of Hubble Dam will be required by a licensed engineer, likely by 2015 or sooner. This dam does have evidence of signs of ageing, and an inspection of this structure should be conducted for public safety in general. Estimated Costs: \$50,000
