Stewart Brook / Dula Pond Watershed Assessment

Prepared For the Town of Bolton

by the Warren County Soil and Water Conservation District

February 2012

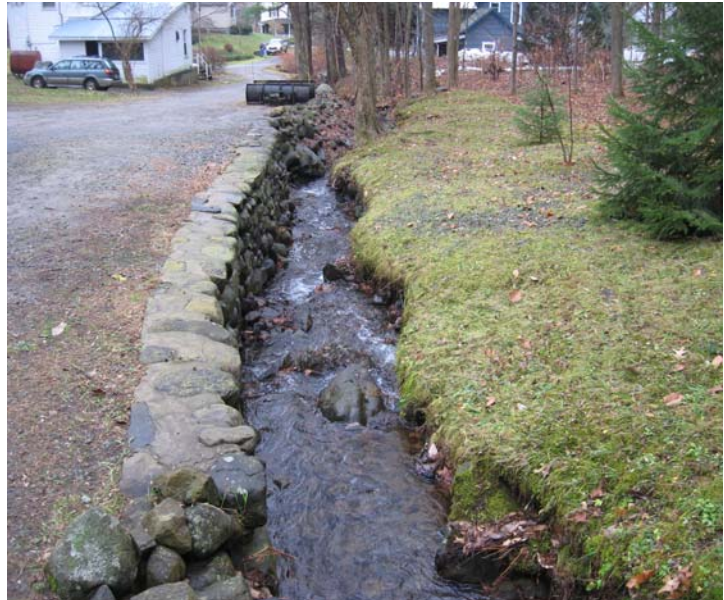
As Stewart Brook runs through the heavily developed hamlet of Bolton, stormwater runoff from these developed areas discharge into the brook in many locations. The road network in the Stewart Brook Watershed crosses and parallels the stream for the majority of its length. The stormwater pipes from the road network outlet directly to Stewart Brook, emptying large quantities of stormwater, sediment and pollutants directly to the stream. This rapid increase in flow to the channel only exacerbates the erosion and flooding issues along the brook length.

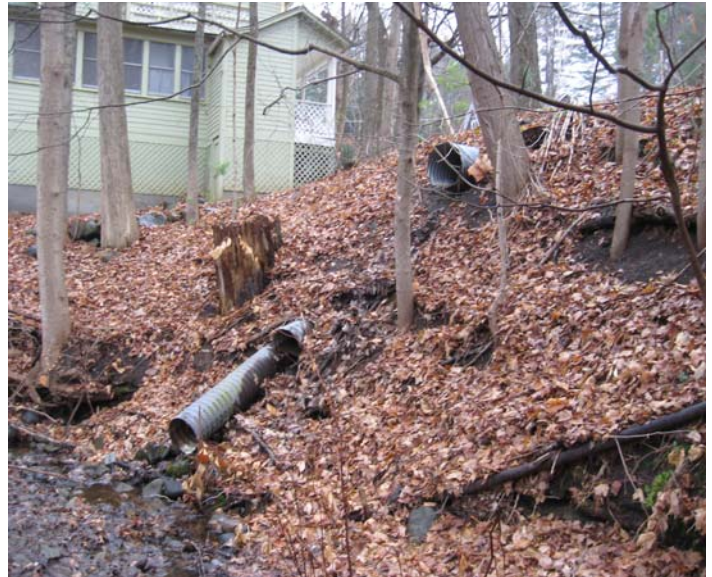
The highest concentration of drop inlets are located along Brook Street, Goodman Avenue and Cross Street, most of which drain into the stream. There is an opportunity to retrofit several of the existing drop inlets with drywells or other

infiltration devices to filter this stormwater into the ground before it is outlet into the stream.

The best sites for retrofitting with roadside drywells have been identified by SWCD staff, based upon ability to capture and infiltrate stormwater and reasonable ability to construct improvements based on site observations and limitations. The drainage areas and recommended locations of proposed drywells are shown on Appendix A. Each drywell installation costs approximately \$3,000, using a contracted excavator and operator and town trucking and labor assistance.
