Town of Bolton Stormwater Retrofit Opportunities

Warren County Soil and Water
Conservation District

For the Town of Bolton under the Lake George Park
Commission Community Stormwater Grant Program

April 2013

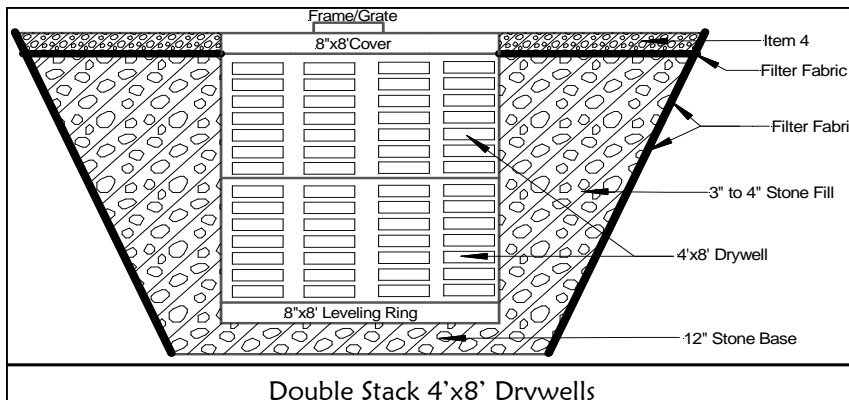
stormwater also prevents large volumes from accumulating at high velocities on steep roads creating other stormwater issues such as roadside erosion. Mohican Road is a straight road with paved swales that allow stormwater velocity to build and increase which in turn increases distance of stormwater travel and decreases infiltration rates. The increased stormwater velocity also carries higher amounts of de-icing materials and other pollutants.

A Mohican Road stormwater infiltration system is already well into the planning stages and consists of three potential locations located a third of a mile west of the intersection of Lake Shore Drive. Each of the planned drywells installations are located above drainage outfalls which will divert the stormwater from the ditching to a drywell. Depending on site constraints, the plan is to install one or two drywells that would be in series at each identified location. A test pit will be dug this spring and the groundwater elevation will determine size and depth of drywells. The series of drywells will all be

located on the south side of Mohican Road due to utilities and other site constraints on the north side. The three drywell location will not be connected lessening the construction and disturbance footprint and allowing the ability to break up stormwater over a larger distance.
