# *West Brook Stormwater Mitigation Project*

## *Final Report*

Warren County Soil and Water Conservation District

February 3, 2004

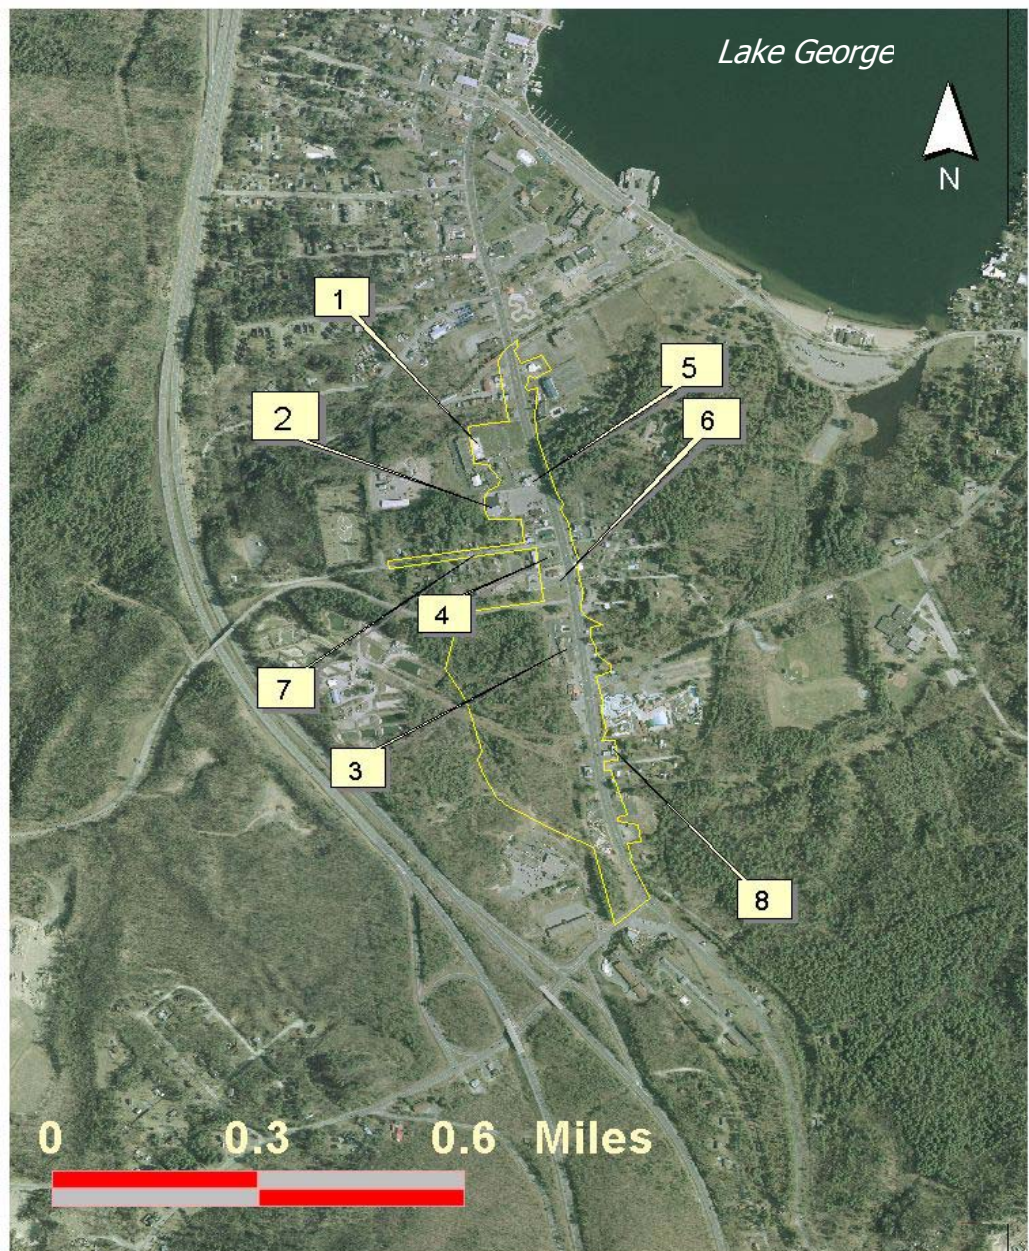
*Aerial photo of the southern tip of Lake George. The numbers identify the locations of the properties retrofitted in this project. The yellow line delineates the subwatershed which drains north into West Brook from NYS Route 9.*

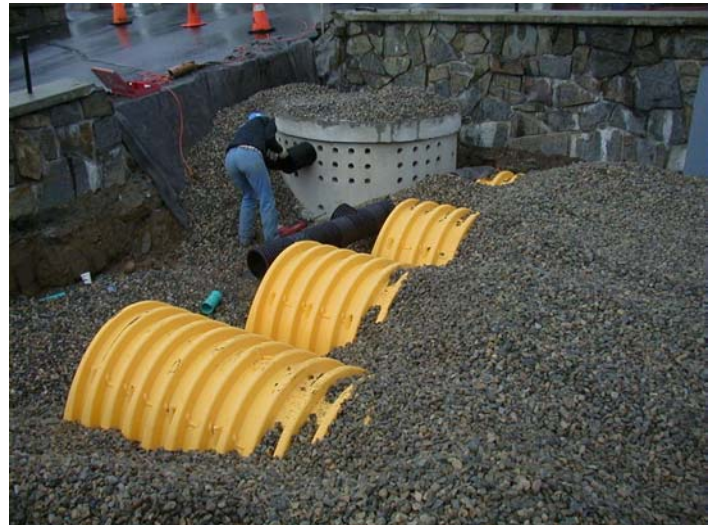
The drainage areas have been divided into areas "A", "B", and "C", which are identified on the drainage area map. Space for stormwater improvement structures is limited at this property, so a best attempt was made to accommodate as much stormwater as possible within the defined project locations. A minimum of the first half-inch of runoff from the drainage area is stored in each structure, and in some cases, up to one-inch.
