Halfway Brook Watershed Management Plan

**WARREN COUNTY SOIL & WATER
CONSERVATION DISTRICT**

**WASHINGTON COUNTY SOIL & WATER
CONSERVATION DISTRICT**

The Halfway Brook Watershed Assessment Plan

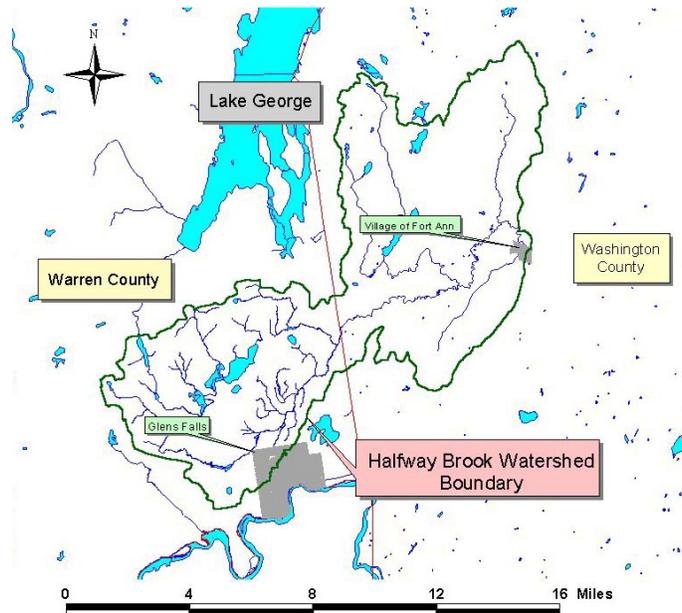
Halfway Brook watershed location map

The main branch of Halfway Brook is 26 miles long, and is located in Warren and Washington Counties. The headwaters of Halfway Brook flow into Wilkie Reservoir, found in the Luzerne Mountains, on the west-side of Queensbury New York. The main stem of Halfway Brook flows generally west to east from Warren County through Washington County. After its 26 mile run, the brook empties into the Lake Champlain Canal, at the Village of Fort Ann in Washington County. The Champlain Canal then flows northward to the South Bay of Lake Champlain.

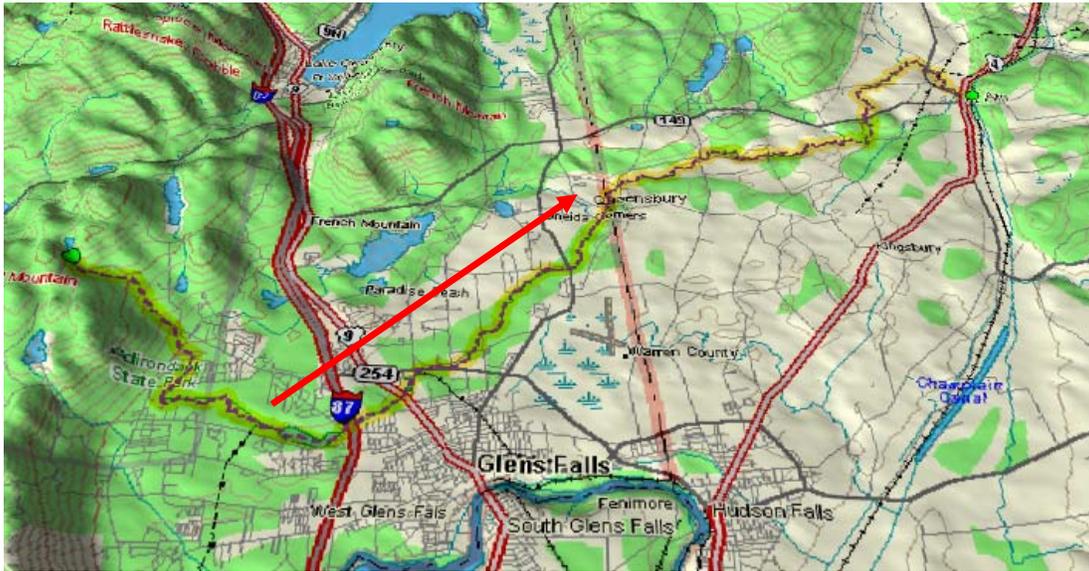
Halfway Brook; highlighted in yellow, travelling wets to east

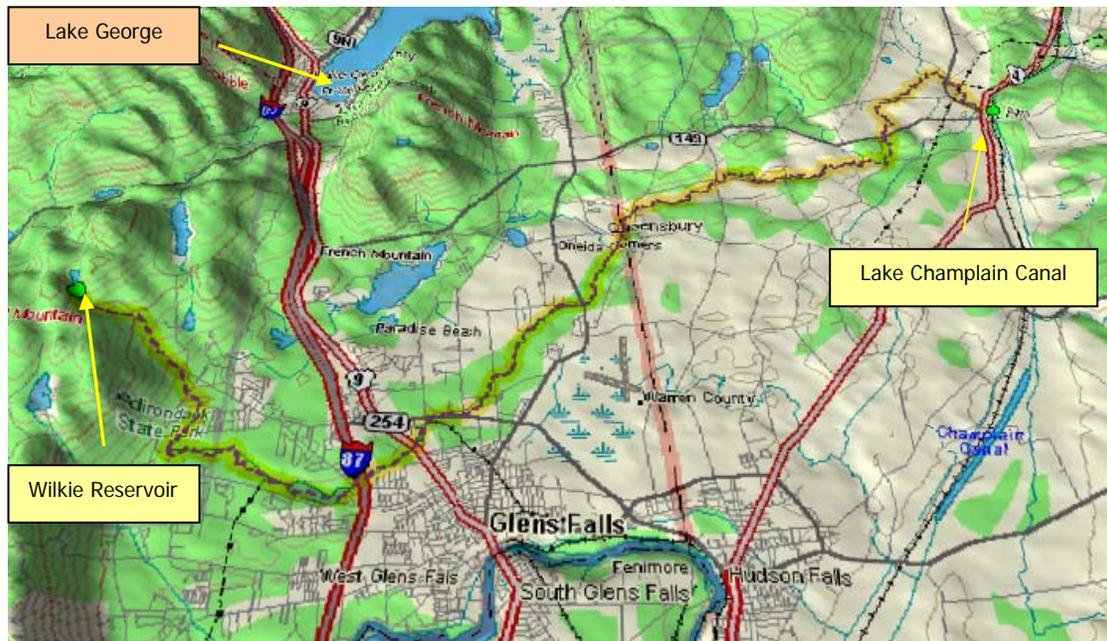
Topography of the Halfway Brook watershed

There is a wide range of topography within the Halfway Brook watershed. The mainstem of Halfway Brook, originating at the Wilkie Reservoir outlet is 1308 feet above mean sea level. The outlet, at the Village of Fort Ann is 136 feet above mean sea level. The resulting slope for the mainstem is 0.85%, a relatively flat slope. The highest elevation in the watershed is Pilot Knob, on the Northwest watershed boundary line, a 2163 feet above mean sea level. In Warren County, the Luzerne Mountains dominate the landscape on the western most section of the watershed. After Halfway Brook crosses West Mountain Road, the total change in elevation to the county boundary is approximately 210 feet.

After the initial drop in elevation (806 feet, 7% slope) from the Wilkie intake Reservoir to West Mountain Road, Halfway Brook travels through the gently sloping land south of the Adirondack Mountains. Large areas of flat topography dominate in the Queensbury-Glens Falls area, with many wetlands bordering the stream. As it crosses the county line, it begins to travel through a deeper valley, with sides in some instances as high as 40 to 50 feet.

It continues its course until reaching South Bay Road (Washington County Route 16), in the Town of Fort Ann. As it travels east of South Bay Road, a waterfall of approximately 40 feet (Kane Falls) occurs. At the bottom of the falls the stream travels approximately 1.4 miles (elevation change from the top of the falls to the canal is 49 feet, 0.7% slope) to the confluence of the Champlain Canal, in the Village of Fort Ann.

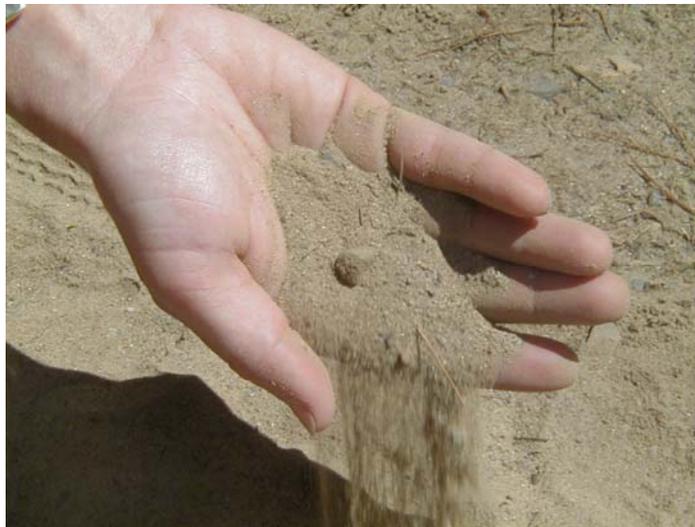
Typical sandy soil of Warren County, NY

Oakville loamy fine sand: This soil is formed in sandy outwash deposits on terraces and plains. Generally the slope is 0 to 8%, and permeability of water through the soil is rapid. These soils are mainly found in the urbanized areas, some areas have been used for farming. These soils are well suited to recreation, but lack the ability to maintain good grass cover due to low amounts of nutrients found in this soil.

Wareham loamy sand: This soil is somewhat poorly drained and very poorly drained. It is found in depressions on sandy plains and low benches in valleys. The slope range is generally from 0 to 3%, and permeability of water through the soil is rapid. A seasonal high water table is found between the surface and a depth of 1.5 feet most of the year. Most areas of this soil are forested. The soil is poorly suited to recreation and urban uses due to the high water table. Bedrock is generally found below 6 feet.

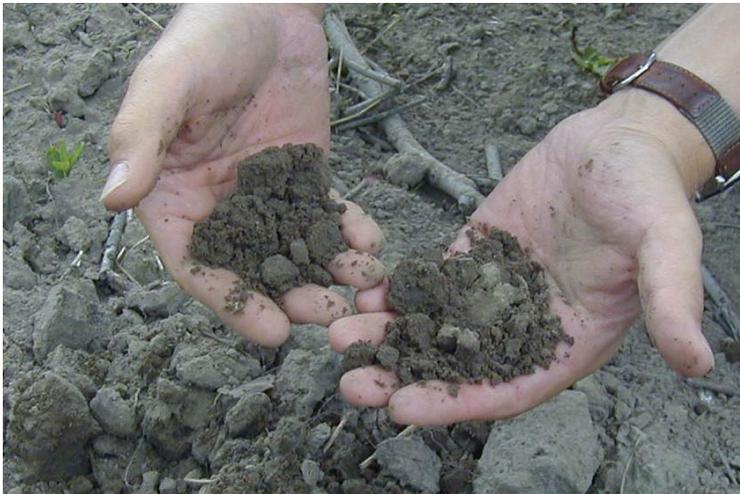
Clay soils of Washington County.

Very near the county boundary on Halfway Brook, the soils change dramatically. The sandy soils of Warren County are replaced by more clay dominant soils of Washington County. The clay soils of Washington County, like Warren County, are the result of glaciation. Vergennes and Kingsbury soils formed from lake laid deposits from what was once an estuary of the Champlain Sea.

The clay soils of the county are found on broad plains that are nearly level or gently sloping, ranging from 0 to 12% grade. Permeability can range from moderately well drained to somewhat poorly drained. A seasonal high water table perched on a very impermeable subsoil at a depth of 6 to 18 inches is common. The three commonly found soils in the watershed follow:

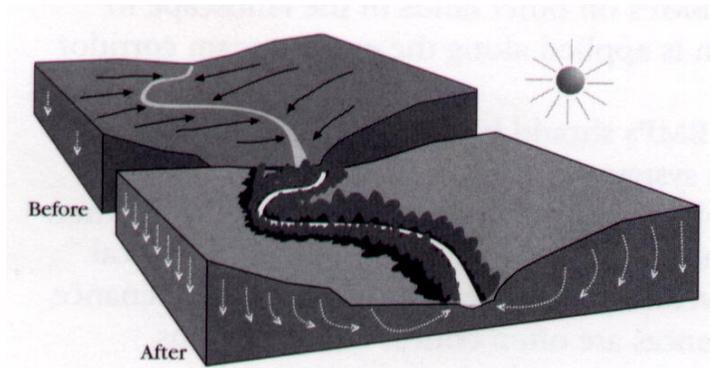
Vegetation management (The Federal Interagency Stream Restoration Working Group, 1998)

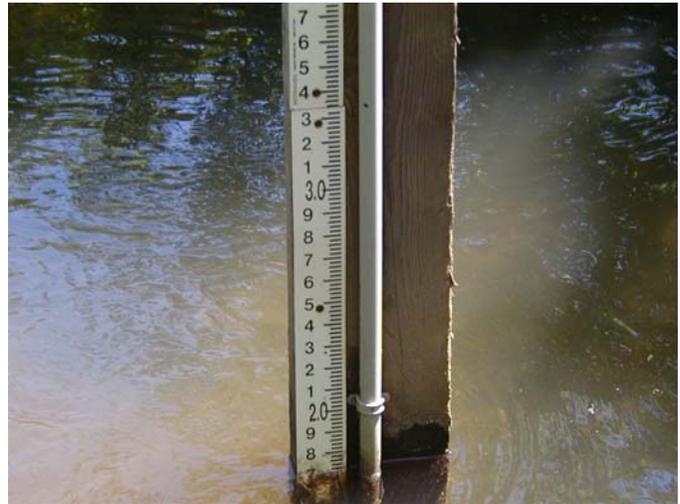
Staff gauge at Meadowbrook Road

The depth and velocity of a stream or river is constantly changing. Some of the change is relatively small (evaporation throughout the day), while storm events may turn a small meadow stream a raging torrent. In order to determine the flow without measuring it every time, a stream rating curve needs to be developed. The stream flow (discharge) and staff gauge heights (water surface elevations) are plotted against one another and regression line is created. When the formula is produced, and a reading from the staff gauge is used, the stream's discharge can be determined without actually measuring the flow.

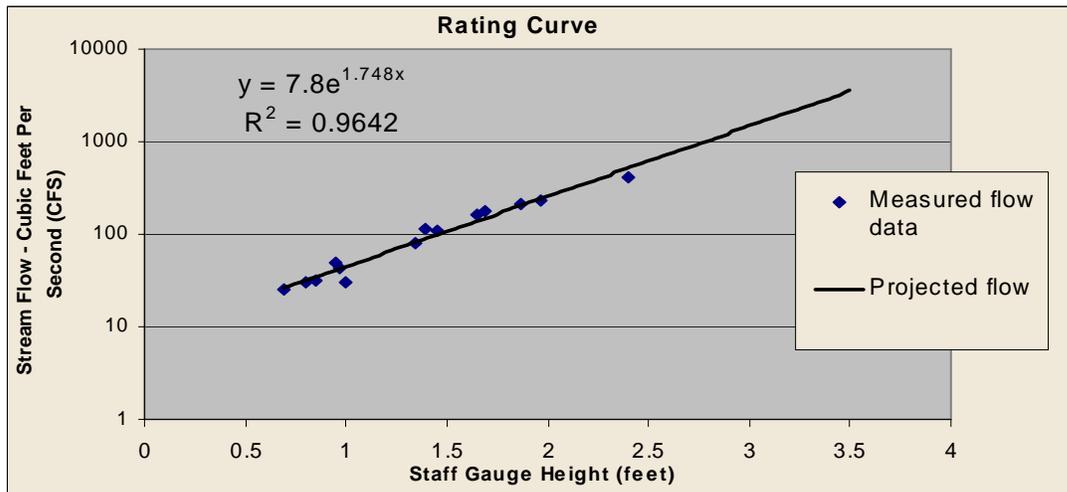
Stage rating curve for Kane Falls, Fort Ann, NY

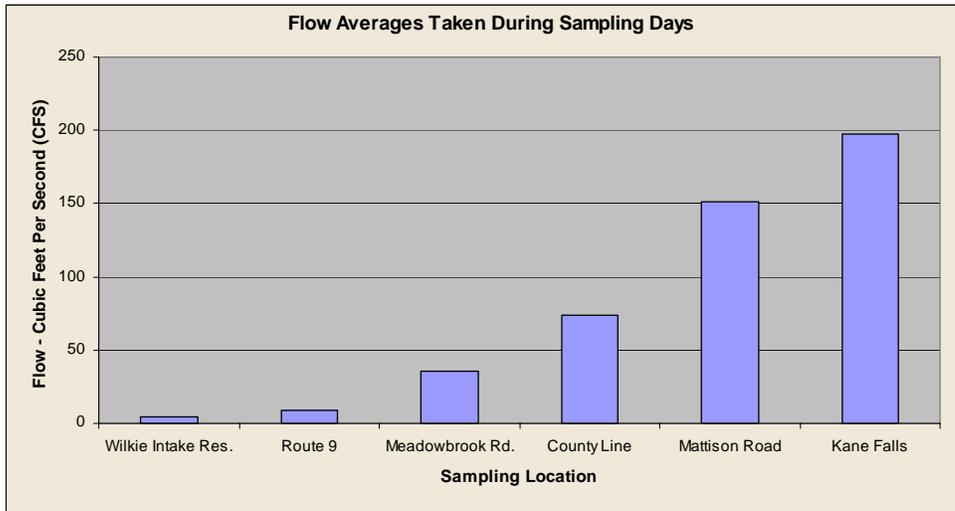
The following charts reflect the flows of Halfway Brook and some of the pollutant concentrations at the various sampling locations.

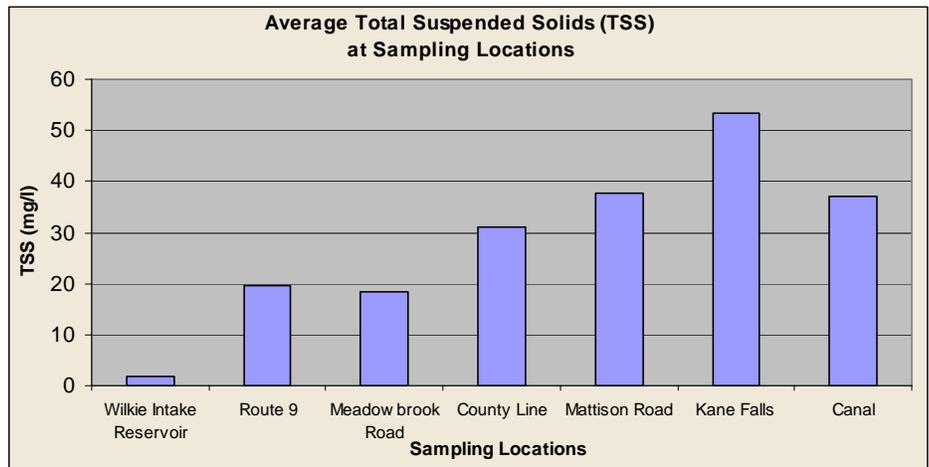
erosion of the stream banks. Agricultural activities and increased runoff from developed lands can accelerate erosion. In the Washington County sampling sites, clay soils are found. An increase in the amount of clay particles in the water, due to erosion or run off may increase the amount phosphorus (see reactive phosphorus) in the water. If this occurs, the phytoplankton living in the stream will utilize this and their population levels will expand. Reducing erosion within the watershed would likely reduce the TSS levels at the lower sampling locations, as well as reduce phosphorus levels.

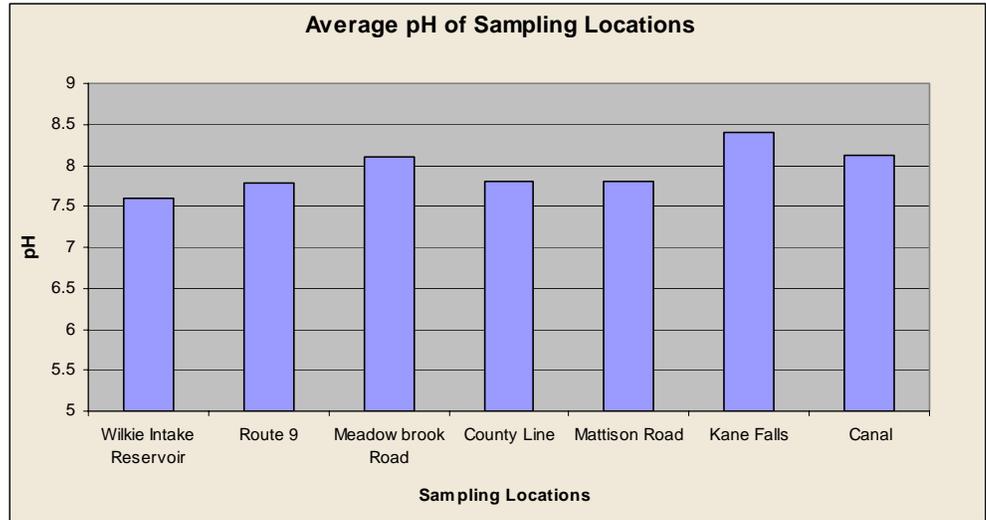
pH of a waterbody (Behar et al., 1997). pH can affect many chemical and biological processes in water, and influence what organisms are found there. Most aquatic organisms prefer a range of 6.5 to 8.0 (Behar et al., 1997). Halfway Brook's average pH is between 7.6 and 8.4, which is within normal parameters.

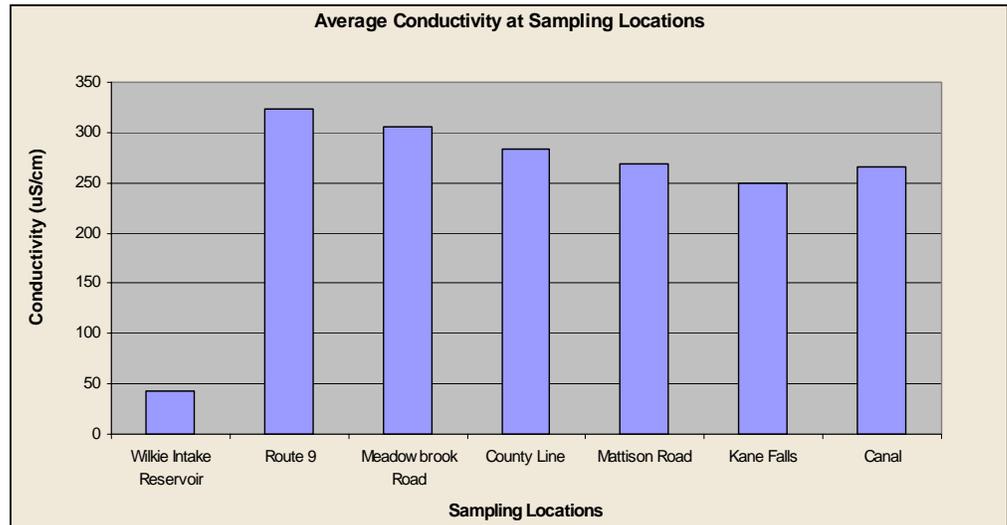
that once established can be used as a baseline for comparing with other future measurements (Behar, et al., 1997). Conductivity is affected primarily by the geology of the area and by the presence of naturally occurring electrolytes (i.e. salts) (Behar et al., 1997). Streams with granite predominating the geology of the region tend to have lower conductivity, while streams with high amounts of clay have higher conductivity. Sources that are not naturally occurring which would affect conductivity; failing septic discharges, discharge of heavy metals or water runoff from developed areas or agricultural land. The general range in the United States for conductivity is from 50 to 1500 $\mu\text{S}/\text{cm}$ (microsiemens per centimeter) (Behar et al., 1997). Waters that have a good mixed fishery have a range between 150 and 500 $\mu\text{S}/\text{cm}$ (Behar et al., 1997). The range for Halfway Brook falls well under the typical high range of 1500. According to the data, conductivity increases dramatically downstream of the Wilkie Intake Reservoir and runoff is the likely source for the increase.

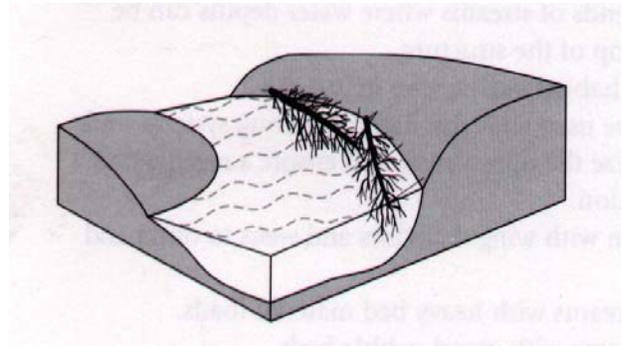
Tree Cover Structure (The Federal Interagency Stream Restoration Working Group, 1998)

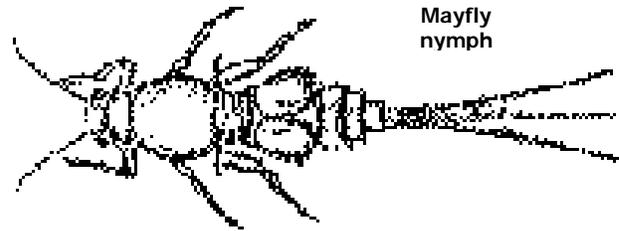
Downstream of Route 9, the stream macroinvertebrate populations are representative of a moderately impacted stream. The water quality drop at the Meadowbrook Road site may be an effect of stormwater inputs. Between the two sampling locations (approx. 1.75 linear miles) there are three tributaries that enter Halfway Brook. All three carry stormwater runoff from developed areas to a degree, and this may influence the insect population.

The survey was conducted during the 1999 summer sampling season, which was one of the driest in the past century. Sampling was conducted shortly after Tropical Storm Floyd, which contributed significant rainfall to the region. The data collected in 1998 at Fort Ann closely follows the samples obtained in 1999. This suggests that the extreme weather patterns that were experienced did not affect the samples.

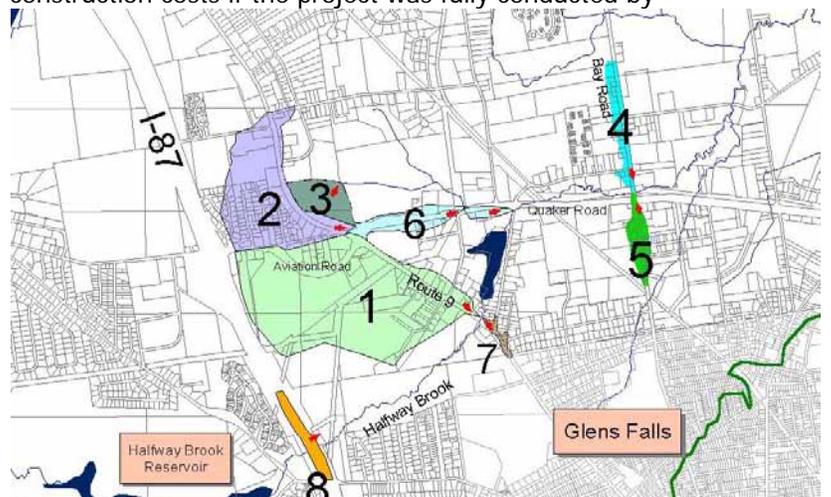
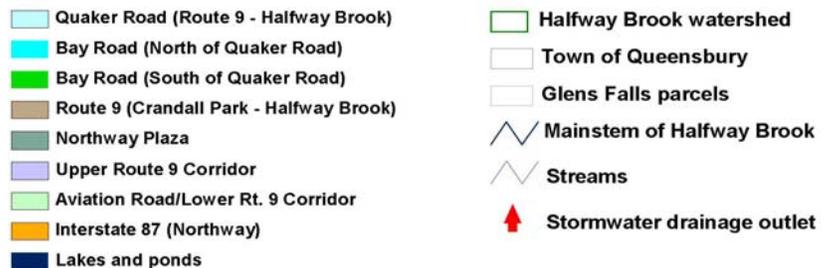
Stormwater location maps - Queensbury, NY

Overview: The most significant problem found with stormwater impacts to Halfway Brook comes from the route 9 corridor in Queensbury. Stormwater from the Aviation Mall area on Aviation Road flows down to the intersection of Aviation Road and Route 9, entering the Route 9 drainage line. From this

intersection, stormwater flows south along Route 9 to the northeast culvert at the intersection of Halfway Brook and Route 9 across the street from Price Chopper. This entire area has been developed primarily with commercial properties, and open space is extremely limited. The stormwater drainage area from the following two combined drainages is over 170 acres, all of which outlets into Halfway Brook through a 48" culvert. To improve the stormwater in this area, the drainage area should be divided into two parts: Aviation Road and Lower Route 9. This division is necessitated by the lack of available area for stormwater improvement structures on the lower Route 9 corridor.

Recommendation - *Aviation Road*: Stormwater flows down Aviation Road and outlets into the Route 9 drainage line at the intersection of Aviation and Route 9. To improve the water quality coming from this Aviation line, the undeveloped space between Burger King and Mobil Gas on the southern side of Aviation Road could be used as a treatment area. There is approximately 120 feet by 40 feet of grass area that is undeveloped, potentially available for the installation of one or more underground structures in series (i.e. Vortech or similar structure). This would capture approximately 80 % of the stormwater on Aviation Road and treat it. Although these type of underground stormwater improvement structures do little to remove dissolved pollutants, a large amount of road sand, trash, and debris will be removed from the stormwater.

Recommendation - *Lower Route 9 Corridor (Aviation Road down to Halfway Brook)*: Field work and mapping have shown that there is very limited area to undertake stormwater improvements in this area due to the high level of development and high market value of the land. There are two options for stormwater improvement in this area.

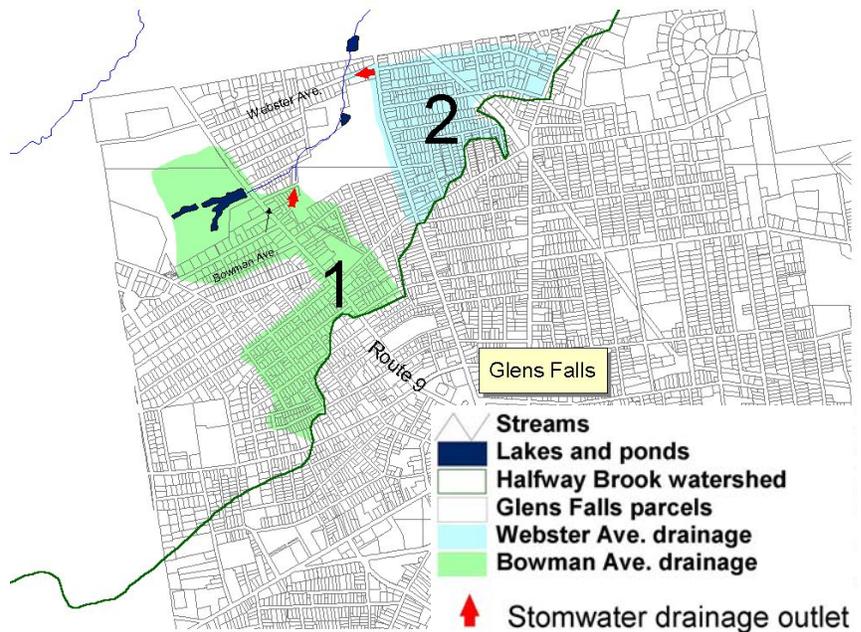
Stormwater location maps – Glens Falls, NY

There is a parcel of undeveloped land owned by the city of Glens Falls which is approximately 30 feet by 30 feet in dimension located at the end of Bowman avenue. This parcel which is adjacent to the outlet of this major stormwater drainage could be utilized for stormwater improvement. Placement of underground water quality improvement structures in this area would increase the detention time and would reduce the stormwater impacts into the Crandall Park tributary to Halfway Brook.

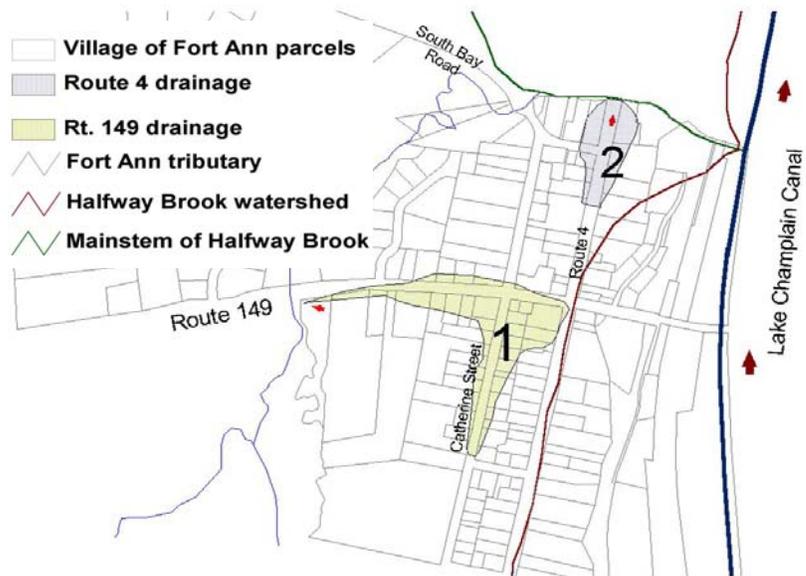
Stormwater location map – Fort Ann, NY

This field area has enough space available (~30 feet by 40 feet) to create a settling pond with a riser structure which will allow the stormwater to infiltrate and settle out any silt and debris.

The outflow from this settling pond would then be a direct outlet into the tributary.
