# Halfway Brook Watershed Management Plan

## August 2000

**WARREN COUNTY SOIL & WATER  
CONSERVATION DISTRICT**

## ***The Halfway Brook Watershed Assessment Plan***

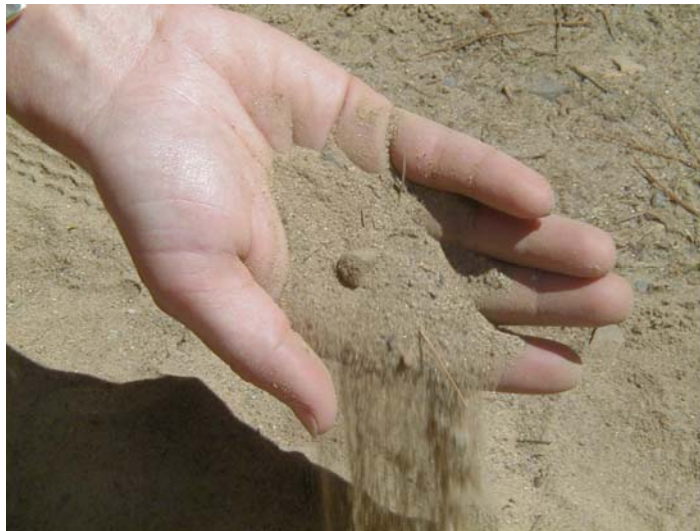
Typical sandy soil of Warren County, NY

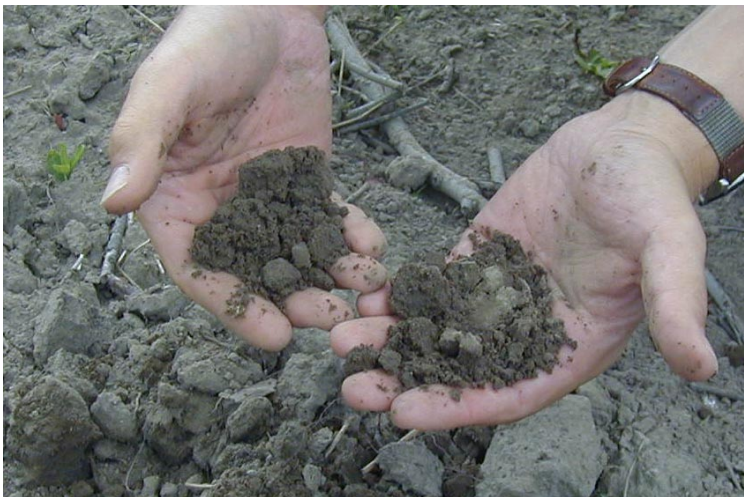
Clay soils of Washington County.

Very near the county boundary on Halfway Brook, the soils change dramatically. The sandy soils of Warren County are replaced by more clay dominant soils of Washington County. The clay soils of Washington County, like Warren County, are the result of glaciation. Vergennes and Kingsbury soils formed from lake laid deposits from what was once an estuary of the Champlain Sea.

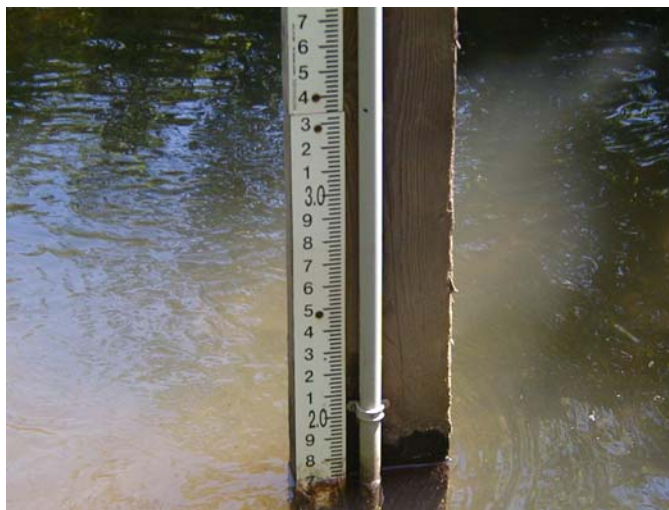
Staff gauge at Meadowbrook Road

The depth and velocity of a stream or river is constantly changing. Some of the change is relatively small (evaporation throughout the day), while storm events may turn a small meadow stream a raging torrent. In order to determine the flow without measuring it every time, a stream rating curve needs to be developed. The stream flow (discharge) and staff gauge heights (water surface elevations) are plotted against one another and regression line is created. When the formula is produced, and a reading from the staff gauge is used, the stream's discharge can be determined without actually measuring the flow.
